September 9, 2023

**Certified Arborist Assessment  
6200 SW 123 Terrace, Pinecrest, Florida  
NLE Project No. 34623002**

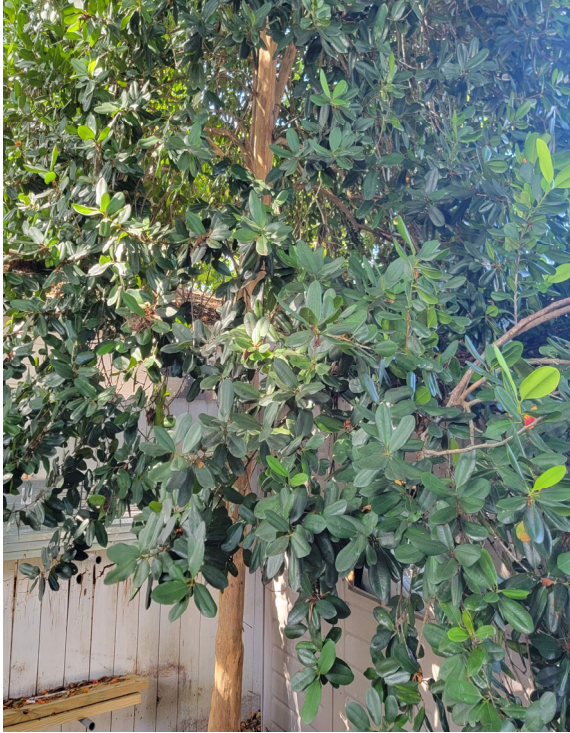
Tree 1 bay rum tree  
(*Pimenta racemosa*)  
6 inch DBH, GOOD condition  
35 foot height, 20 foot spread

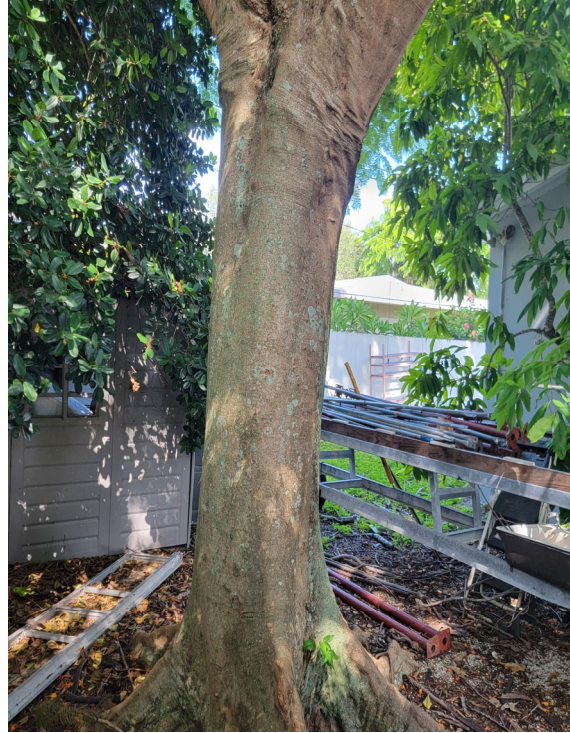
Tree 2 royal poinciana  
(*Delonix regia*)  
26 inch DBH GOOD condition  
55 foot height, 65 foot spread

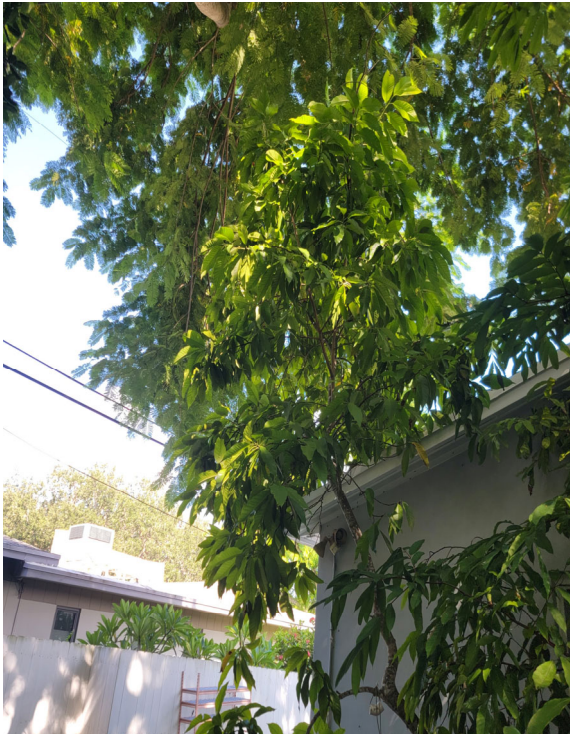
Tree 3 Champak tree  
(*Michelia champaca*)  
4 inch DBH, GOOD condition  
25 foot height, 20 foot spread

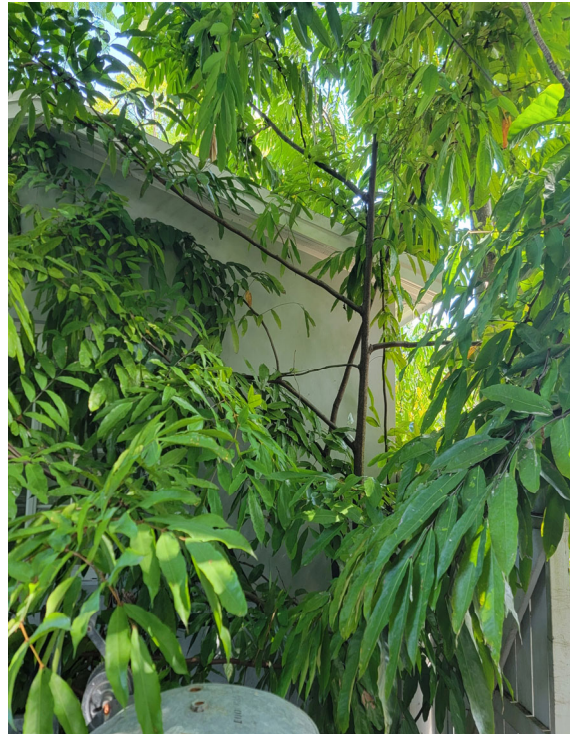
Tree 4 Champak tree  
(*Michelia champaca*)  
4 inch DBH GOOD condition  
25 foot height, 20 foot spread

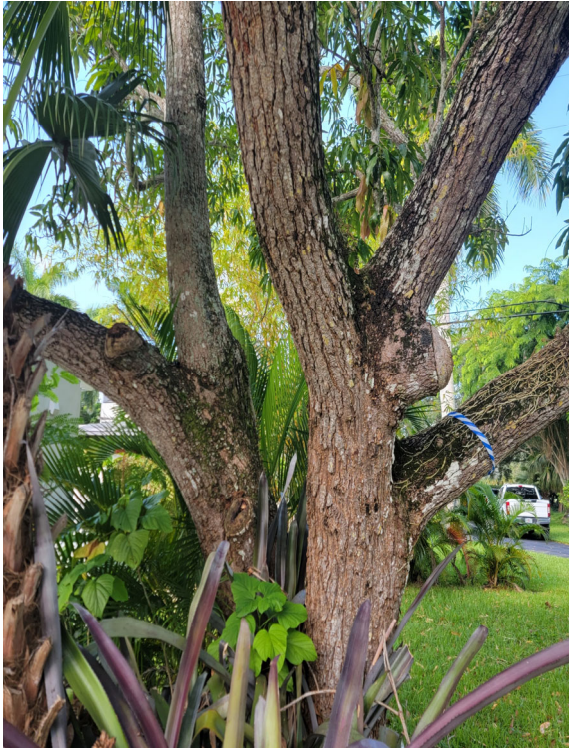
Tree 5 mango  
(*Mangifera indica*)  
28 inch DBH, GOOD condition  
35 foot height, 35 foot spread

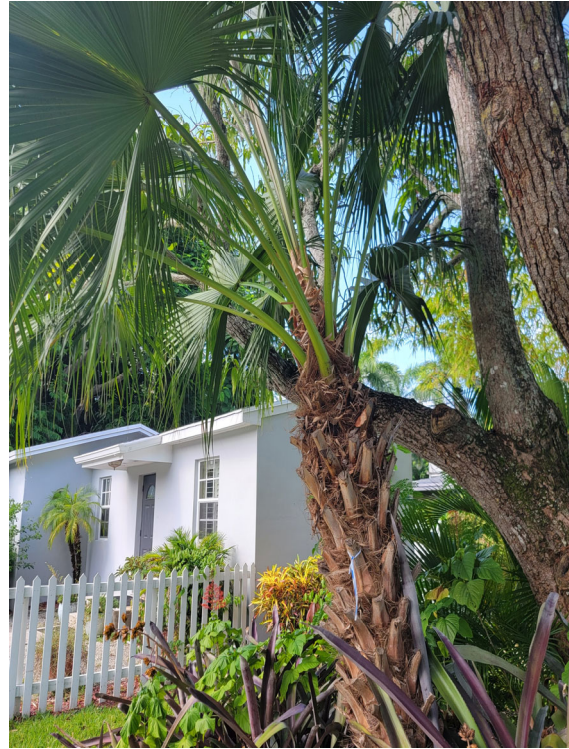
Tree 6 sabal palm  
(*Sabal palmetto*)  
10 inch DBH GOOD condition  
16 foot height, 12 foot spread

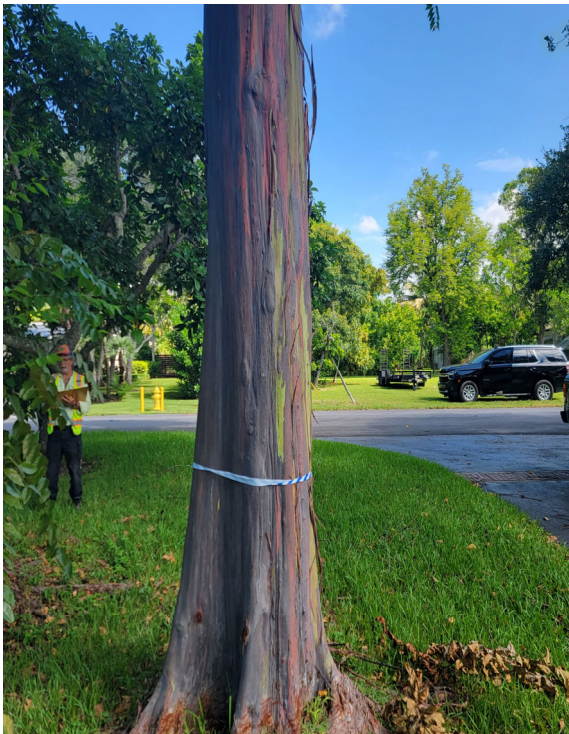
Tree 7 rainbow eucalyptus  
(*Eucalyptus deglupta*)  
25 inch DBH, GOOD condition  
65 foot height, 45 foot spread

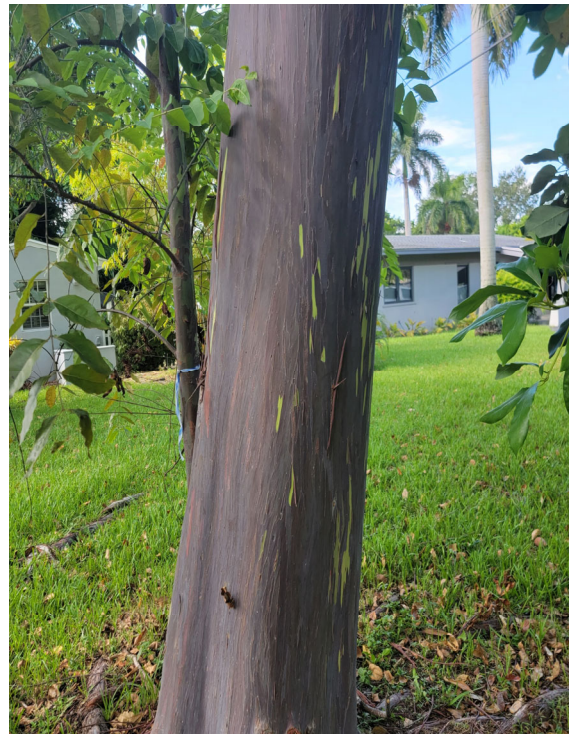
Tree 8 rainbow eucalyptus  
(*Eucalyptus deglupta*)  
22 inch DBH GOOD condition  
65 foot height, 45 foot spread

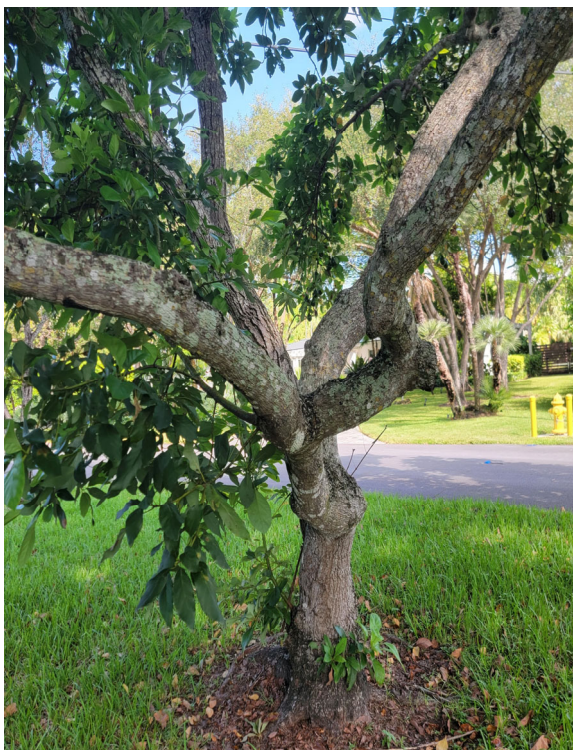
Tree 9 avocado  
(*Persea americana*)  
15 inch DBH, GOOD condition  
30 foot height, 35 foot spread

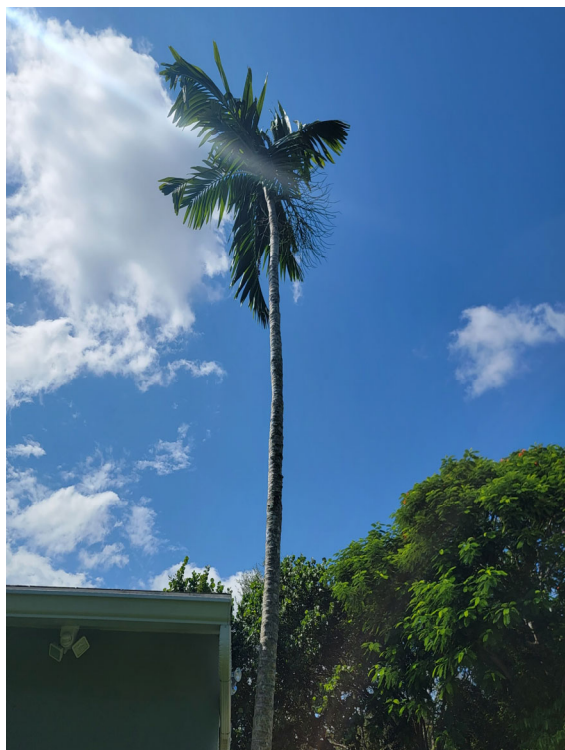
| Tree # | Common Name | Scientific Name | DBH (inches) | Condition | Number of stems | Height (feet) | Spread (feet) | Canopy (square feet) | Prohibited? | Specimen? | Comments |
|---|---|---|---|---|---|---|---|---|---|---|---|
| 10 | macarthur palm | <i>Ptychosperma macarthurii</i> | 5 | POOR | 2 | 36 | 8 | 50 | | | 30'c.t. |

Tree 10 macarthur palm  
(*Ptychosperma macarthurii*)  
5 inch DBH POOR condition  
36 foot height, 8 foot spread

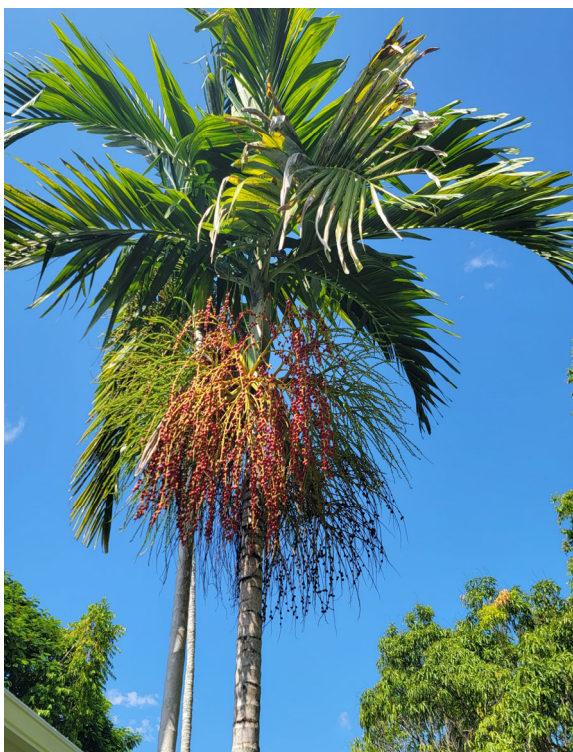
Tree 11 macarthur palm  
(*Ptychosperma macarthurii*)  
cluster inch DBH, FAIR condition  
20 foot height, 10 foot spread

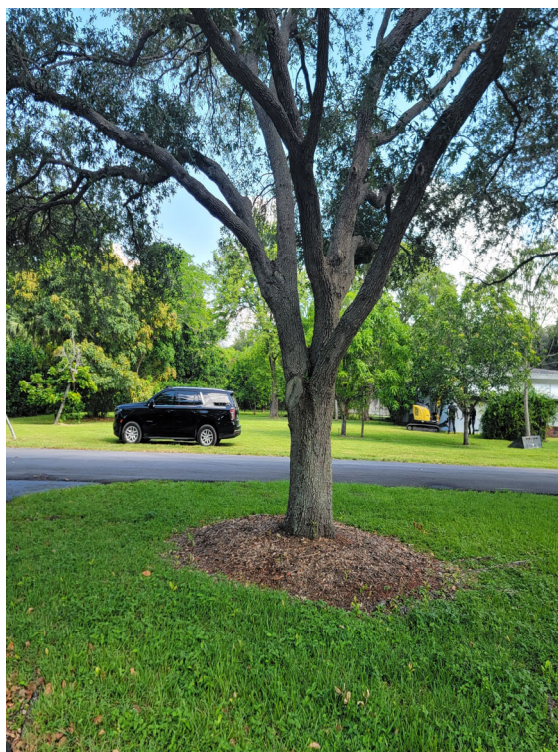
Tree 12 live oak  
(*Quercus virginiana*)  
24 inch DBH GOOD condition  
40 foot height, 30 foot spread

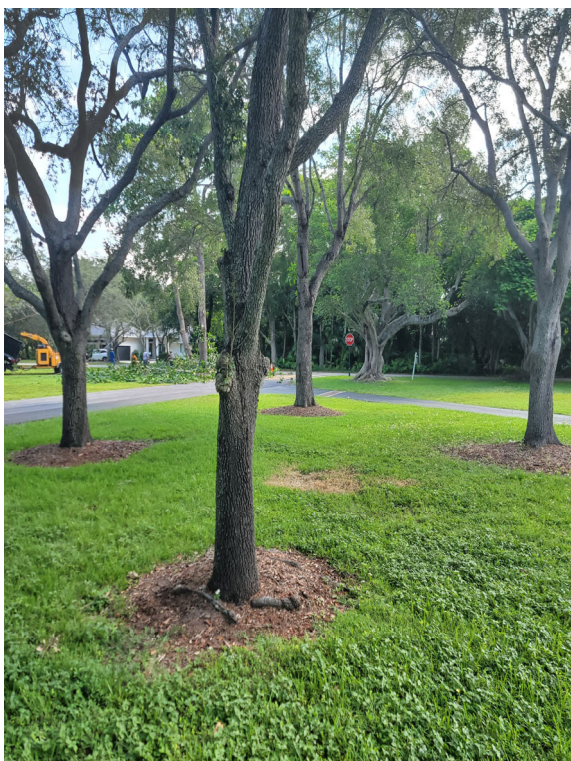
Tree 13 live oak  
(*Quercus virginiana*)  
13 inch DBH, GOOD condition  
40 foot height, 25 foot spread

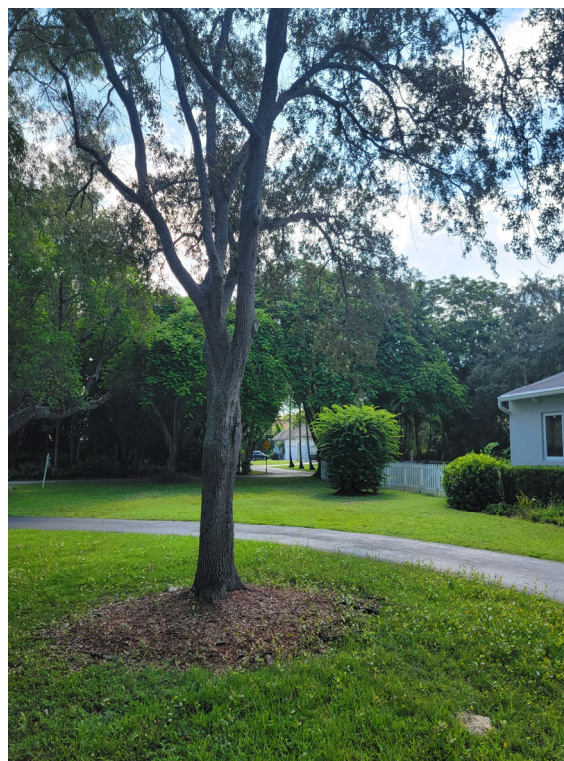
| Tree # | Common Name | Scientific Name | DBH (inches) | Condition | Number of stems | Height (feet) | Spread (feet) | Canopy (square feet) | Prohibited? | Specimen? | Comments |
|---|---|---|---|---|---|---|---|---|---|---|---|
| 14 | live oak | <i>Quercus virginiana</i> | 22 | FAIR | 1 | 40 | 25 | 491 | | Yes | |

Tree 14 live oak  
(*Quercus virginiana*)  
22 inch DBH FAIR condition  
40 foot height, 25 foot spread

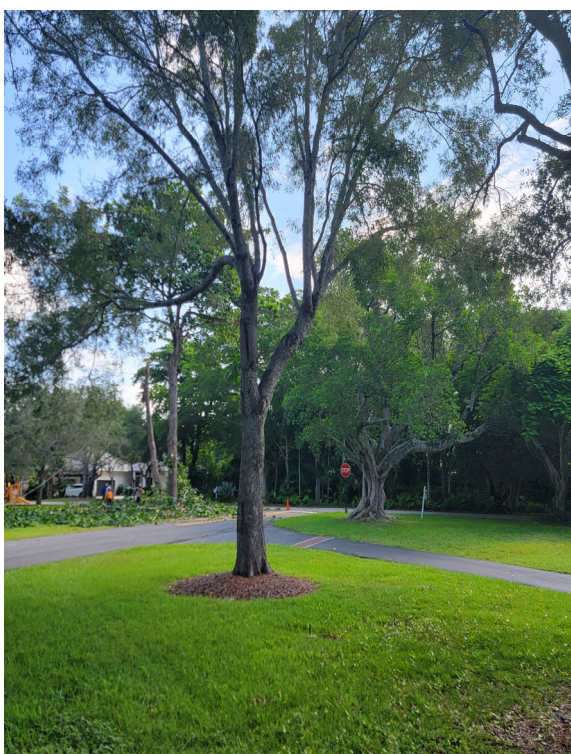
Tree 15 mahogany  
(*Swietenia mahagoni*)  
21 inch DBH, GOOD condition  
45 foot height, 45 foot spread

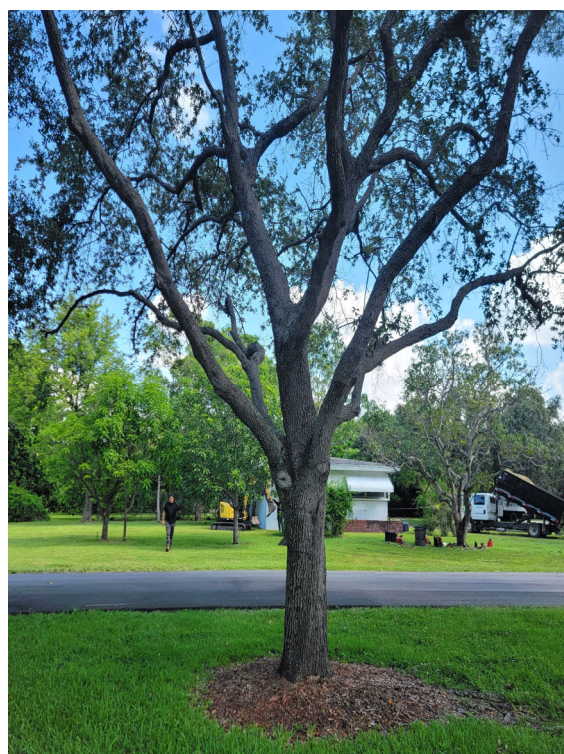
Tree 16 live oak  
(*Quercus virginiana*)  
19 inch DBH GOOD condition  
40 foot height, 40 foot spread

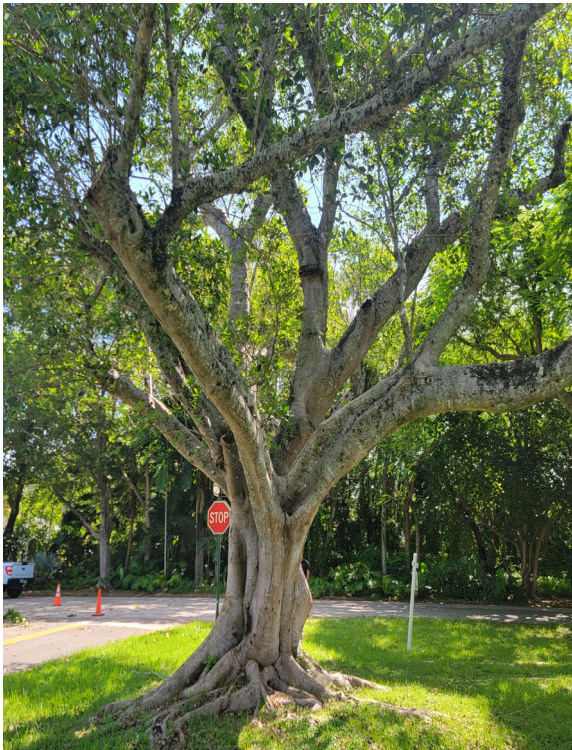
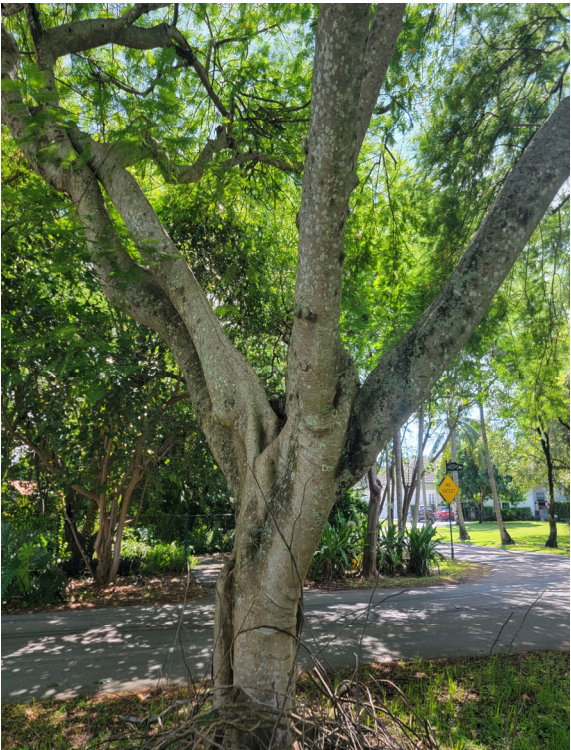
| Tree # | Common Name | Scientific Name | DBH (inches) | Condition | Number of stems | Height (feet) | Spread (feet) | Canopy (square feet) | Prohibited? | Specimen? | Comments |
|---|---|---|---|---|---|---|---|---|---|---|---|
| 17 | strangler fig | <i>Ficus aurea</i> | 58 | FAIR | 4 | 40 | 40 | 1256 | | Yes | ROW, trunk cavities |

| <p>Tree 17 strangler fig<br/>(<i>Ficus aurea</i>)<br/>4 inch DBH, FAIR condition<br/>40 foot height, 40 foot spread</p> <p>ROW, trunk cavities</p> | <p>Tree 18 royal poinciana<br/>(<i>Delonix regia</i>)<br/>35 inch DBH GOOD condition<br/>35 foot height, 50 foot spread</p> <p>ROW</p> |

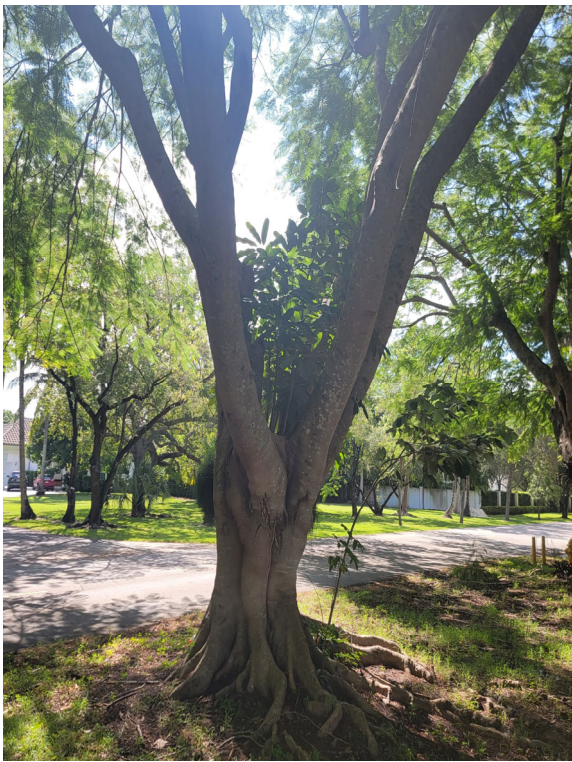
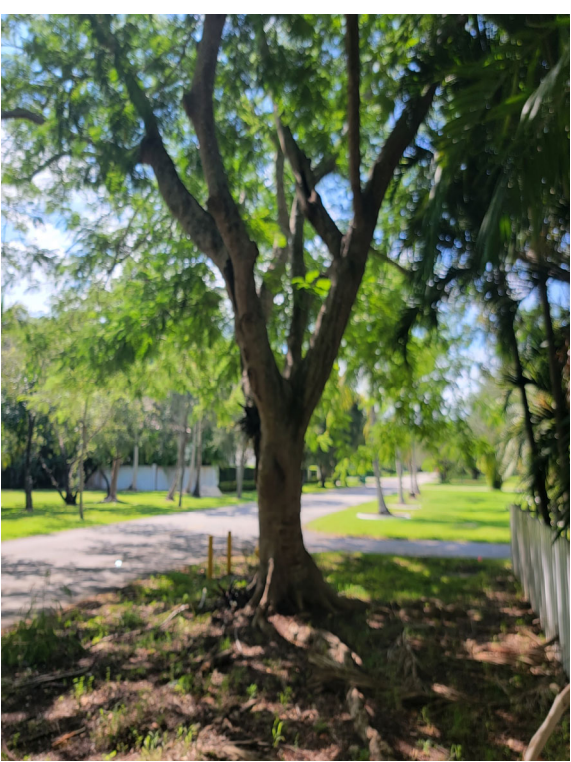
| Tree # | Common Name | Scientific Name | DBH (inches) | Condition | Number of stems | Height (feet) | Spread (feet) | Canopy (square feet) | Prohibited? | Specimen? | Comments |
|---|---|---|---|---|---|---|---|---|---|---|---|
| 19 | royal poinciana | <i>Delonix regia</i> | 40 | POOR | 3 | 45 | 50 | 1963 | | Yes | ROW, large tear out in trunk |

| <p>Tree 19 royal poinciana<br/>(<i>Delonix regia</i>)<br/>40 inch DBH, POOR condition<br/>45 foot height, 50 foot spread</p> <p>ROW, large tear out in trunk</p> | <p>Tree 20 royal poinciana<br/>(<i>Delonix regia</i>)<br/>33 inch DBH GOOD condition<br/>40 foot height, 50 foot spread</p> <p>ROW</p> |

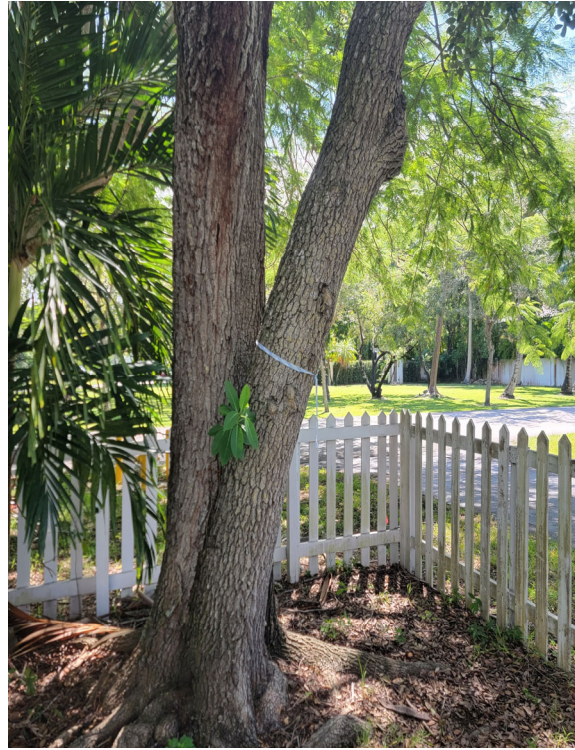
| Tree # | Common Name | Scientific Name | DBH (inches) | Condition | Number of stems | Height (feet) | Spread (feet) | Canopy (square feet) | Prohibited? | Specimen? | Comments |
|---|---|---|---|---|---|---|---|---|---|---|---|
| 22 | live oak | <i>Quercus virginiana</i> | 25 | FAIR | 2 | 40 | 30 | 707 | | Yes | |

Tree 22 live oak  
(*Quercus virginiana*)  
25 inch DBH FAIR condition  
40 foot height, 30 foot spread

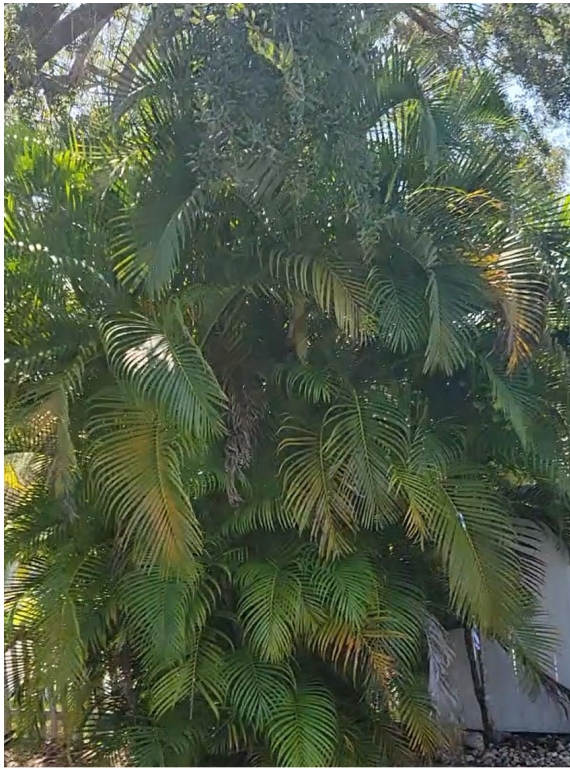
Tree 24 areca palm  
(*Dypsis lutescens*)  
cluster inch DBH, FAIR condition  
18 foot height, 18 foot spread

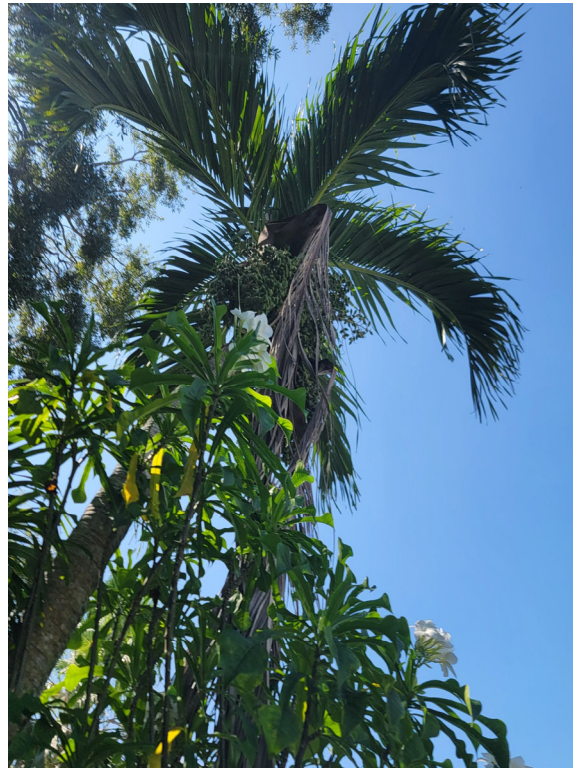
Tree 25 Christmas palm  
(*Adonidia merrellii*)  
7 inch DBH FAIR condition  
20 foot height, 12 foot spread

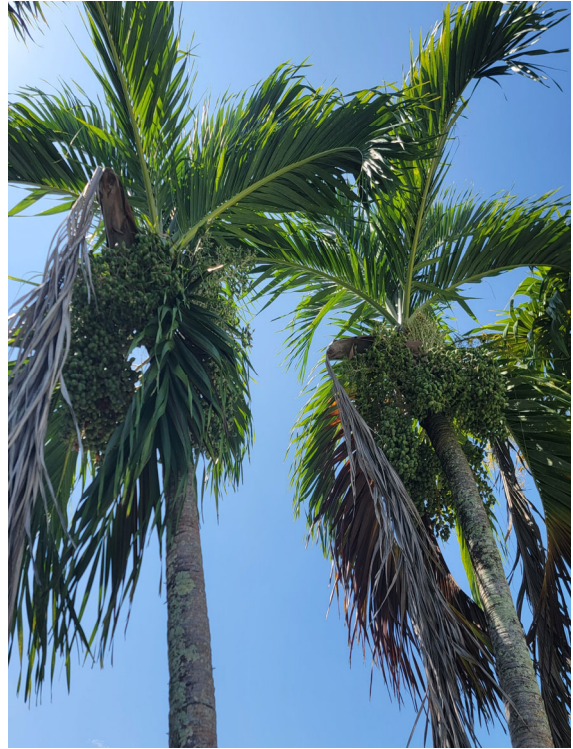
Tree 27 Christmas palm  
(*Adonidia merrellii*)  
cluster inch DBH FAIR condition  
16 foot height, 12 foot spread

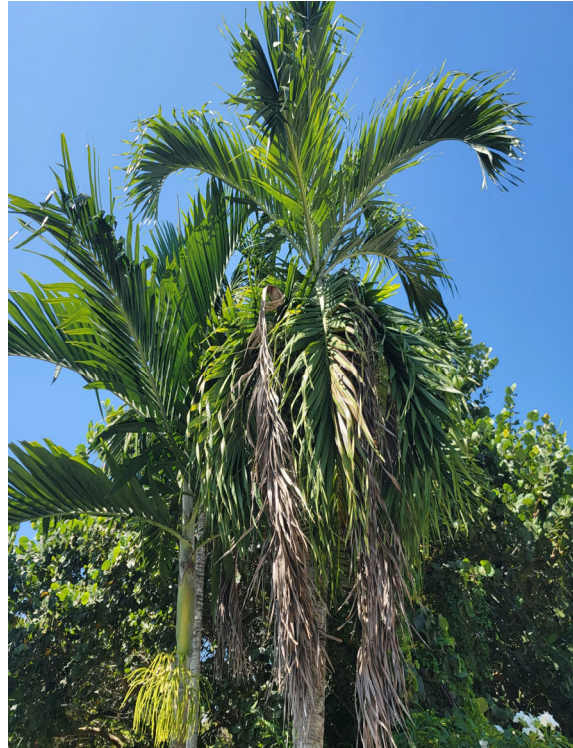
Tree 28A Christmas palm  
(*Adonidia merrellii*)  
8 inch DBH FAIR condition  
23 foot height, 12 foot spread

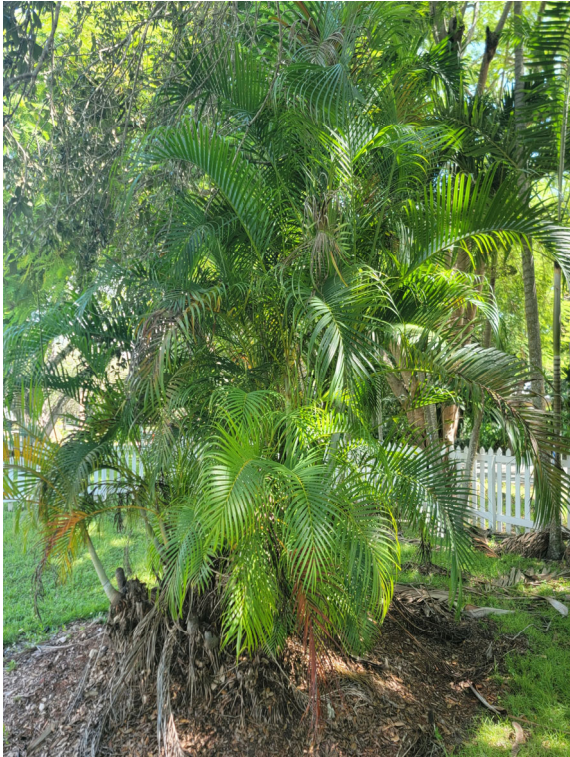
| Tree # | Common Name | Scientific Name | DBH<br>(inches) | Condition | Number<br>of stems | Height<br>(feet) | Spread<br>(feet) | Canopy<br>(square<br>feet) | Prohibited? | Specimen? | Comments |
|---|---|---|---|---|---|---|---|---|---|---|---|
| 31 | areca palm | <i>Dypsis lutescens</i> | cluster | POOR | 1 | 16 | 16 | 201 | | | |

Tree 31 areca palm  
(Dypsis lutescens)  
cluster inch DBH, POOR condition  
16 foot height, 16 foot spread
