## Arboriculture Tree Report

10635 SW 63<sup>rd</sup> Ave, Pinecrest

**Prepared by:** John Sutton  
International Society of Arboriculture Certified Arborist

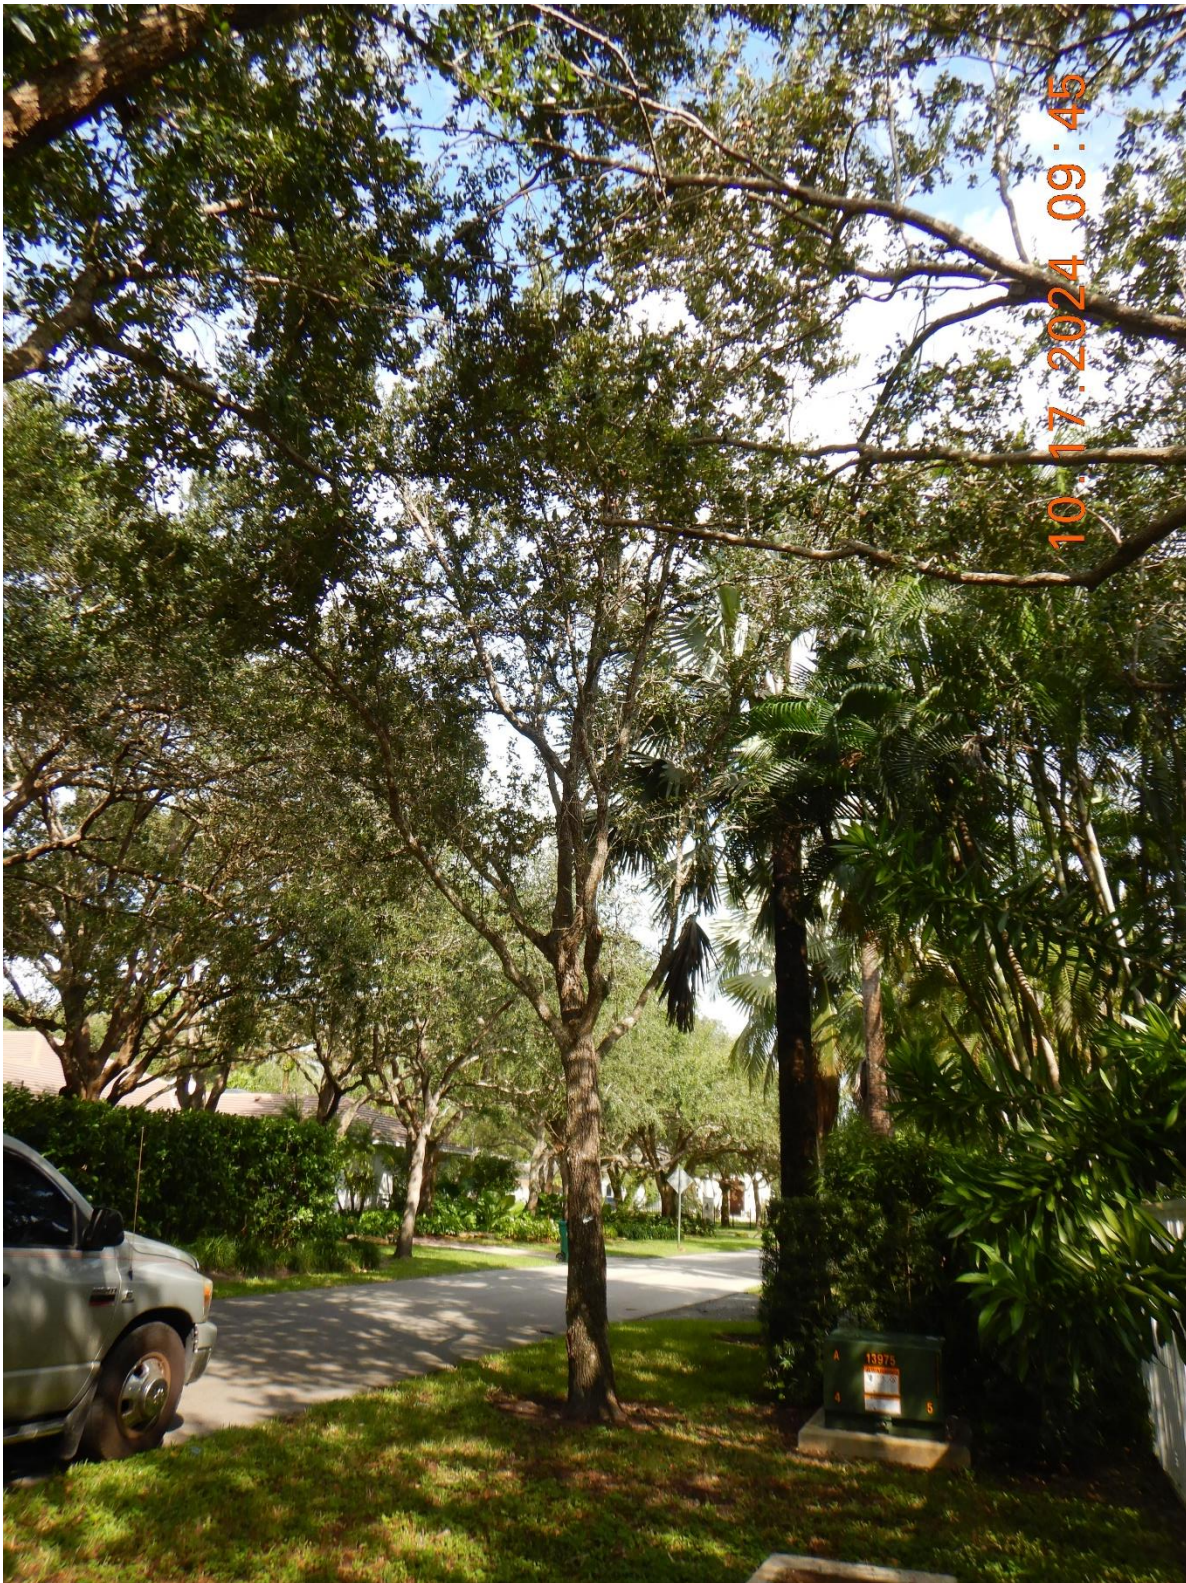
| 1 | Live oak | Quercus virginiana | 12.5 | 12.5 | 6.25 | 30 | 30x28 | 70% | Co-canopy, restricted roots on the West side of the trunk road is 5.5ft away |

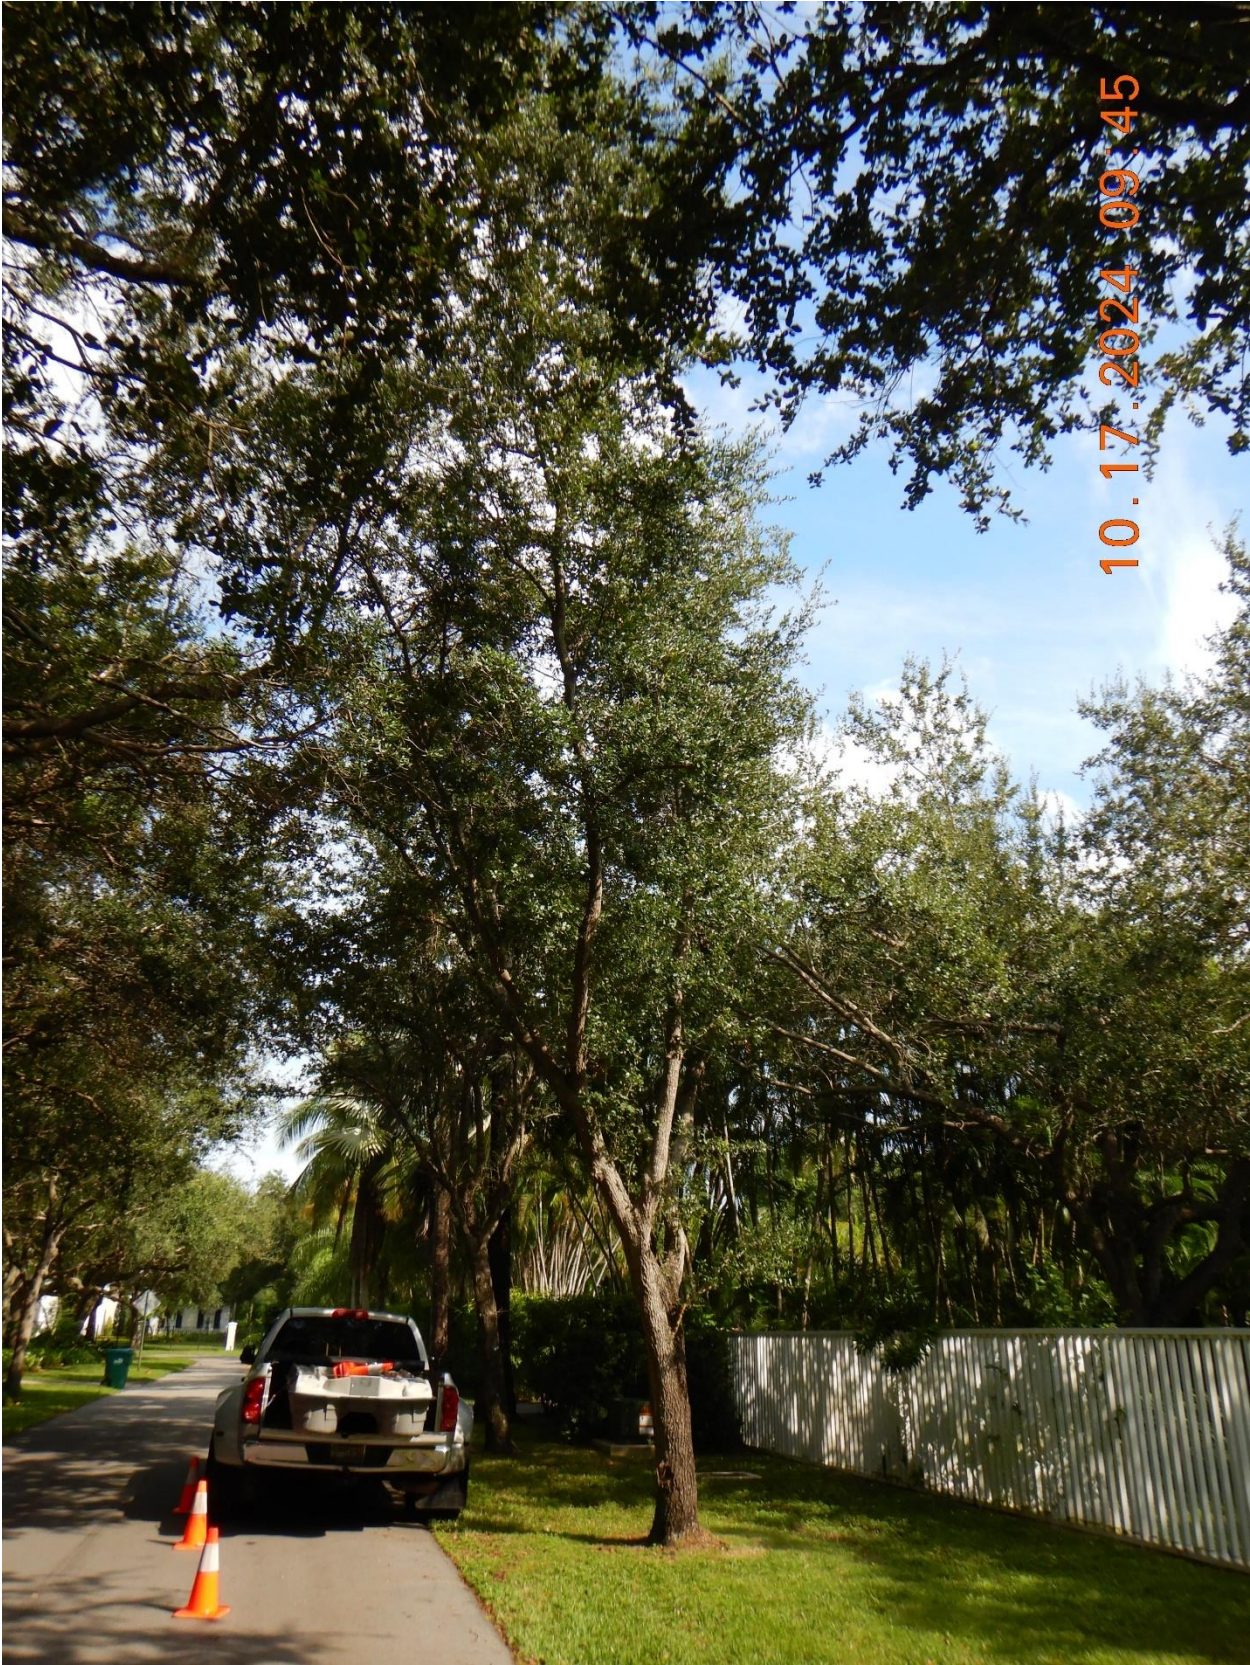
| 2 | Live oak | Quercus virginiana | 14.5 | 14.5 | 7.25 | 32 | 36x26 | 60% | Co-canopy, restricted roots on the West side of the trunk road is 5.5ft away, co-dom |

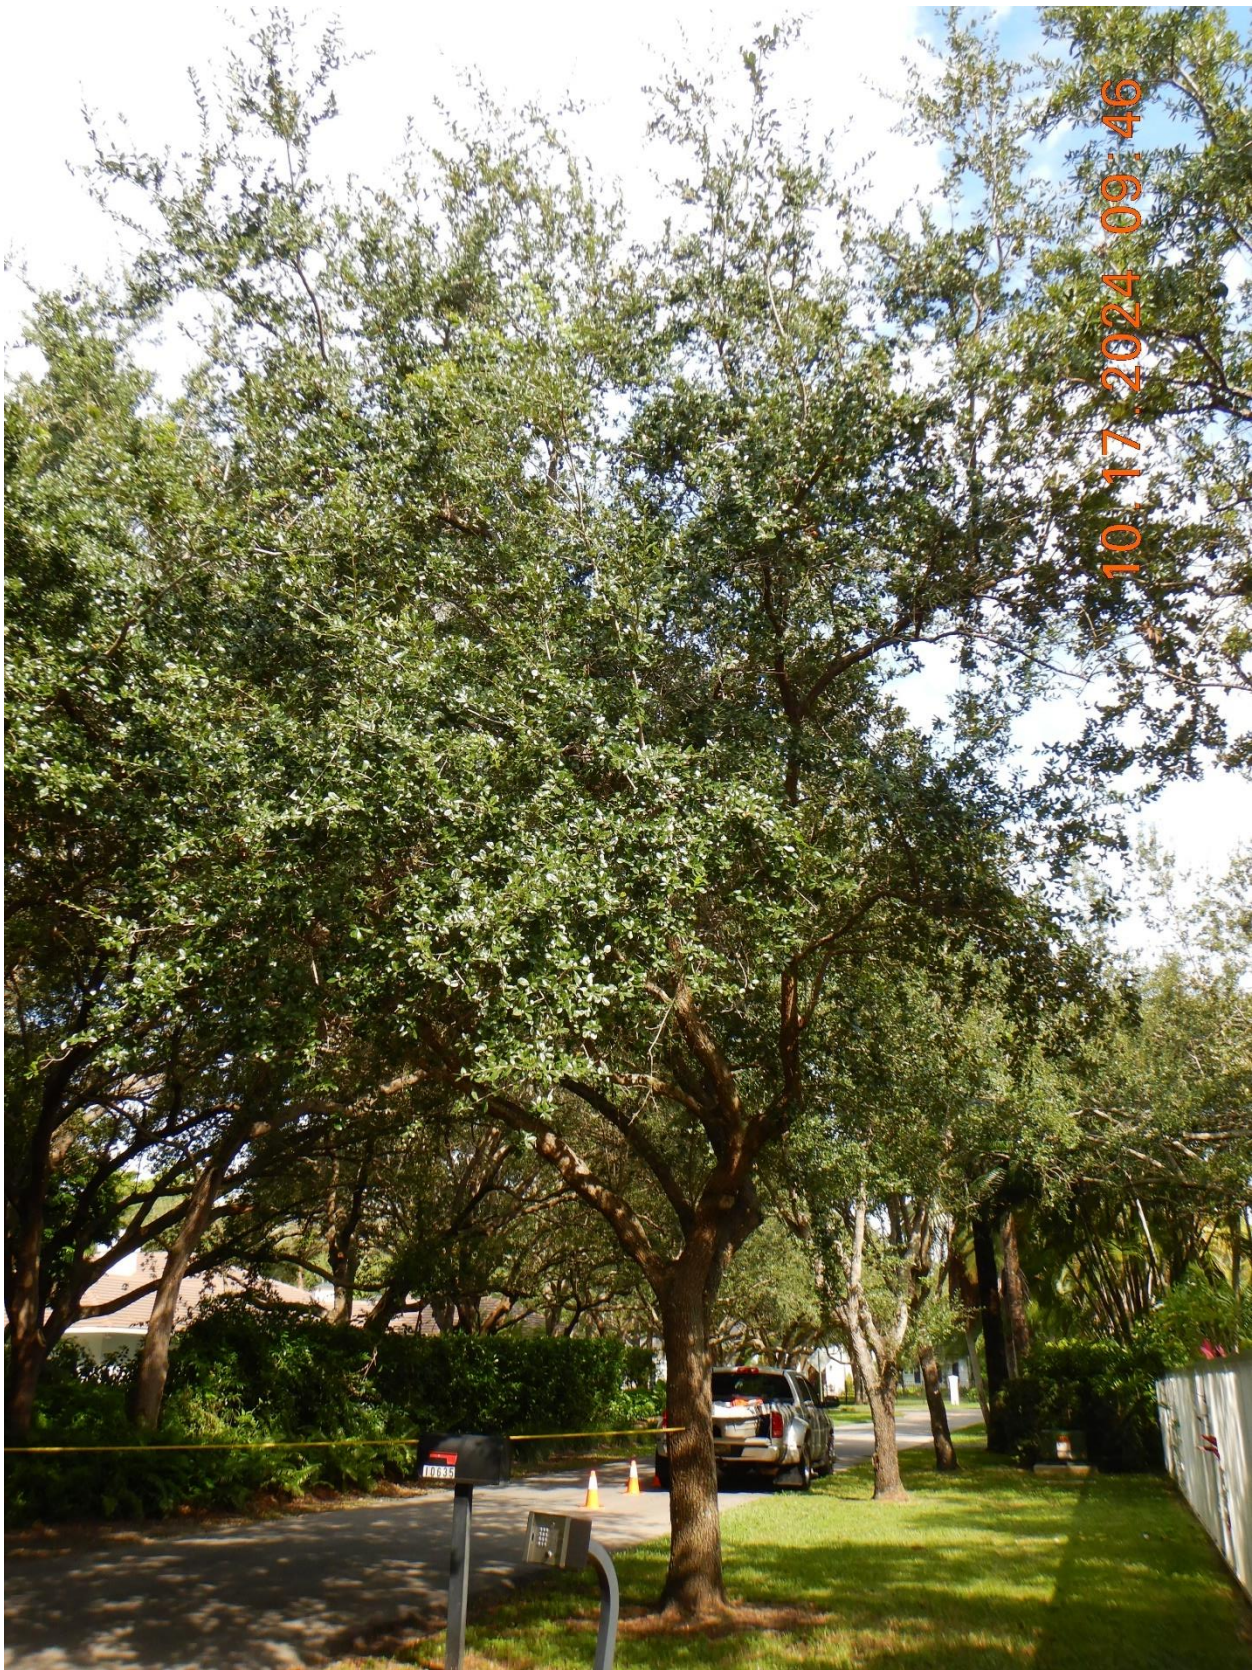
| 3 | Live oak | Quercus virginiana | 15 | 15 | 7.5 | 35 | 38x33 | 70% | Co-canopy, restricted roots on the West side of the trunk road is 5.5ft away, co-dom |

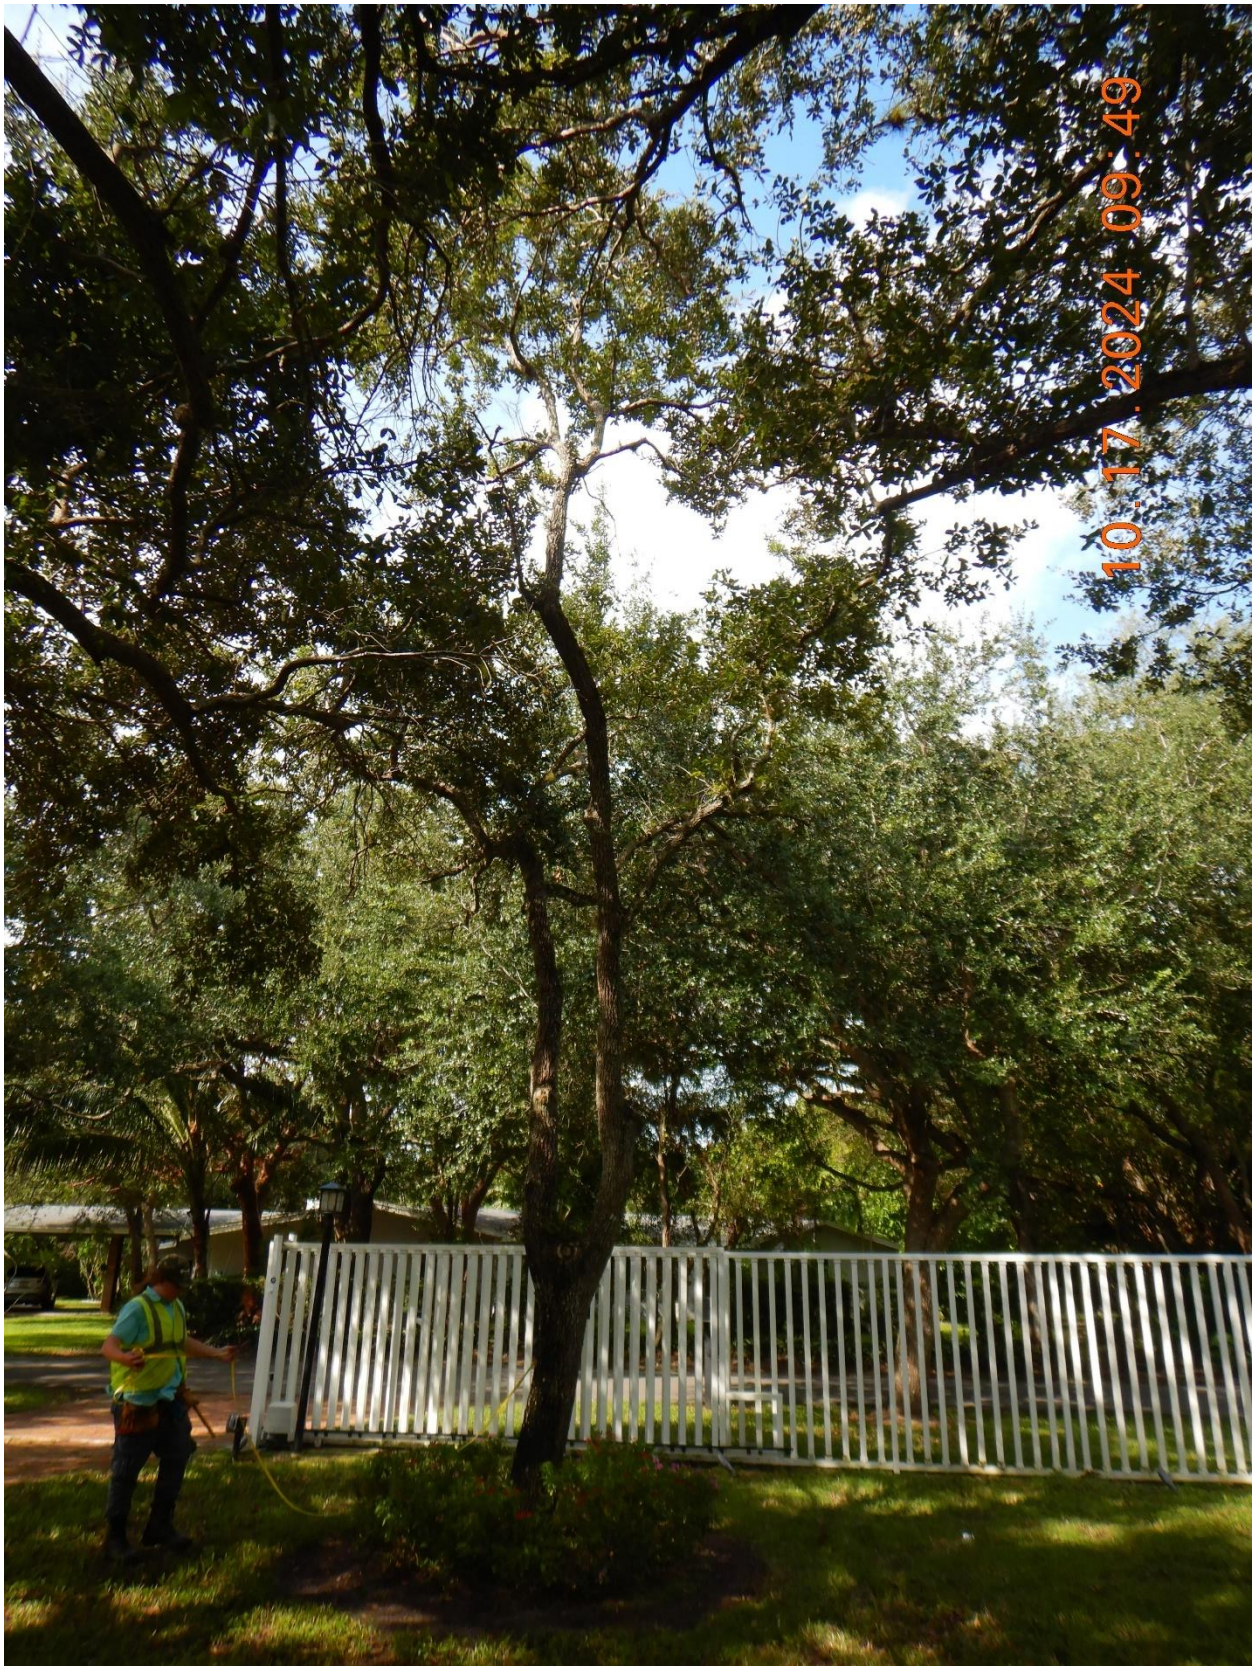
| 4 | Live oak | Quercus virginiana | 11 | 11 | 5.5 | 28 | 32x18 | 50% | Sub-canopy, co-dom |

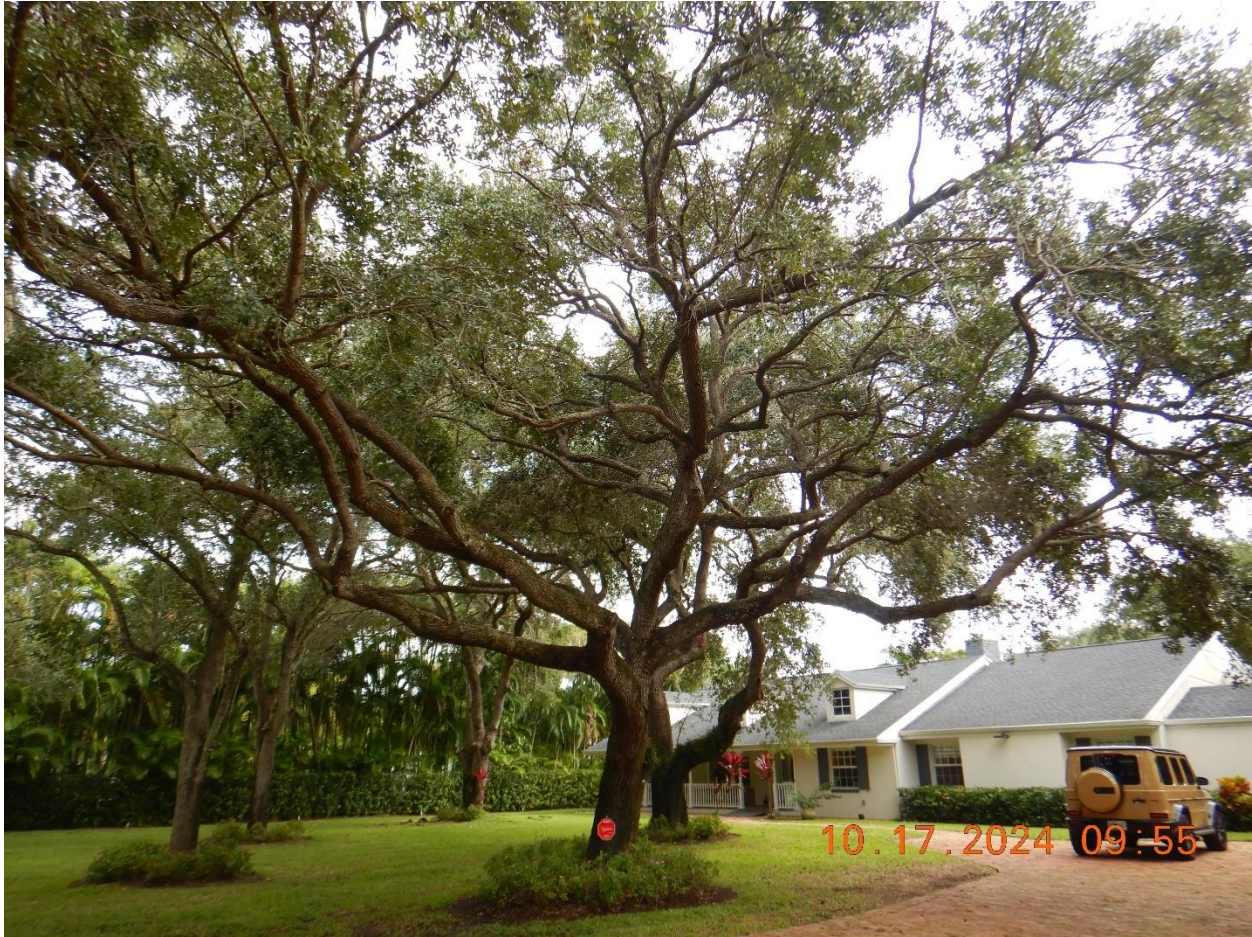
| 5 | Live oak | Quercus virginiana | 23.5 | 23.5 | 11.8 | 35 | 55x35 | 70% | Co-canopy, driveway pavers are approximately 10ft away from the trunk on the south side |

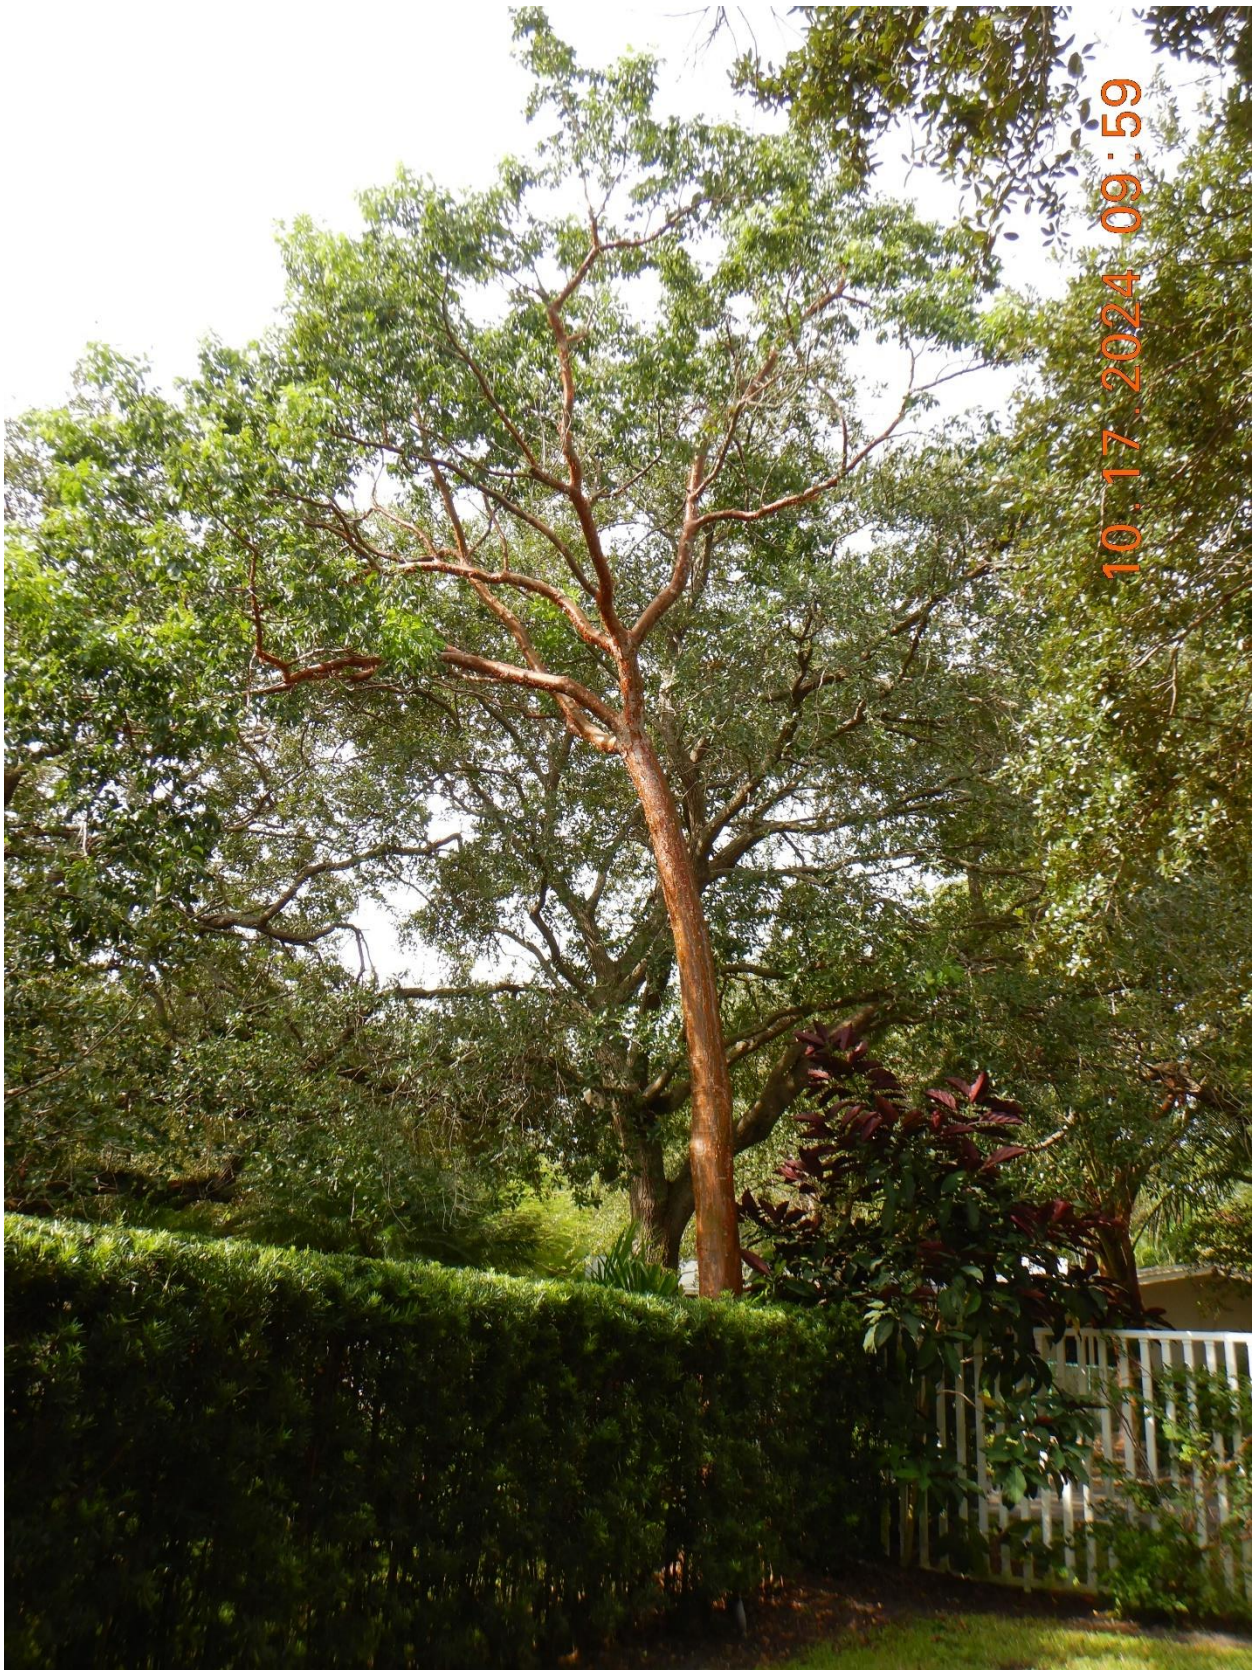
| 6 | Gumbo limbo | Bursera simaruba | 13 | 13 | 6.5 | 28 | 26x26 | 50% | The canopy leans toward the neighbor's property |

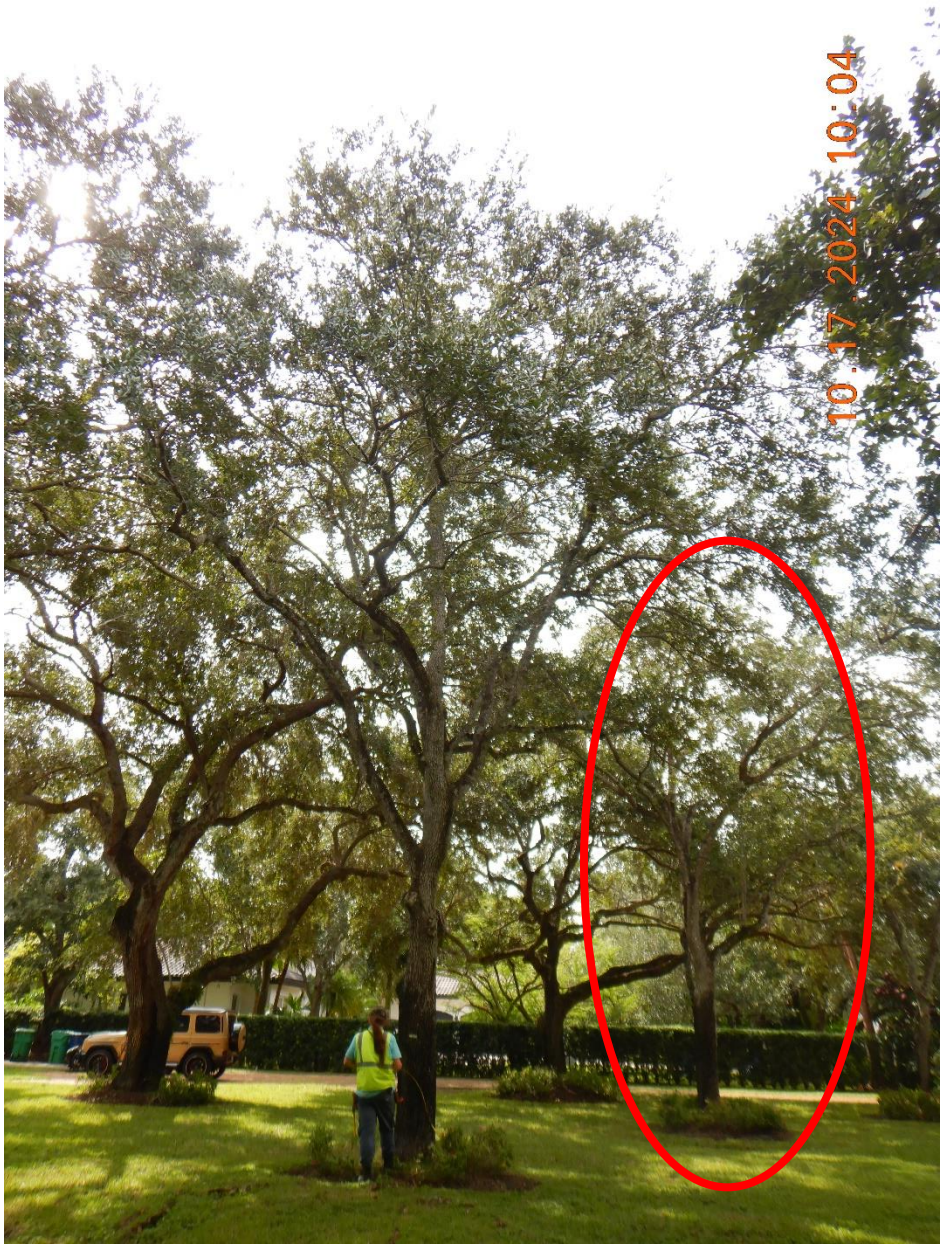
| 7 | Live oak | Quercus virginiana | 16 | 16 | 8 | 30 | 42x38 | 70% | Co-canopy |

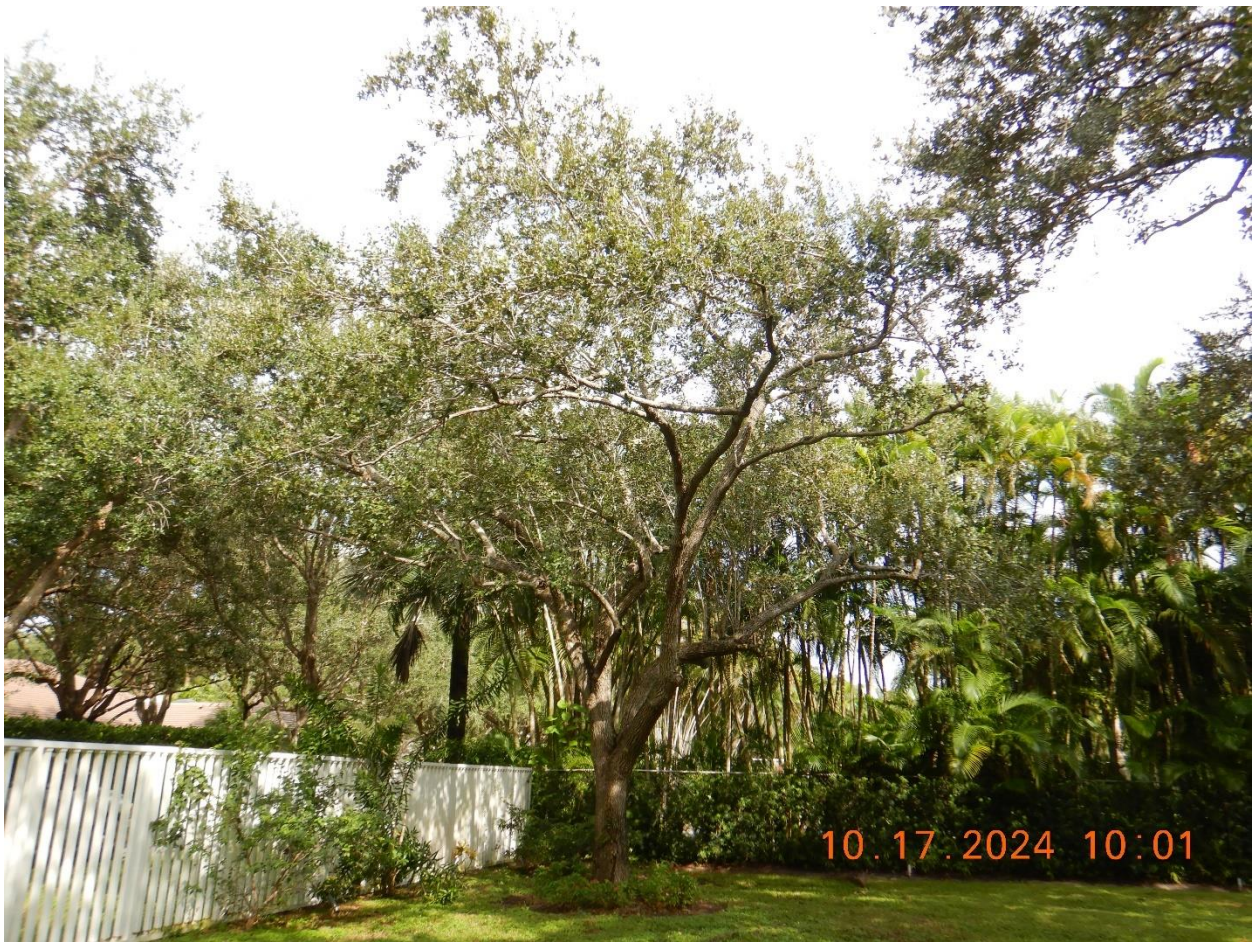
| 8 | Live oak | Quercus virginiana | 17 | 17 | 8.5 | 30 | 36x36 | 80% | |

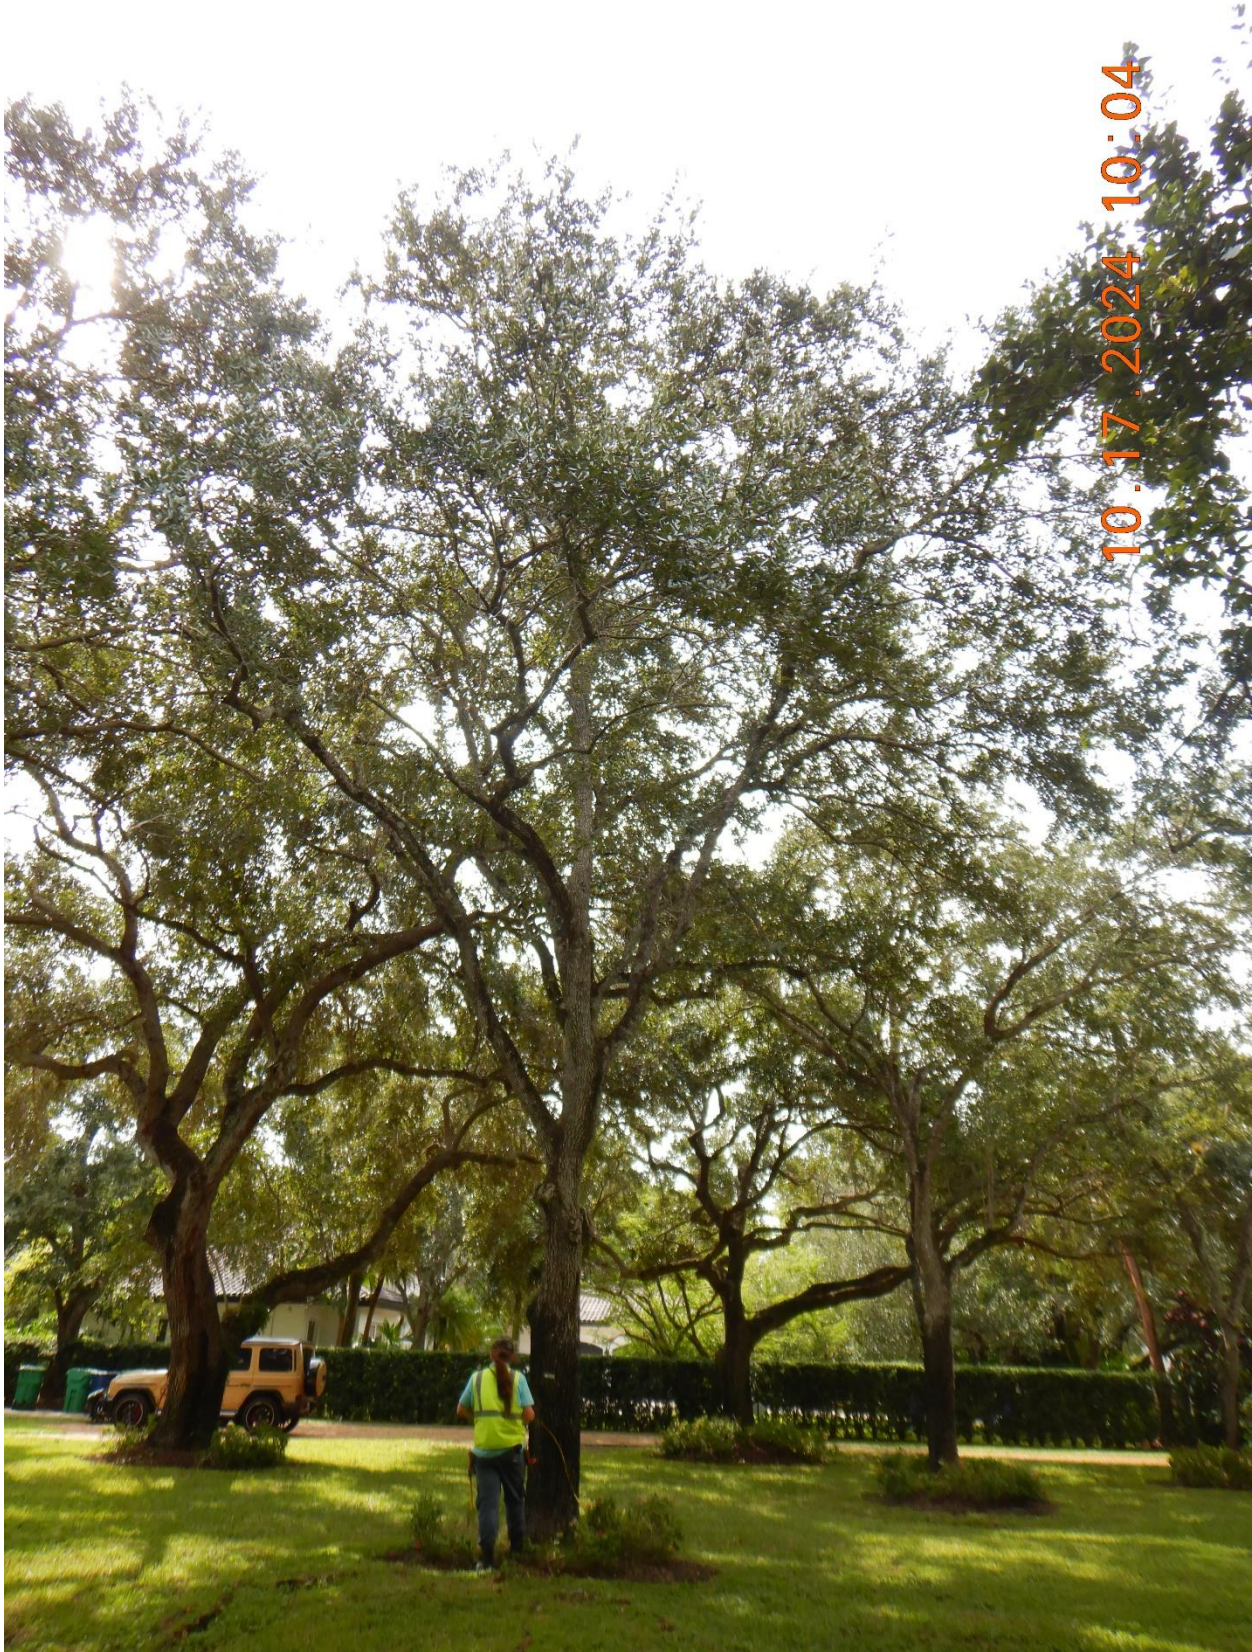
| 9 | Live oak | Quercus virginiana | 18 | 18 | 9 | 35 | 46x36 | 70% | Co-canopy |

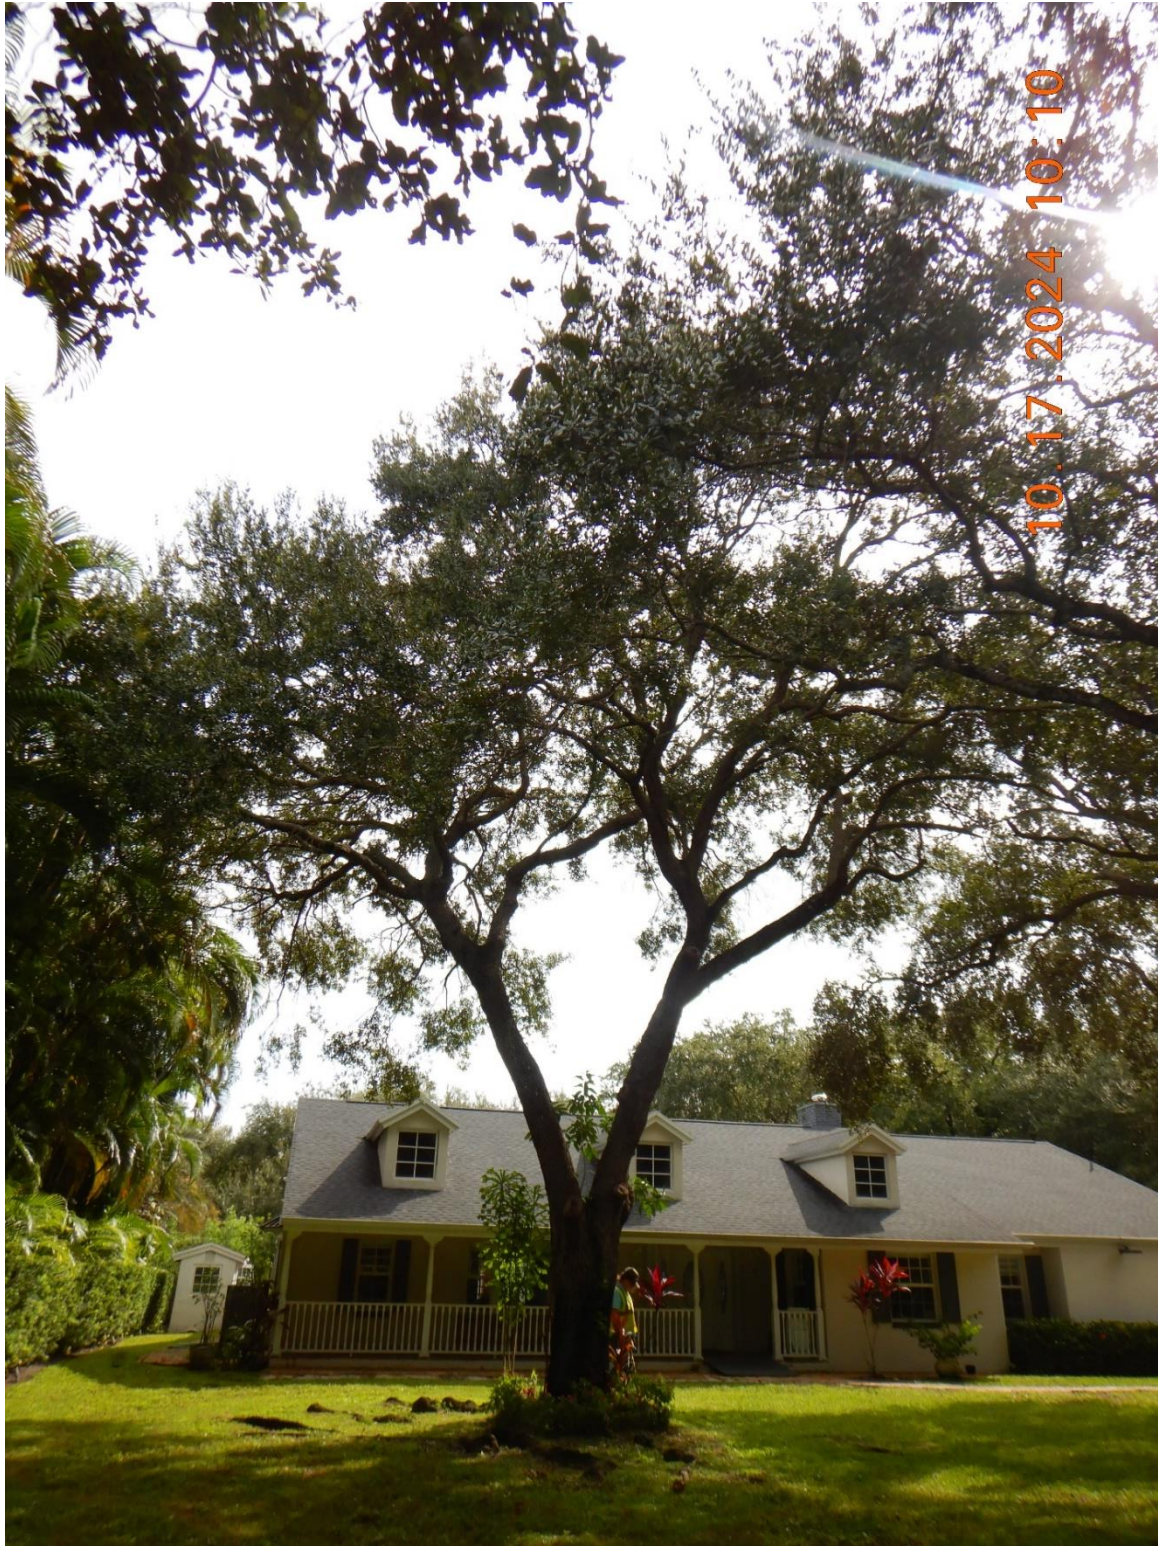
| 10 | Live oak | Quercus virginiana | 29.5 | 29.5 | 14.8 | 42 | 54x42 | 70% | Co-canopy, co-dom |

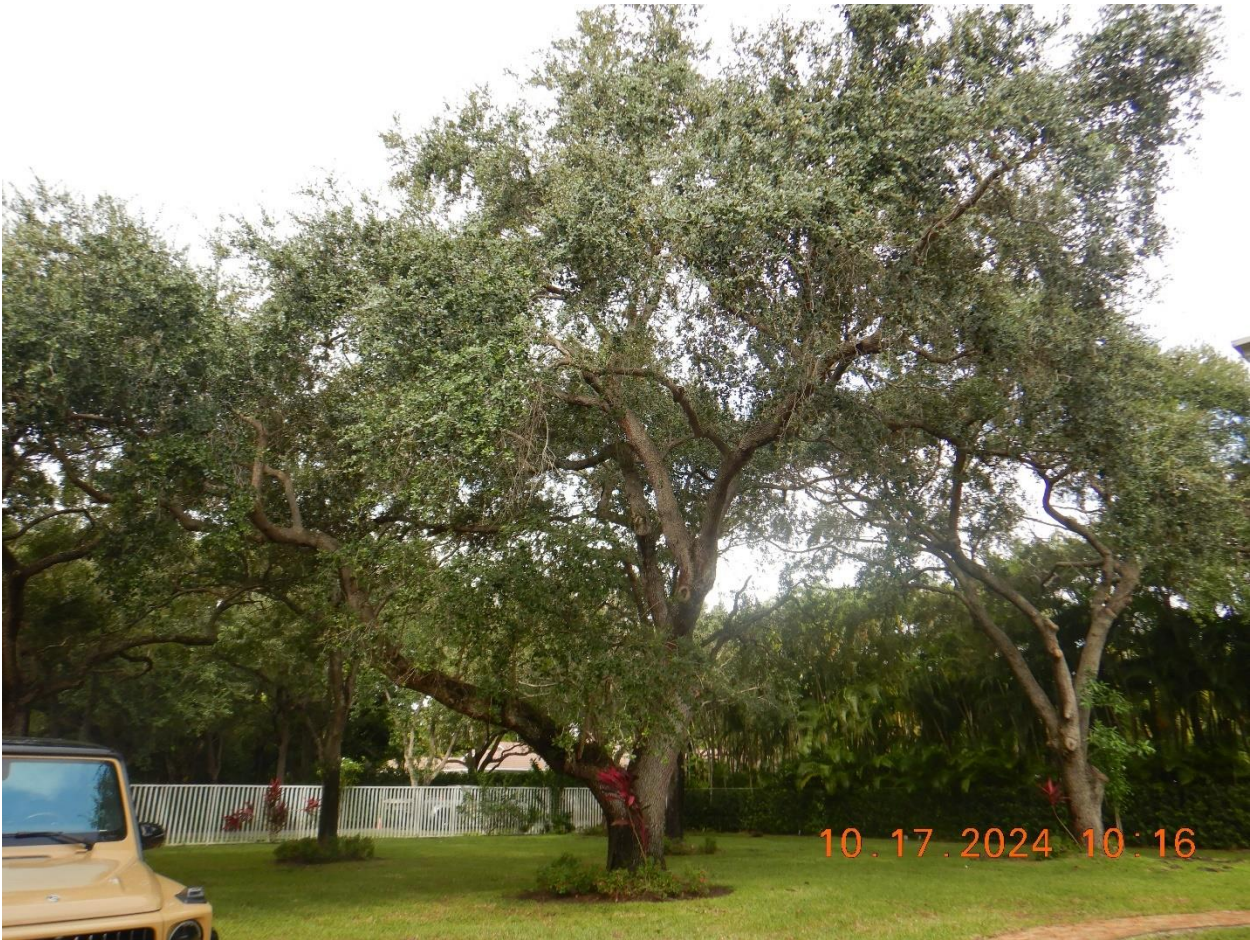
| 11 | Live oak | Quercus virginiana | 35 | 35 | 17.5 | 40 | 70x60 | 70% | Co-canopy, co-dom |

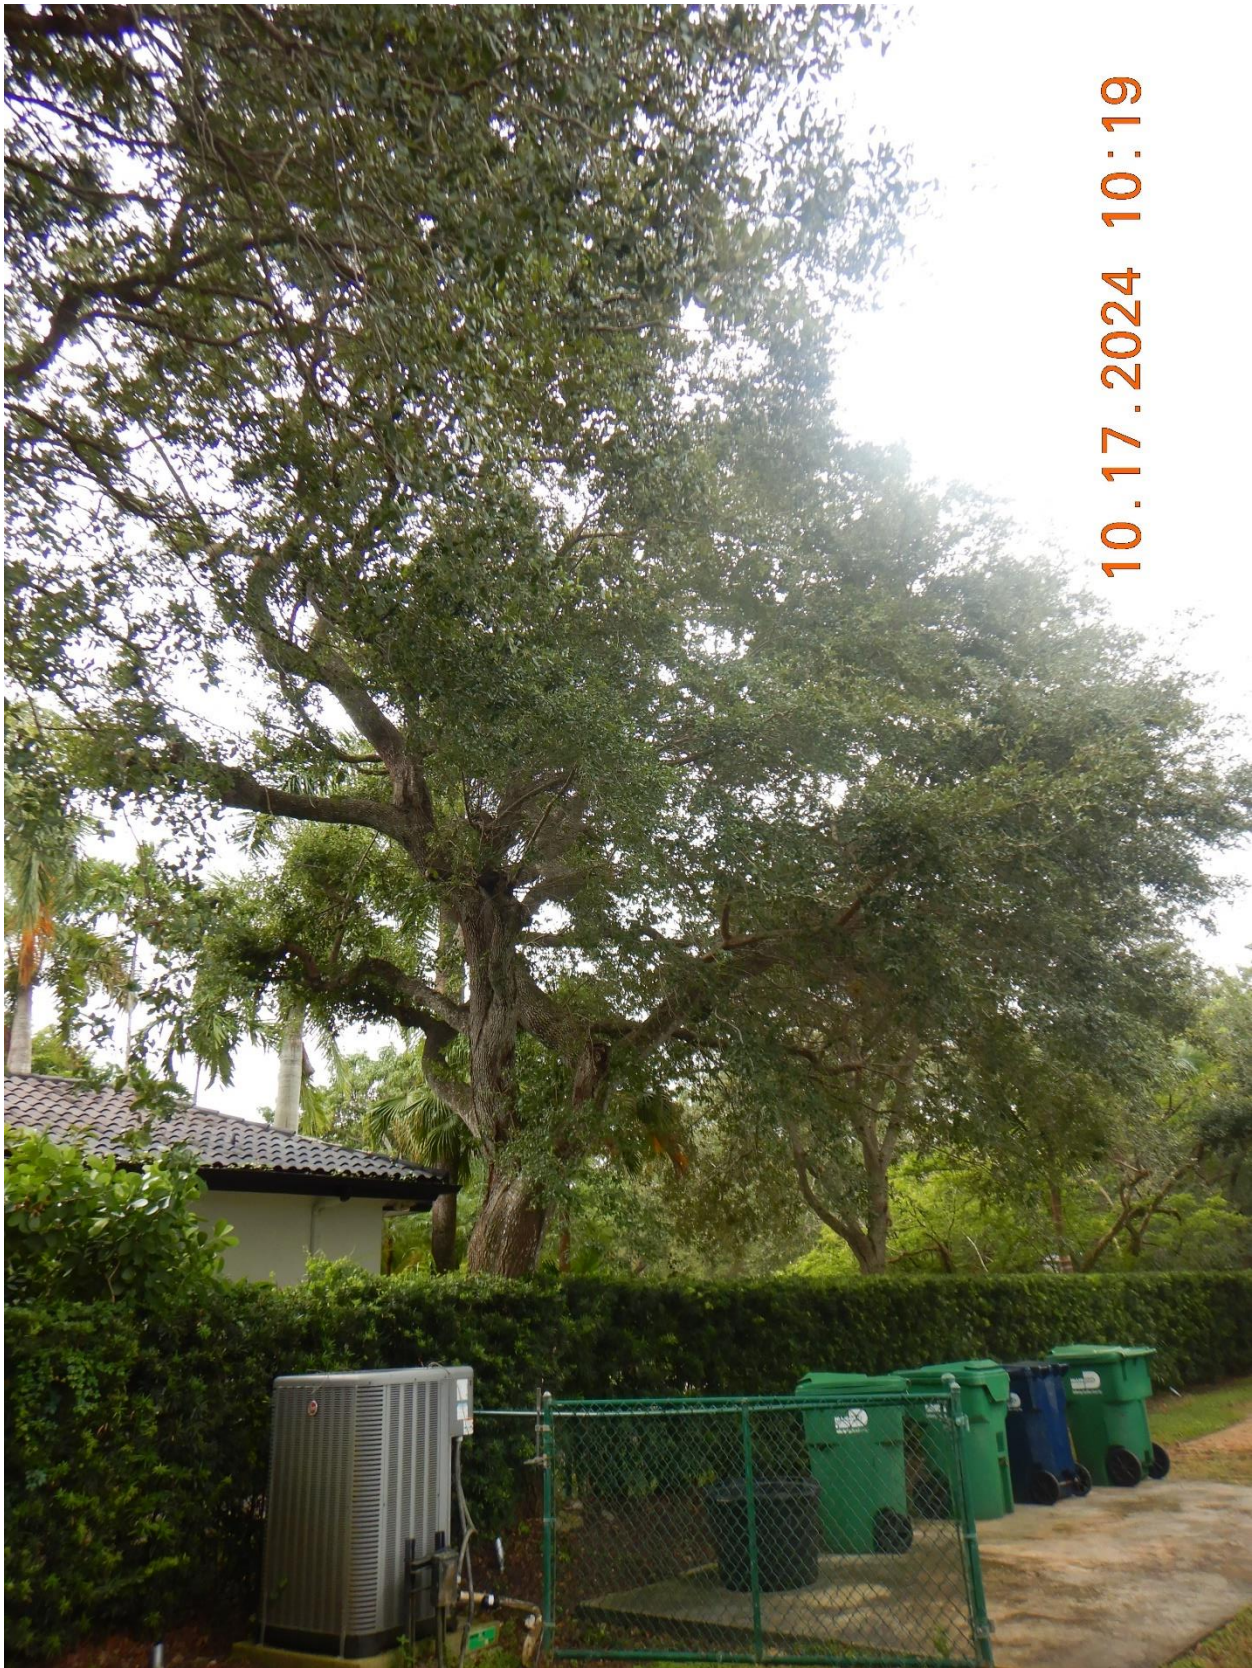
| 12 | Live oak | Quercus virginiana | 24 | 24 | 12 | 35 | 42x42 | 60% | Co-canopy |

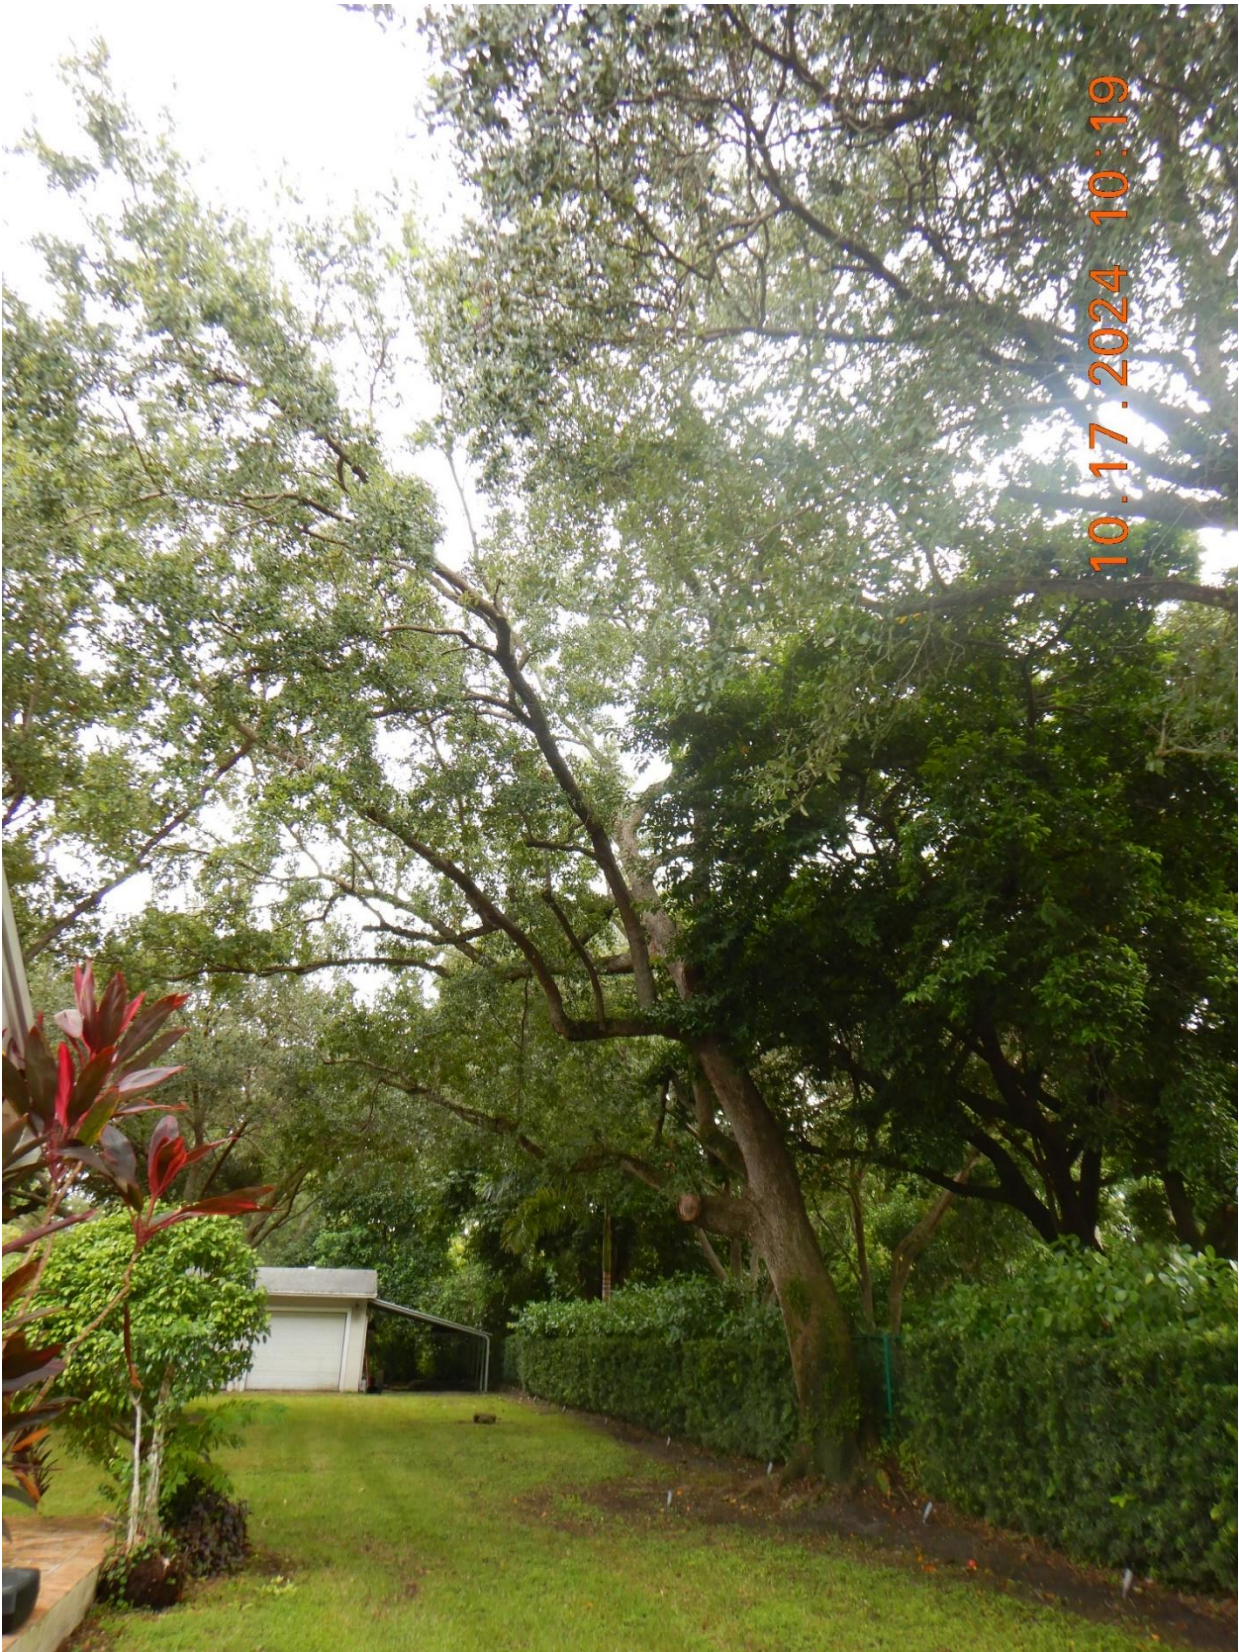
| 13 | Live oak | Quercus virginiana | 32 | 32 | 16 | 45 | 58x33 | 50% | Co-canopy, non-symmetrical canopy |
