## Arboriculture Tree Report

10635 SW 63<sup>rd</sup> Ave, Pinecrest

**Prepared by:** John Sutton  
International Society of Arboriculture Certified Arborist

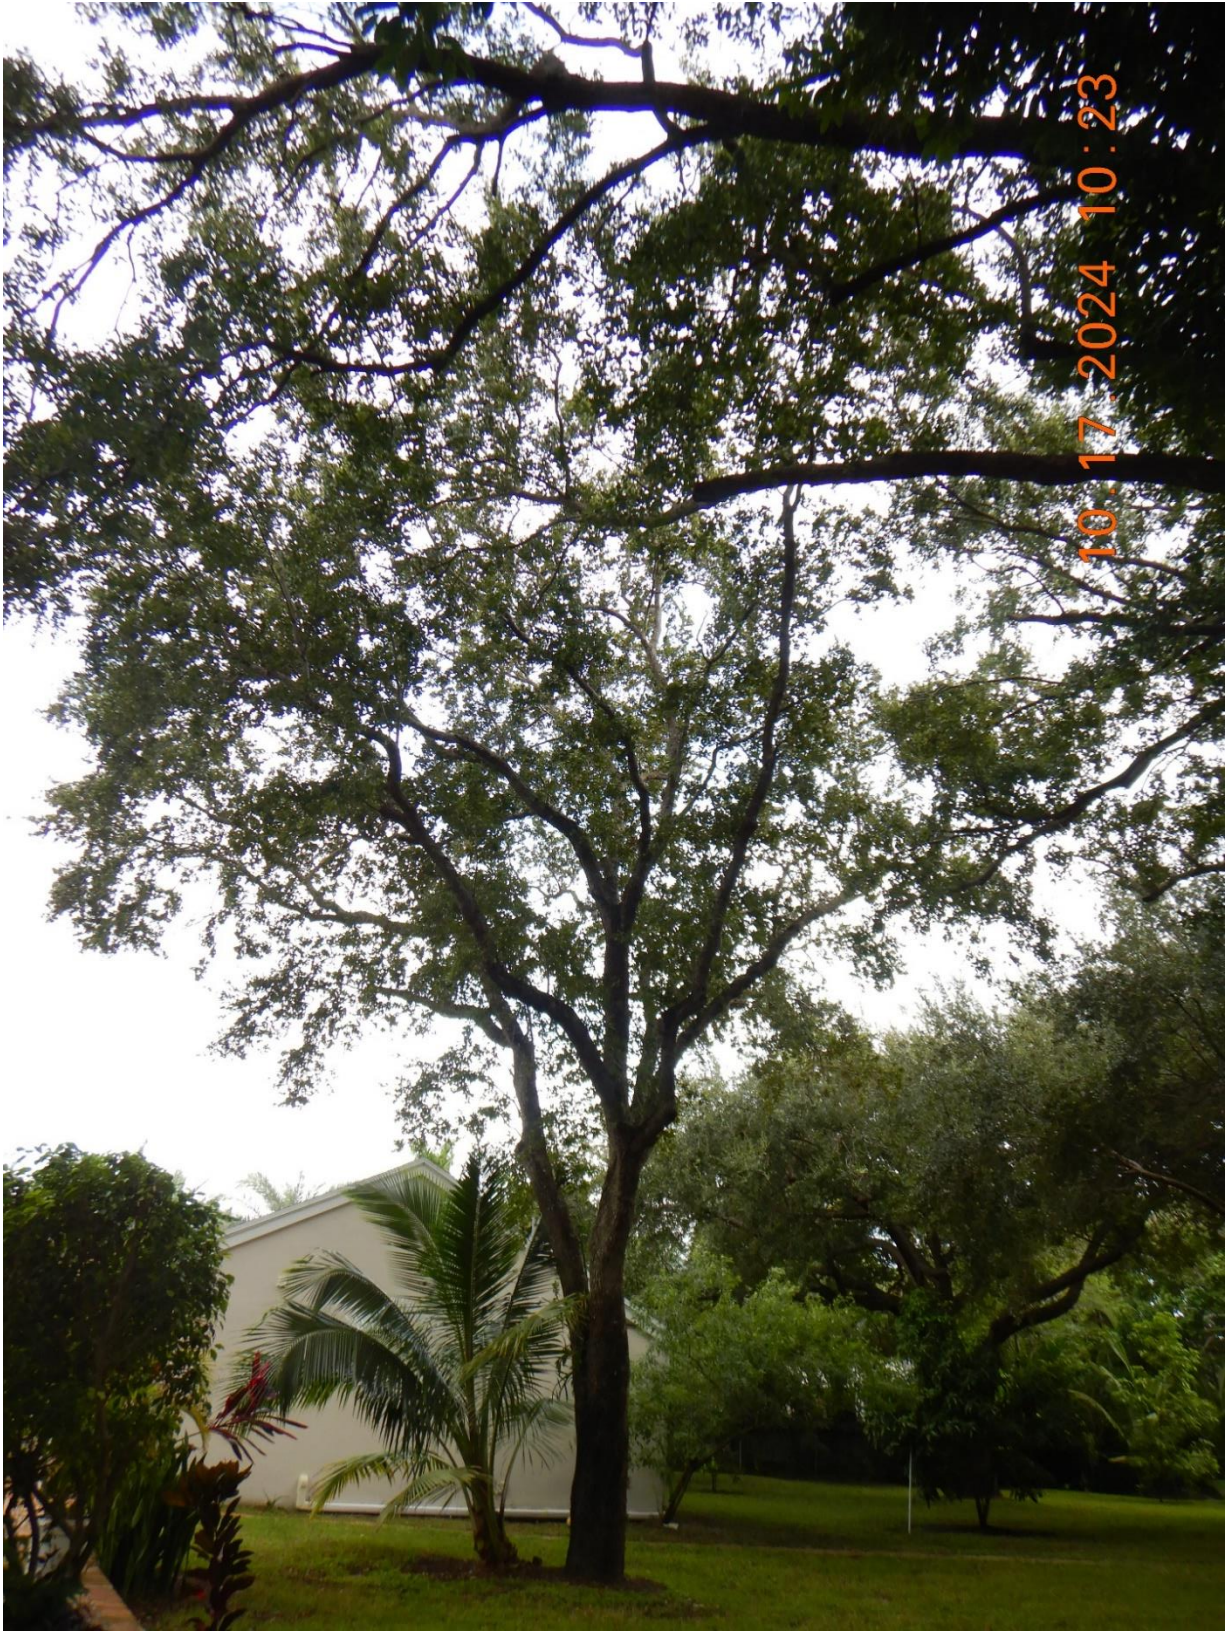
| 14 | Live oak | Quercus virginiana | 25 | 25 | 12.5 | 35 | 42x42 | 70% | Multi co-dom |

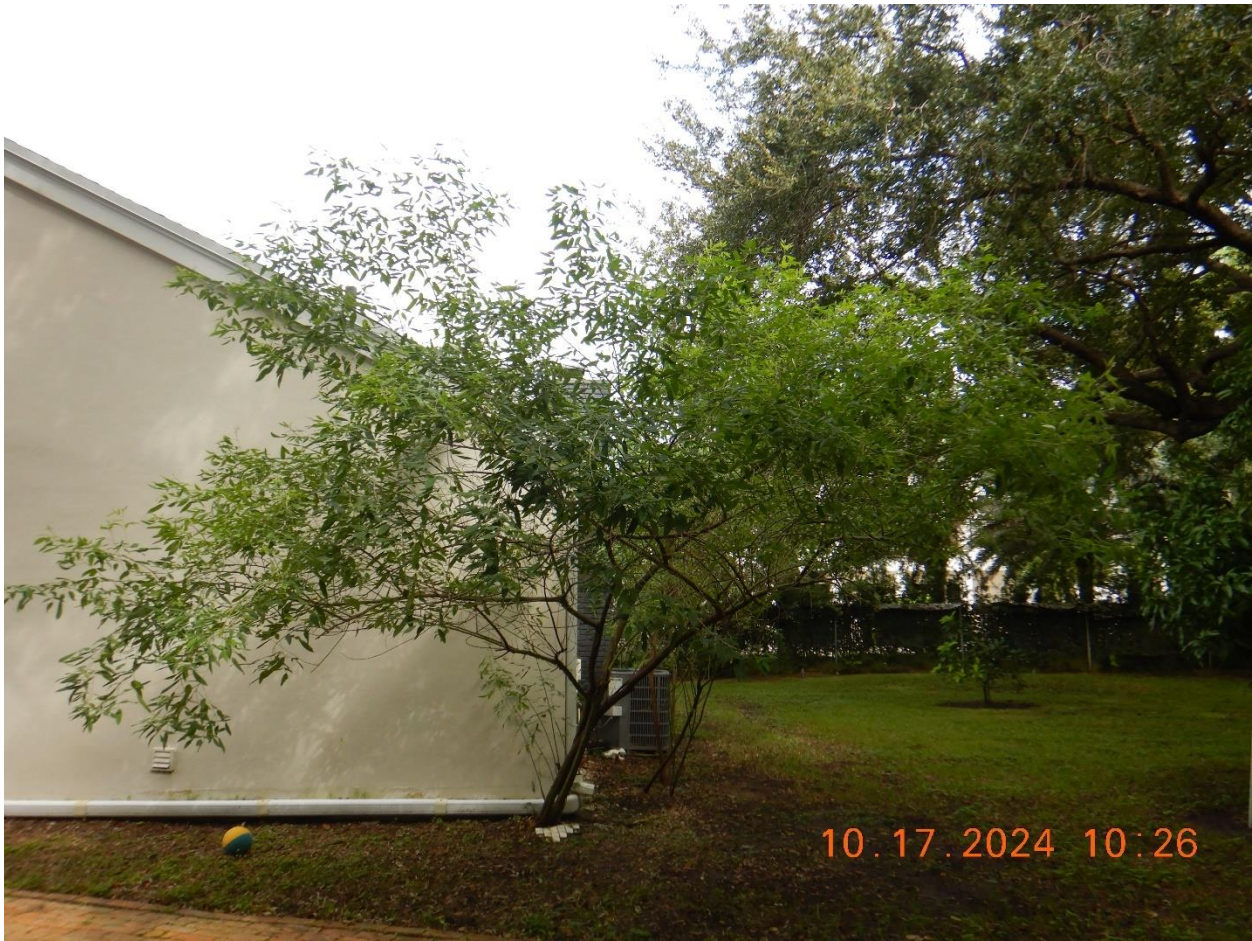
| 15 | Pigeon<br>pea | Cajanus<br>cajan | 6 | 6 | 3 | 12 | 22x22 | 70% | Multi-stemmed |

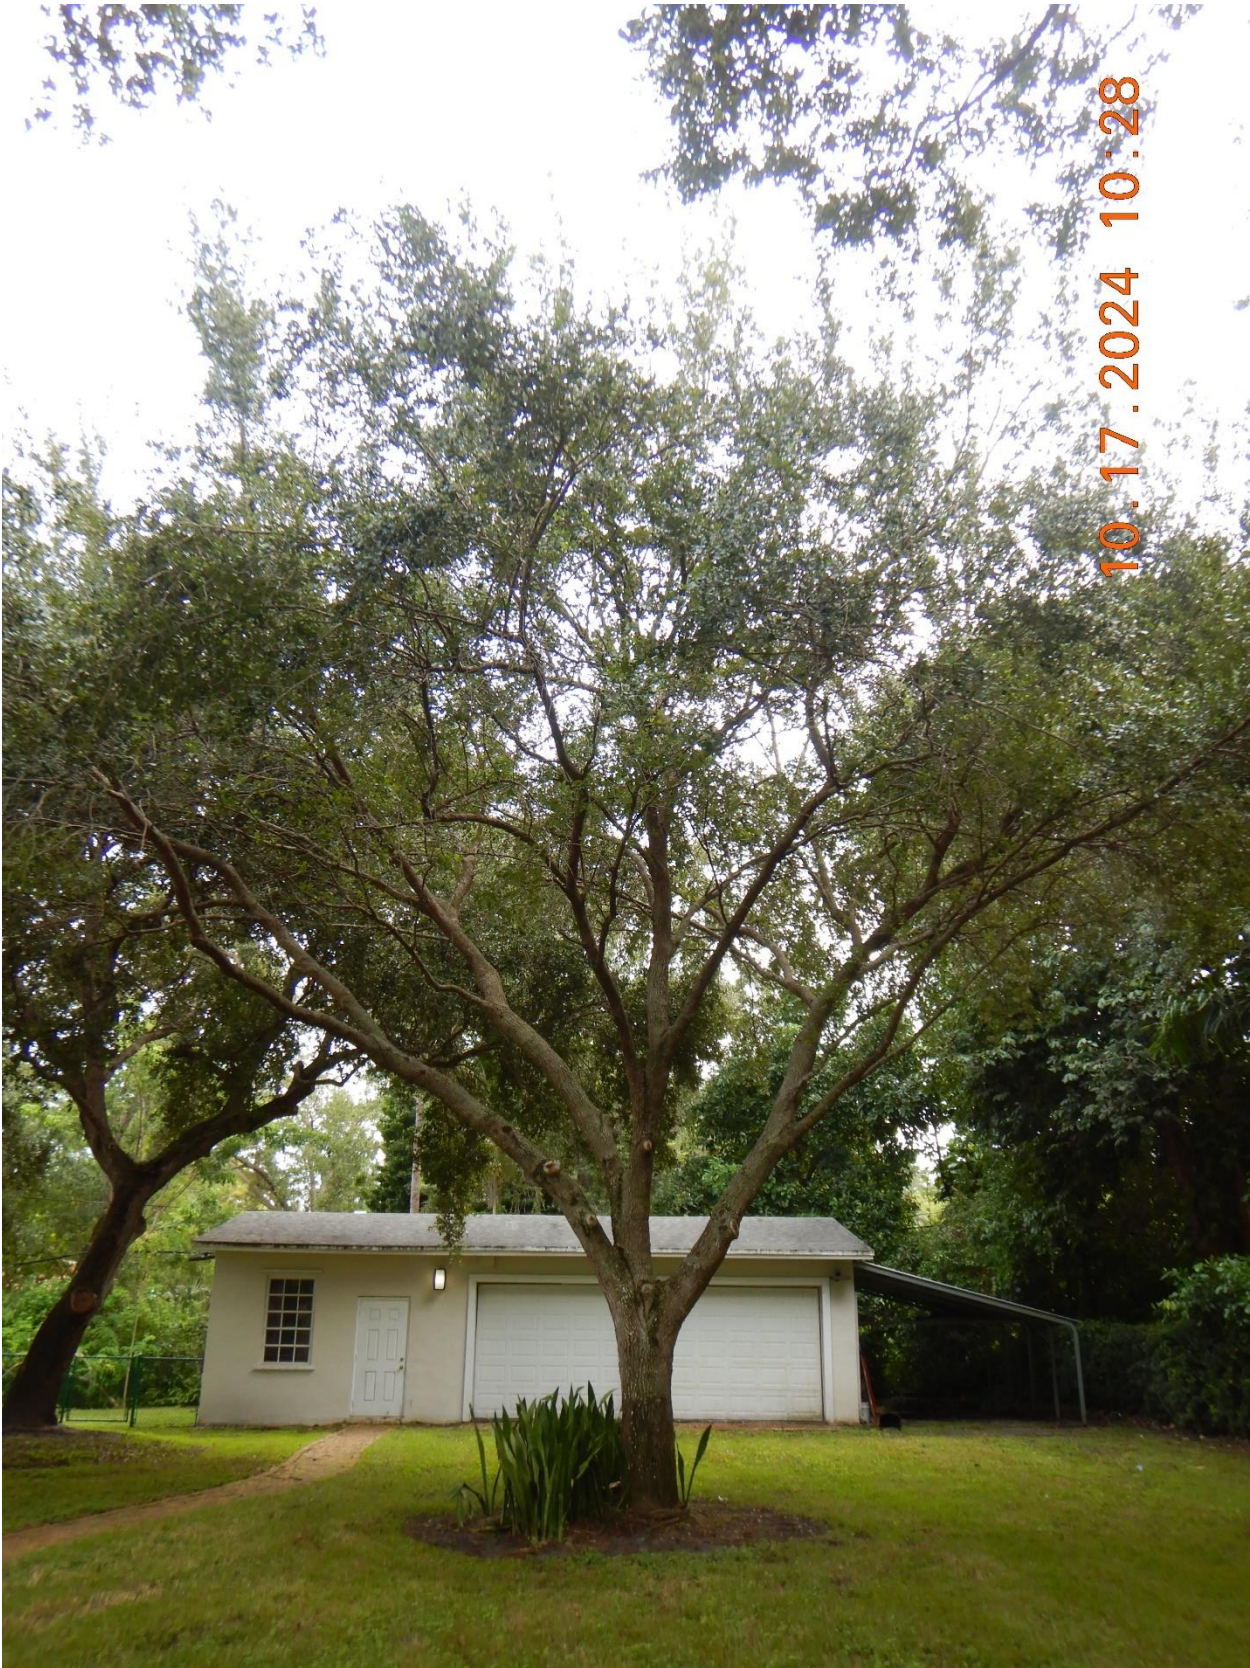
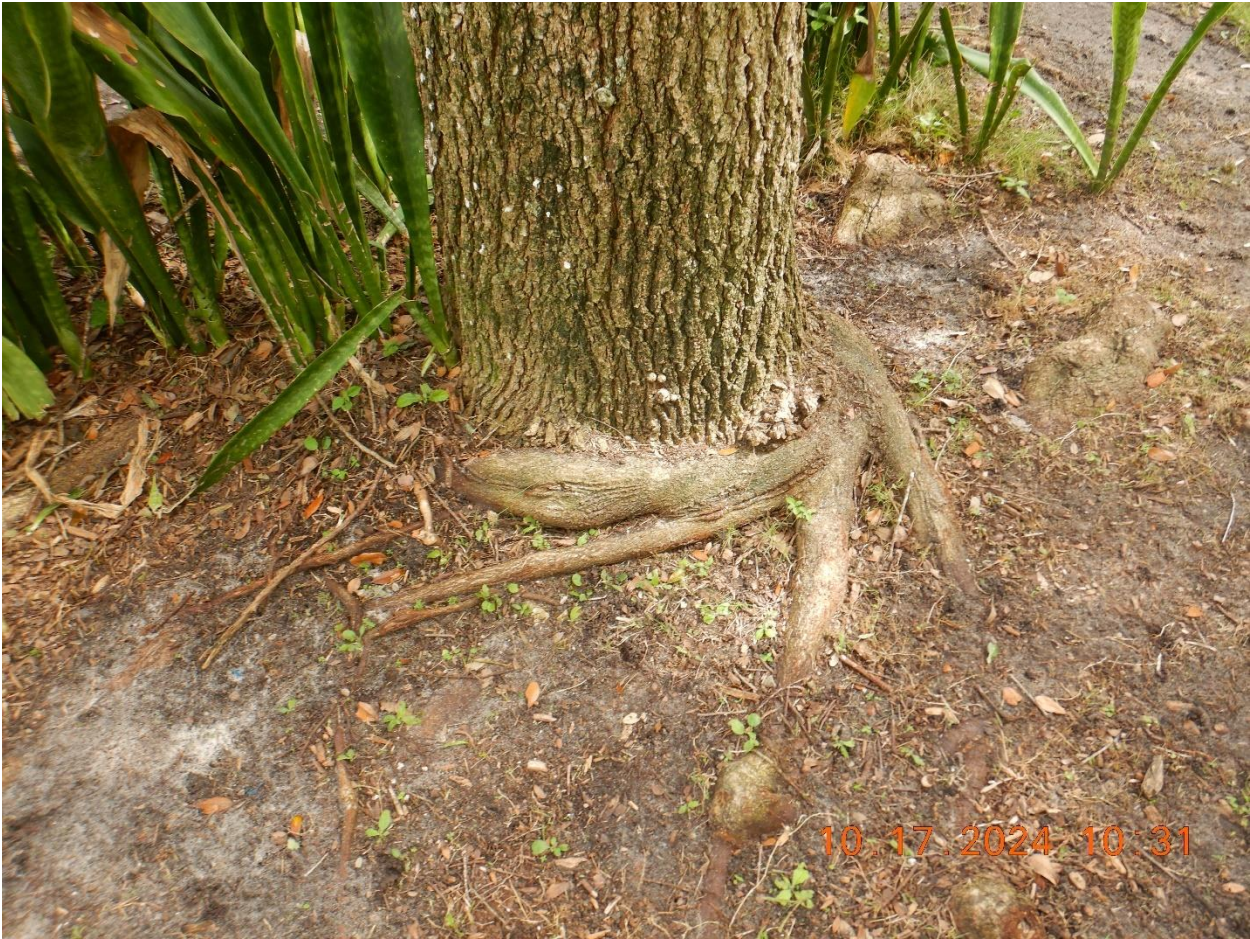
| 16 | Live oak | Quercus virginiana | 18 | 18 | 9 | 35 | 60x46 | 50% | Girdling roots, co-canopy |

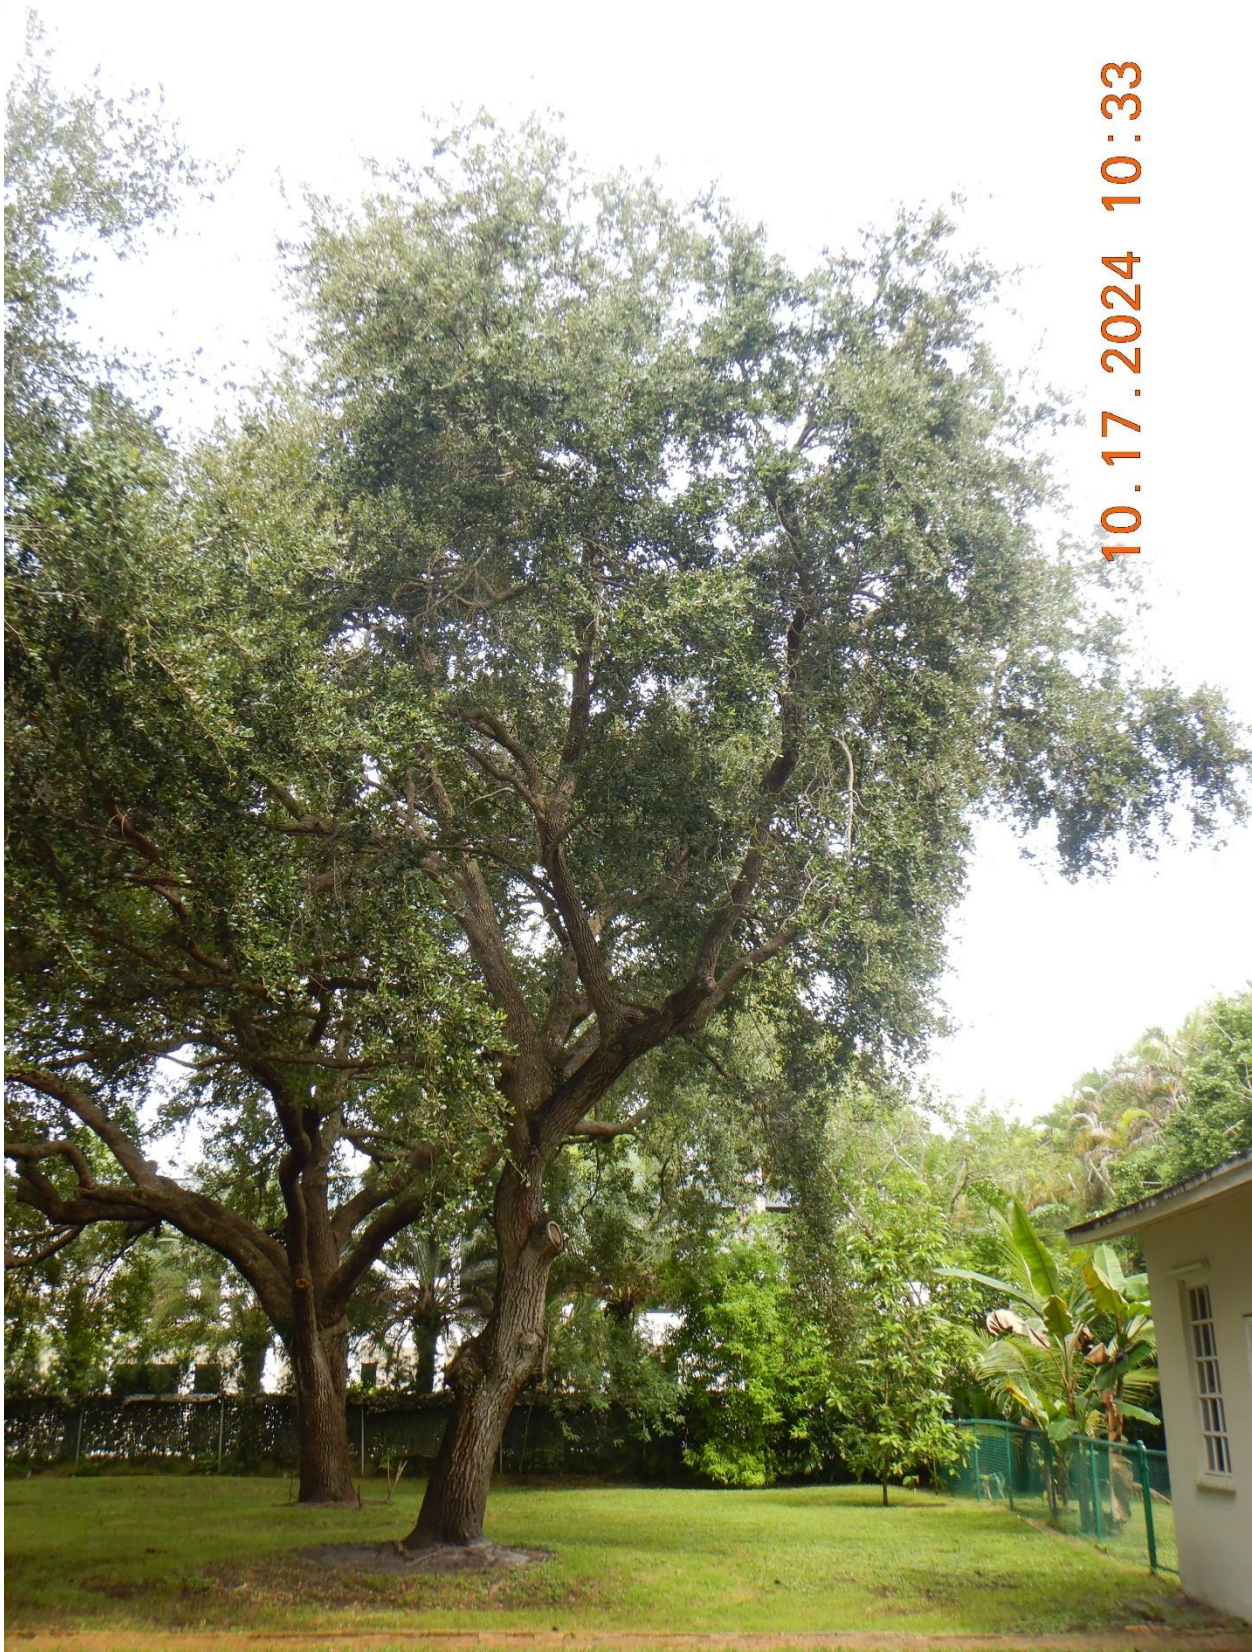
| 17 | Live oak | Quercus virginiana | 16.5 | 16.5 | 8.25 | 35 | 60x52 | 60% | Co-canopy, co-dom |

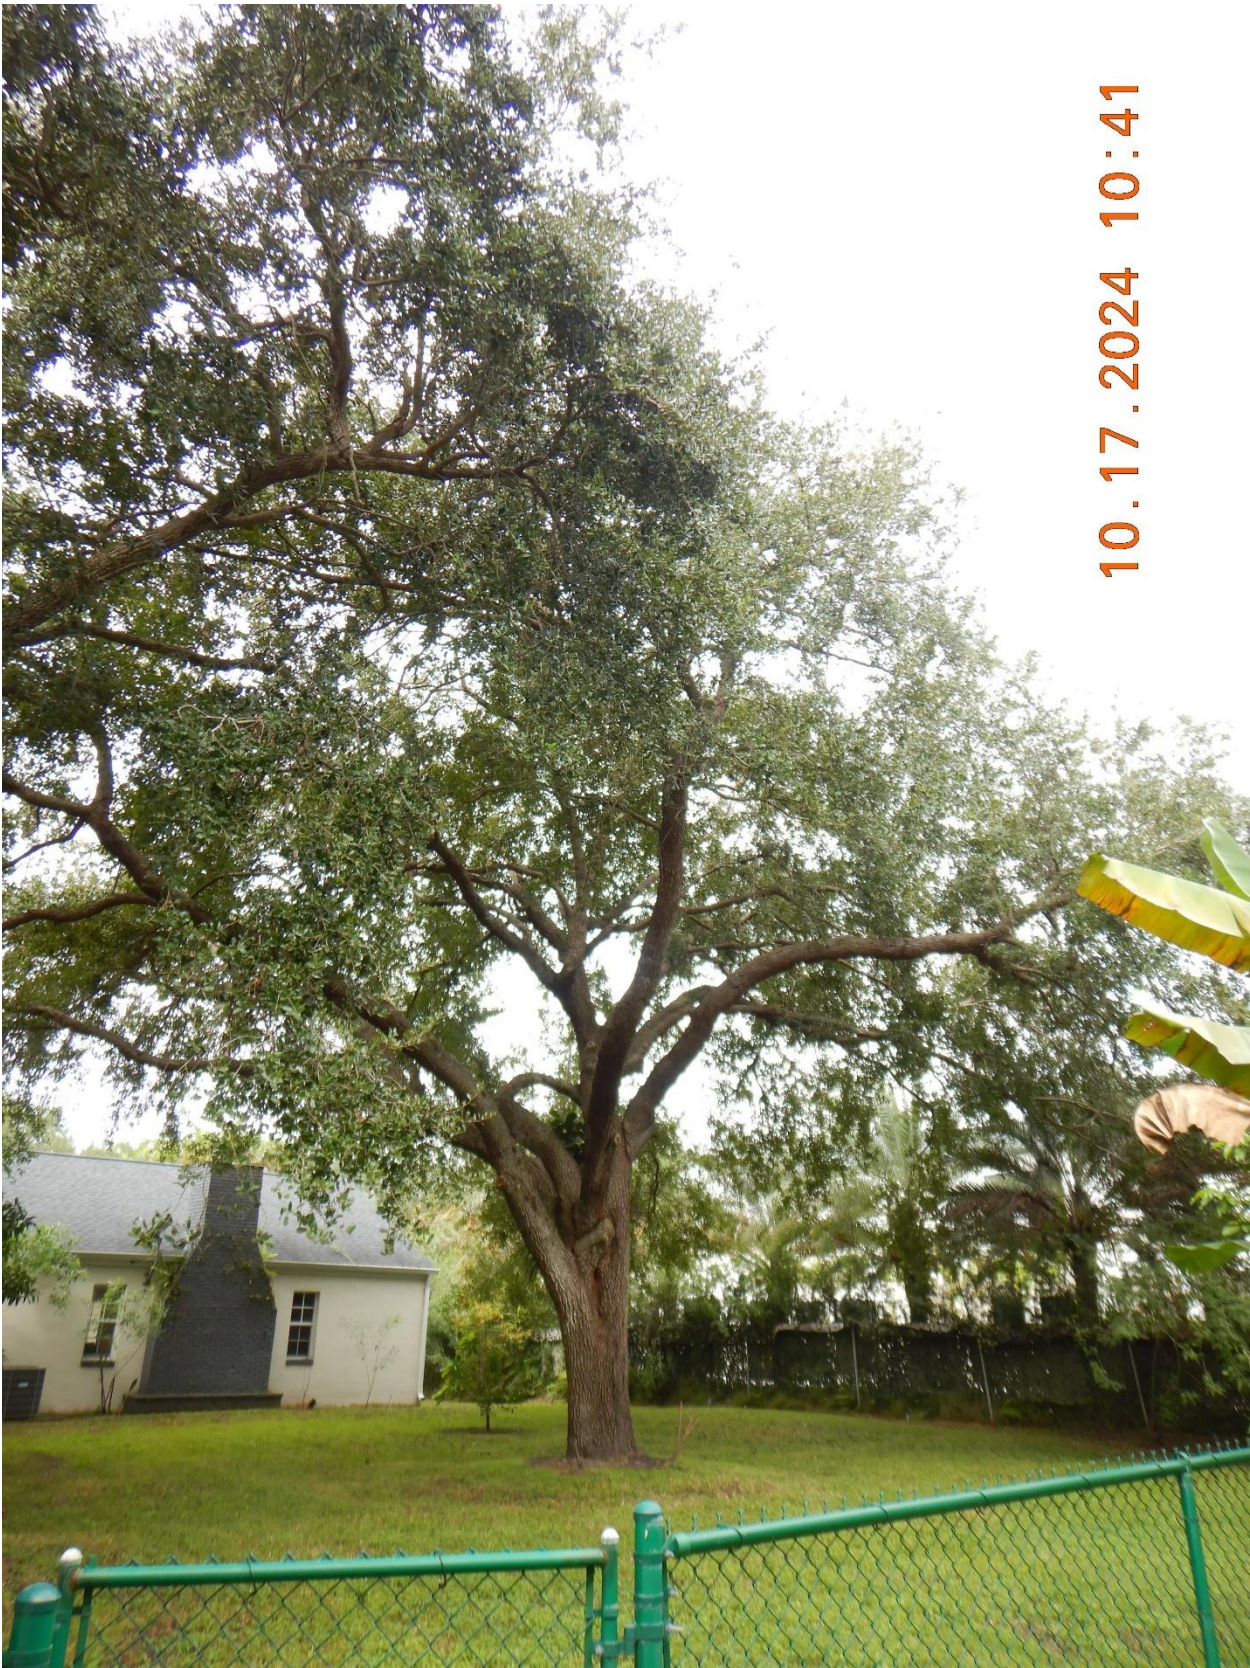
| 18 | Live oak | Quercus virginiana | 31 | 31 | 15.5 | 45 | 60x60 | 60% | Co-canopy, multi-co-dom with inclusion, poor structure |

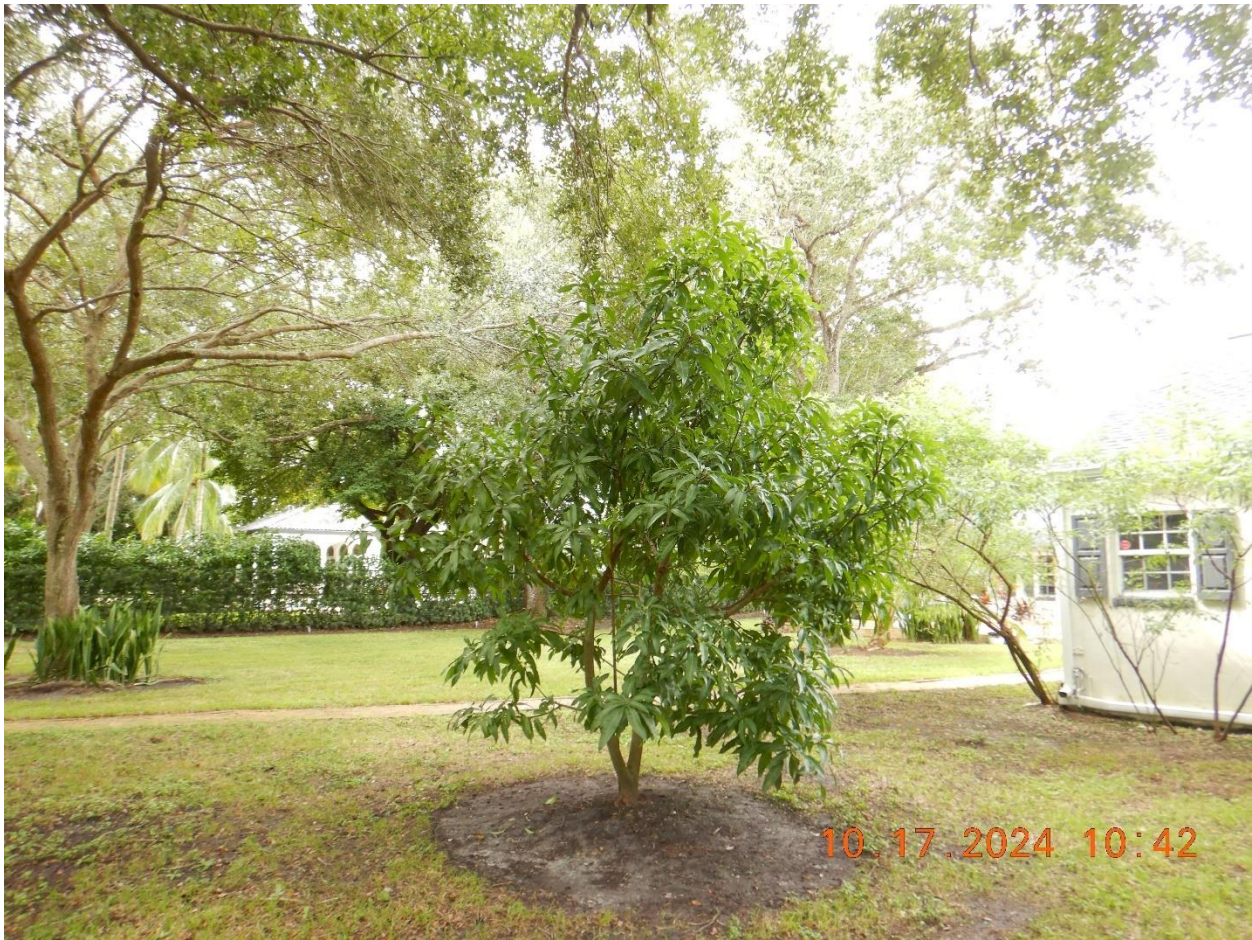
| 19 | Mango | Mangifera indica | 5 | 5 | 2.5 | 15 | 18x18 | 70% | Co-dom |

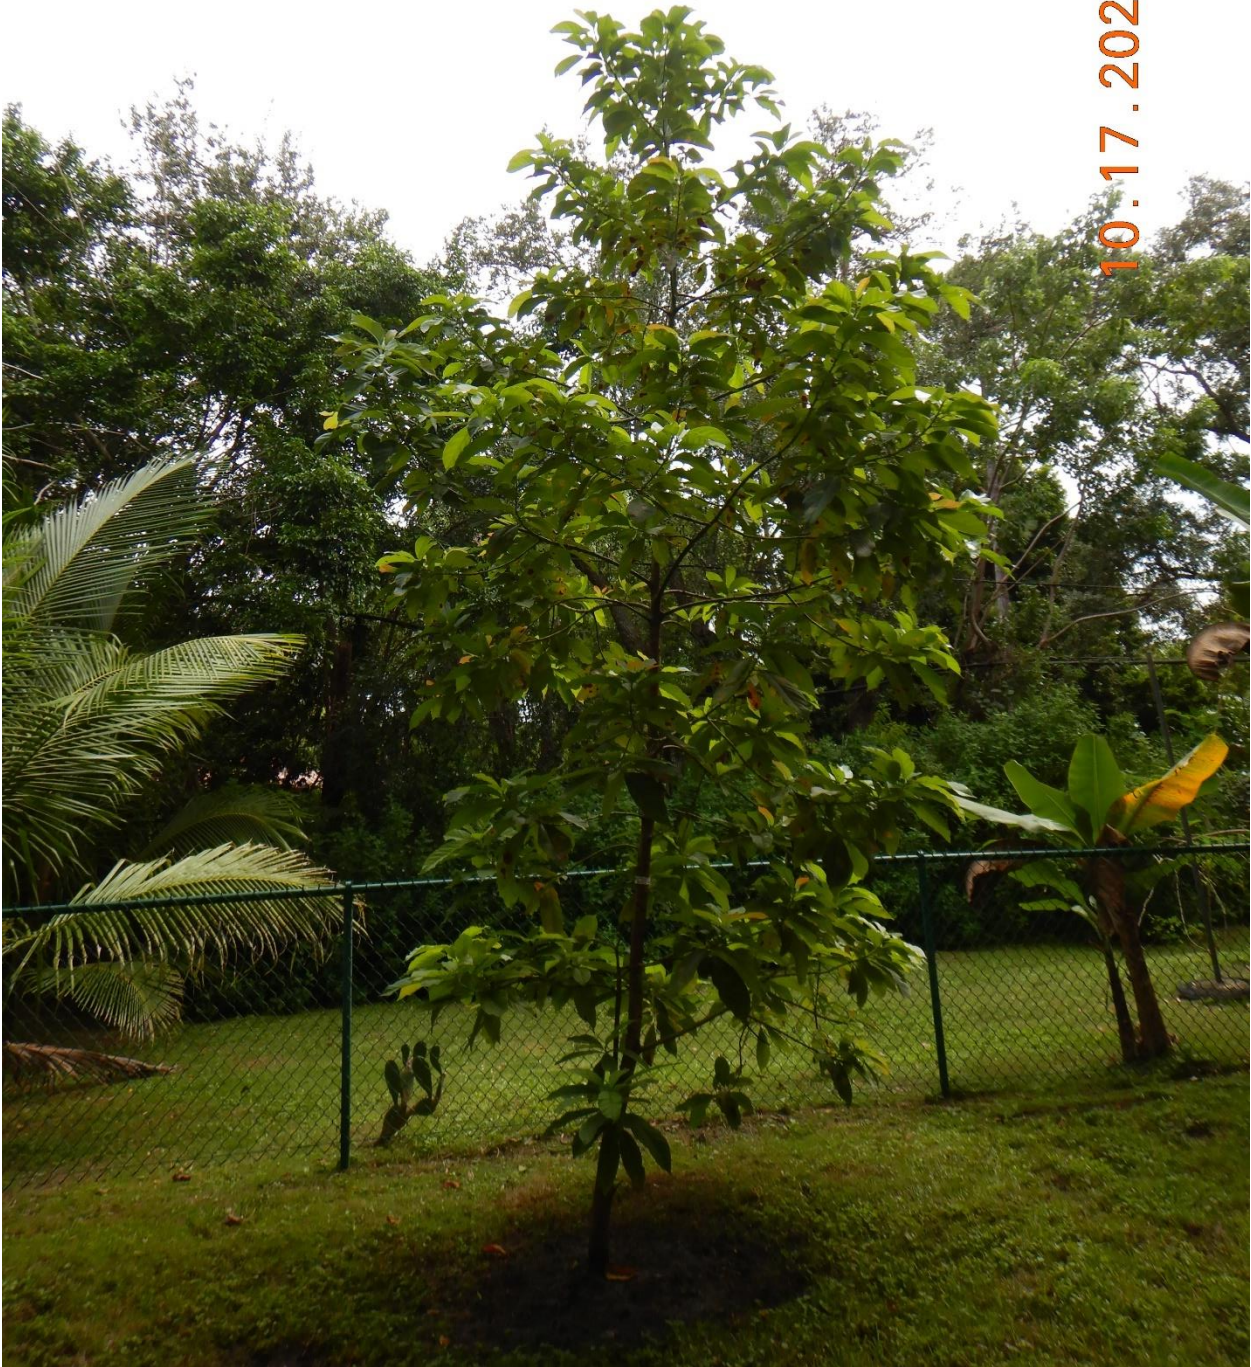
| 20 | Avocado | Persea americana | 2 | 2 | 1 | 18 | 8x8 | 70% | |

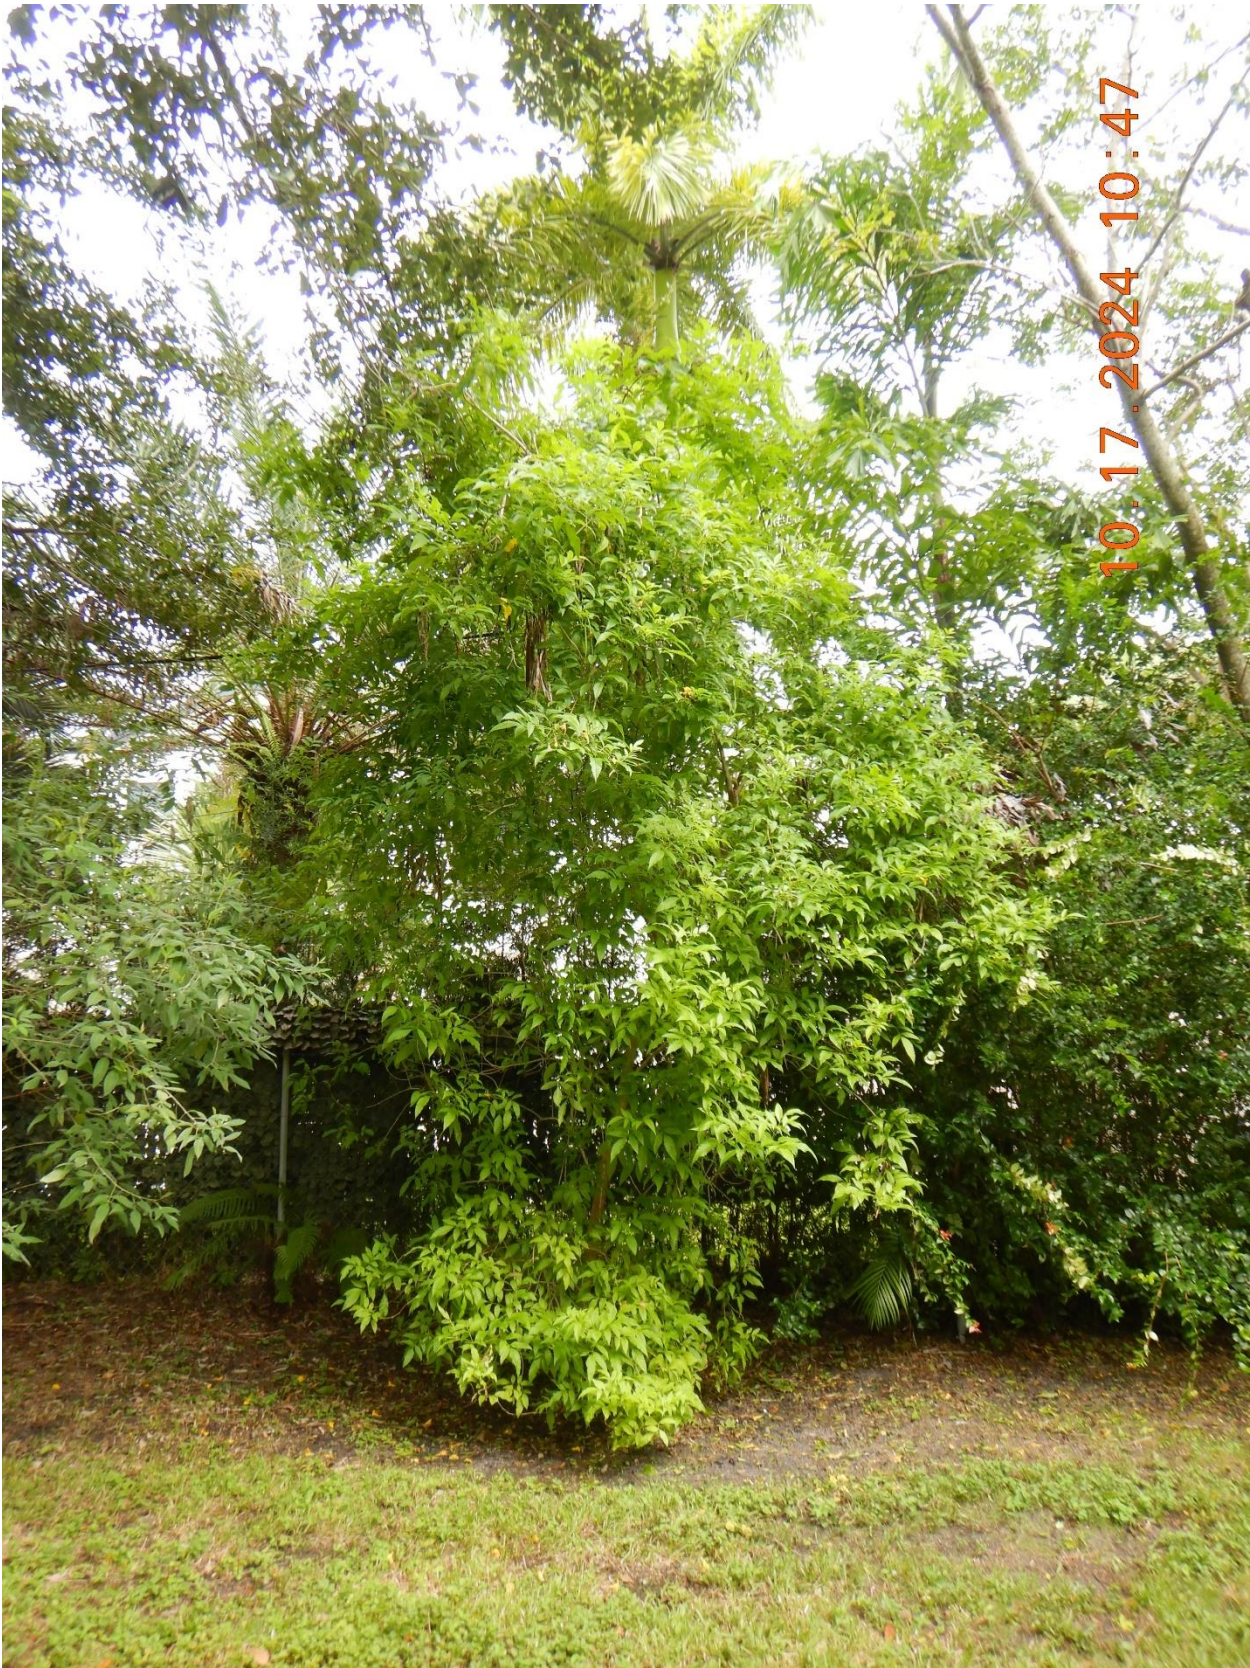
| 21 | Yellow elder | <i>Tecoma stans</i> | 2.5 | 2.5 | 1.25 | 15 | 16x12 | 60% | Co-canopy |

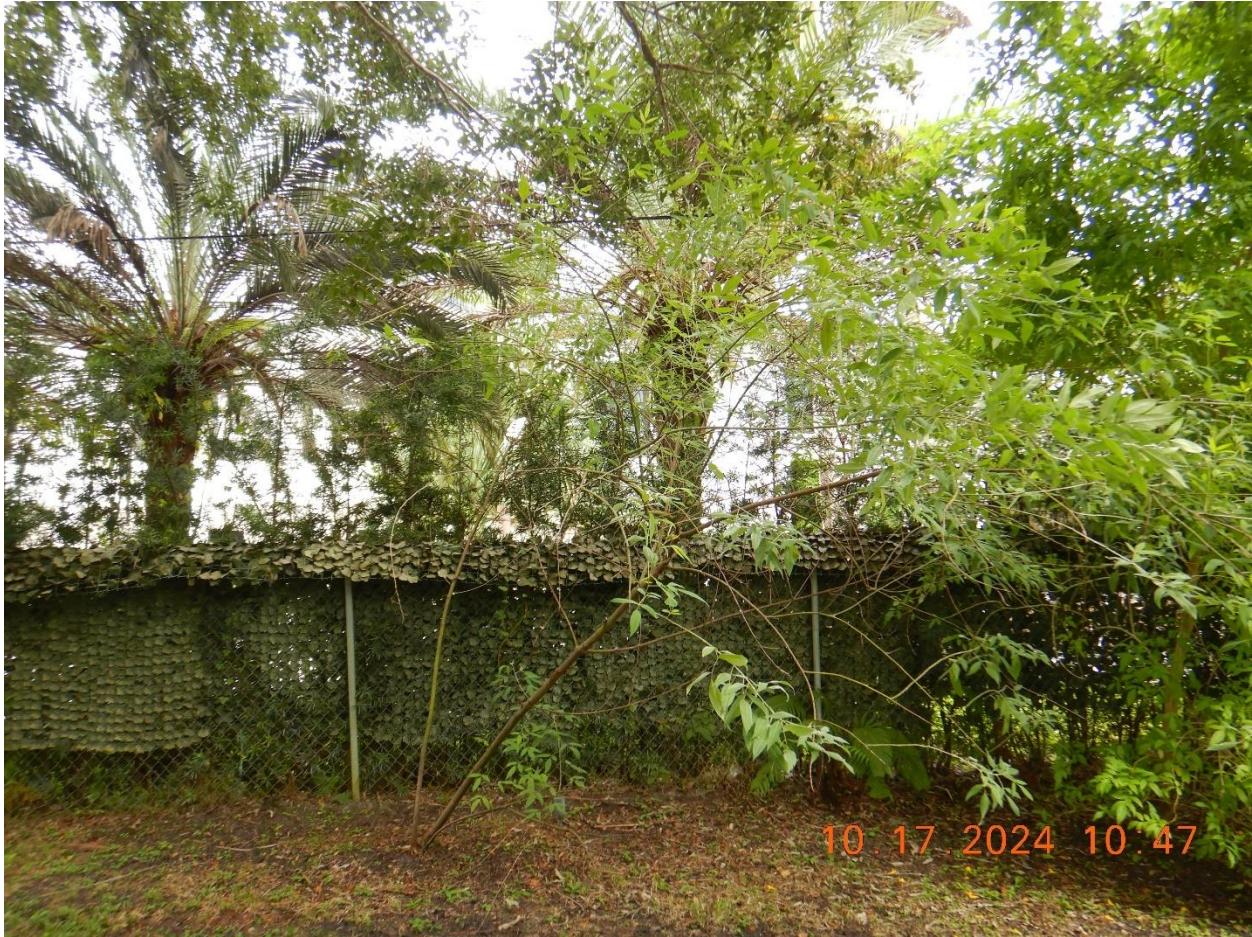
| 22 | Pigeon<br>pea | Cajanus<br>cajan | 2 | 2 | 1 | 10 | 14x9 | 40% | Sub-canopy |

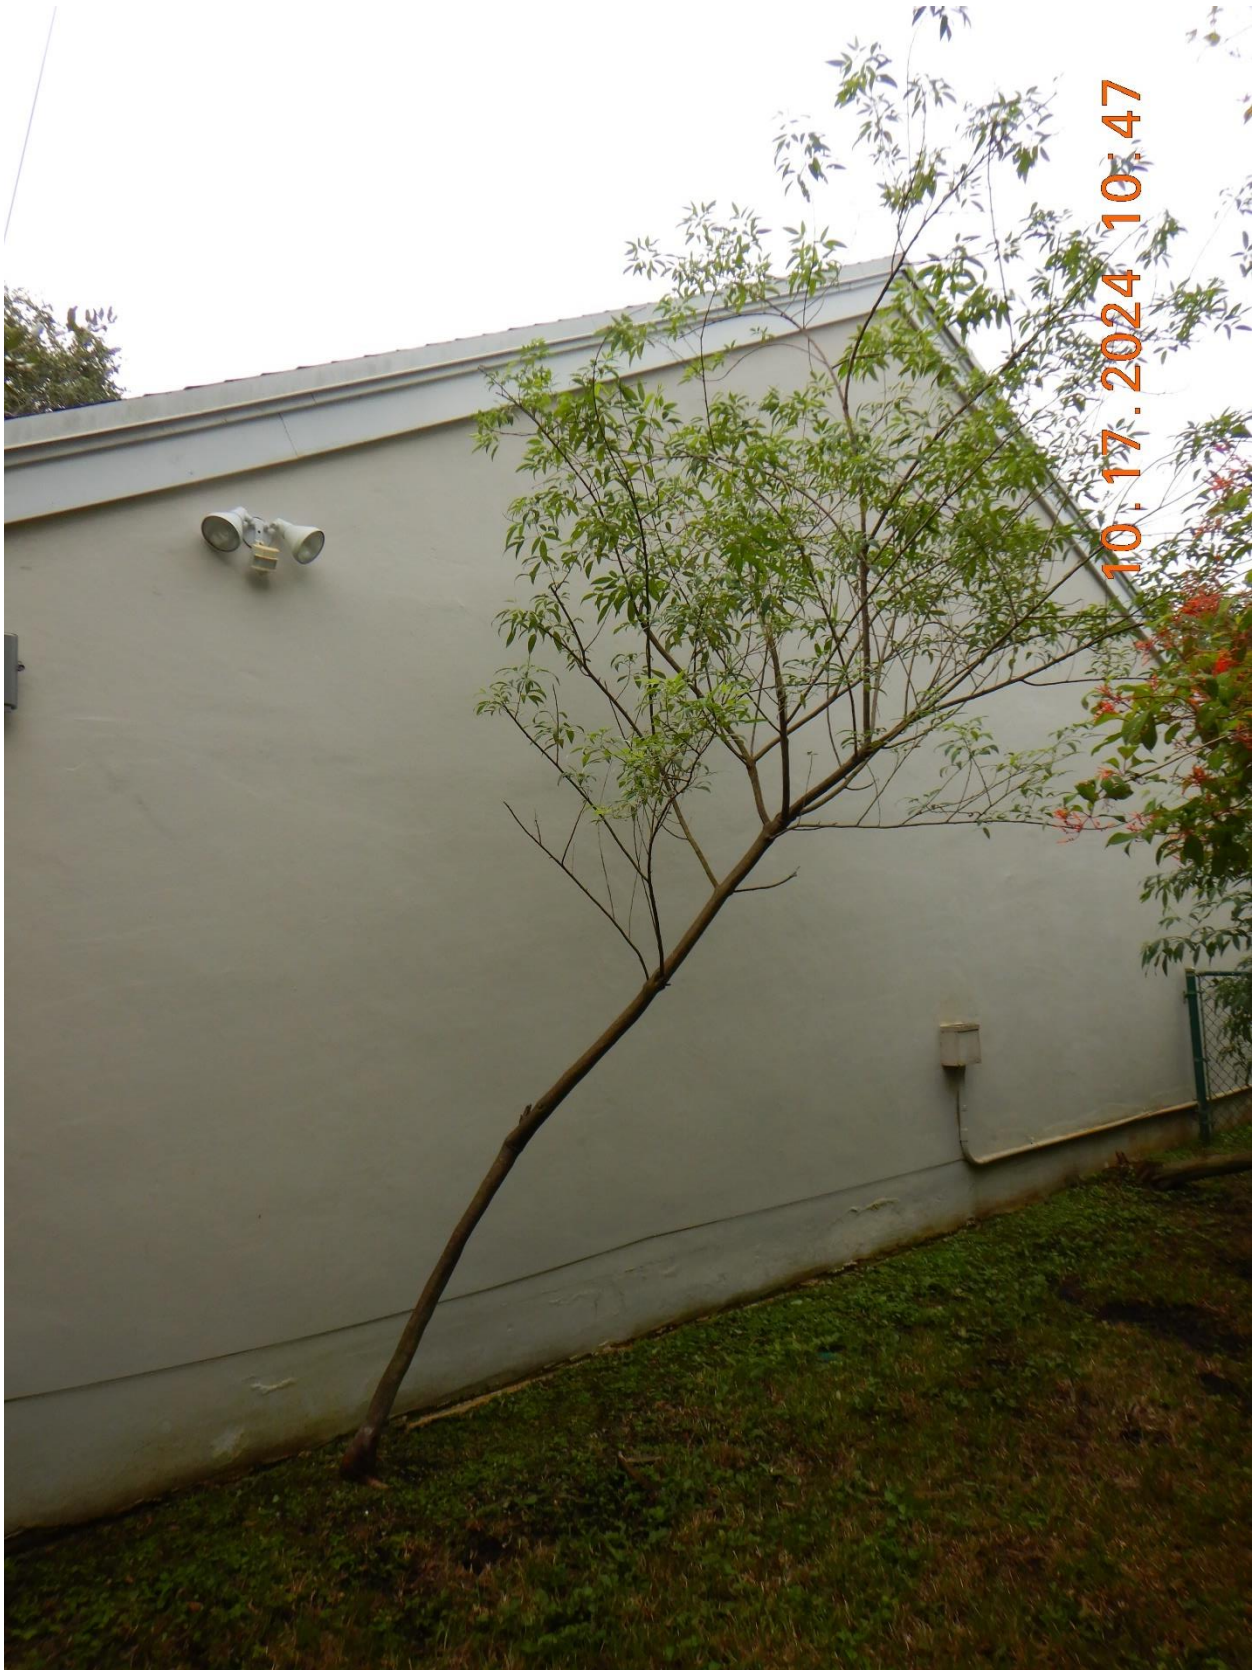
| 23 | Pigeon<br>pea | Cajanus<br>cajan | 2 | 2 | 1 | 11 | 11x9 | 30% | Planted less than 1ft away from structure |

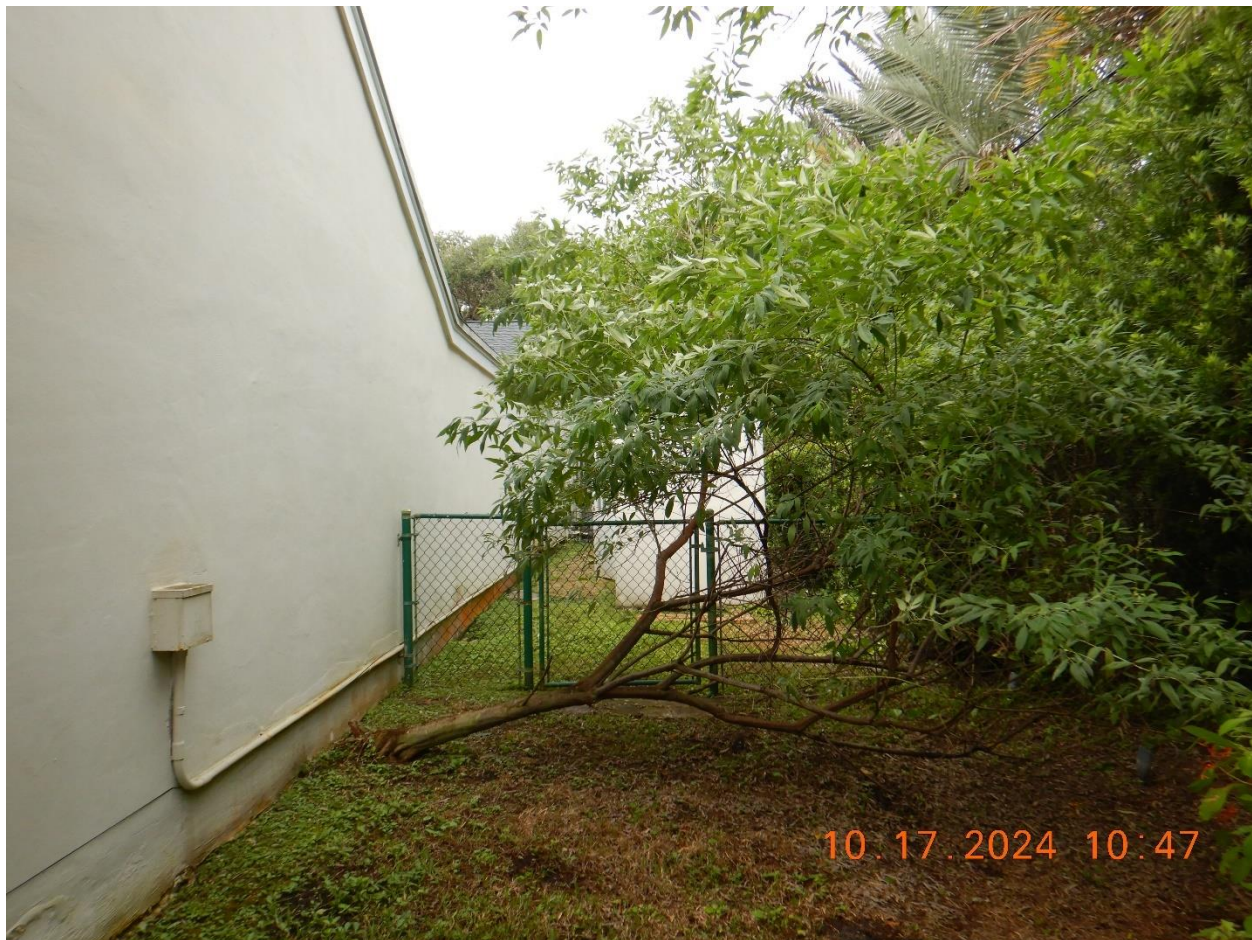
| 24 | Pigeon<br>pea | Cajanus<br>cajan | 4.5 | 4.5 | 2.25 | 12 | 14x15 | 20% | Planted less than 1ft away from structure,<br>previously heaved |
