**Folio- 20-5002-020-0060 9875 SW 69 Ct Miami, FL 33156**

**Tree Risk Assessment**

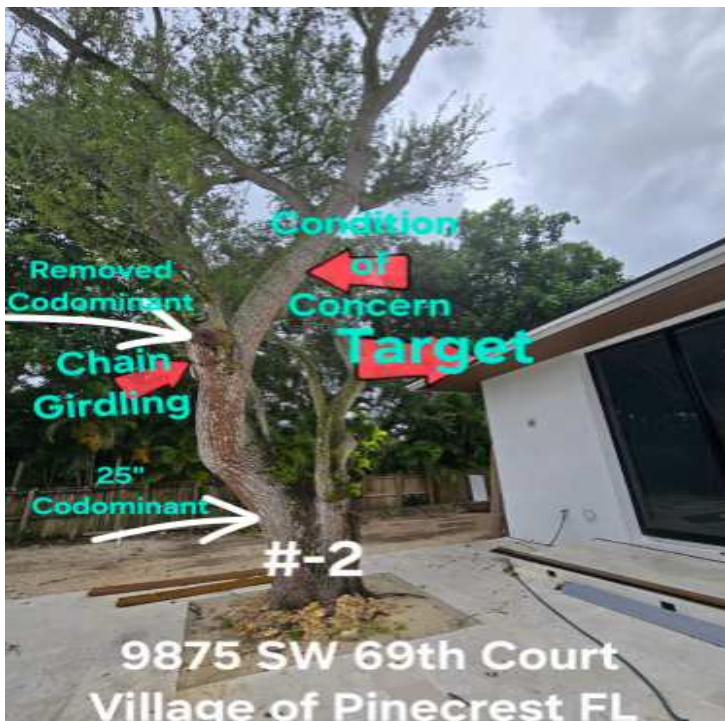
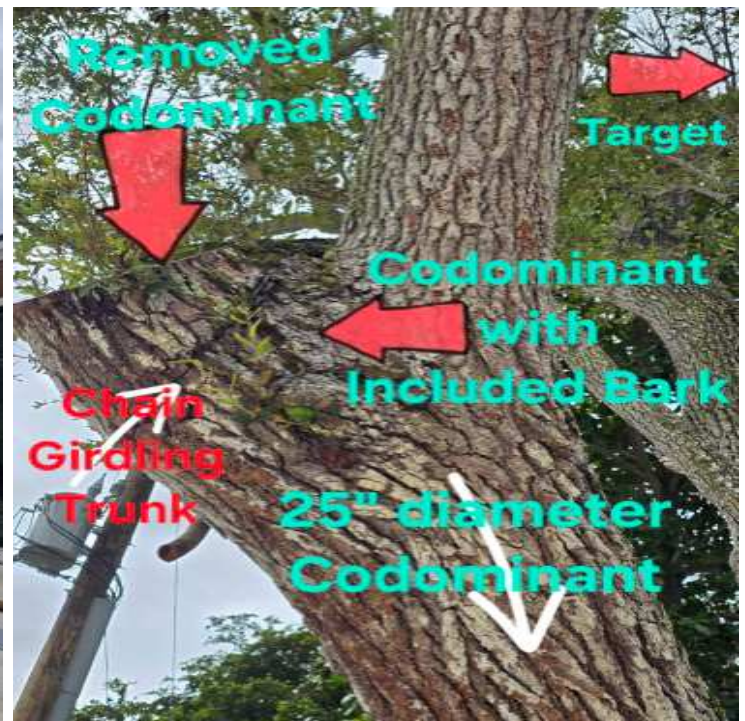
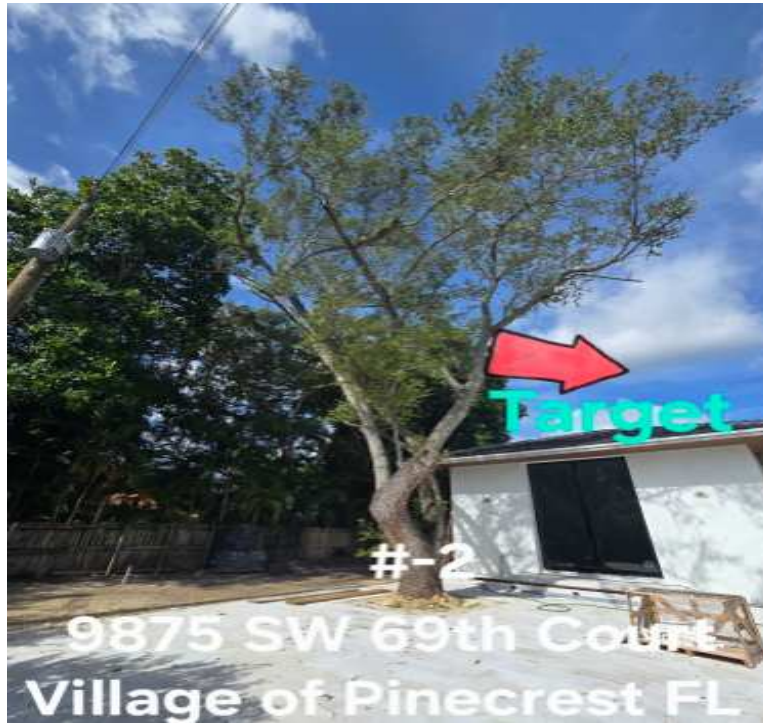
Photos Taken:7-22-2026 by: Joe R. Rodriguez - ISA Certified Arborist FL0124-A

25-inch codominant: This stem divides into three additional codominant stems. One of these stems, oriented toward the swimming pool, was previously cut at approximately 9'ft in height. A metal chain is present and appears to be girdling the remaining stub. This condition is likely contributing to, or has resulted in, internal decay within the stem.

The remaining codominant stem exhibits possible to probable likelihood of failure, with the residence located in close proximity and therefore representing a significant potential target.

**Under normal and extreme weather conditions. EXCLUDING extreme weather/Hurricanes  
Condition of concern- 25" Codominant that splits into two codominants at approx. 8'ft height**

Likelihood of Failure- POSSIBLE within 3 years - Under Normal or Severe Weather Condition  
(Excluding Extreme weather/hurricane)

Likelihood of Impact- HIGH

Likelihood of Failure and Impact- SOMEWHAT LIKELY

Consequences of Failure- SIGNIFICANT

Overall Tree Risk Rating- MODERATE

As previously noted, the Live Oak consisted of multiple codominant stems at DBH. Based on the tree's structural condition and the likelihood of failure associated with the codominant stems, the tree would have been graded as a CULL\*, rather than being considered a specimen-quality tree. For these reasons, and based on the applicable Florida Grades and Standards criteria, I respectfully request reconsideration of the specimen designation and removal of Live Oak #2 from the Specimen Tree classification.
