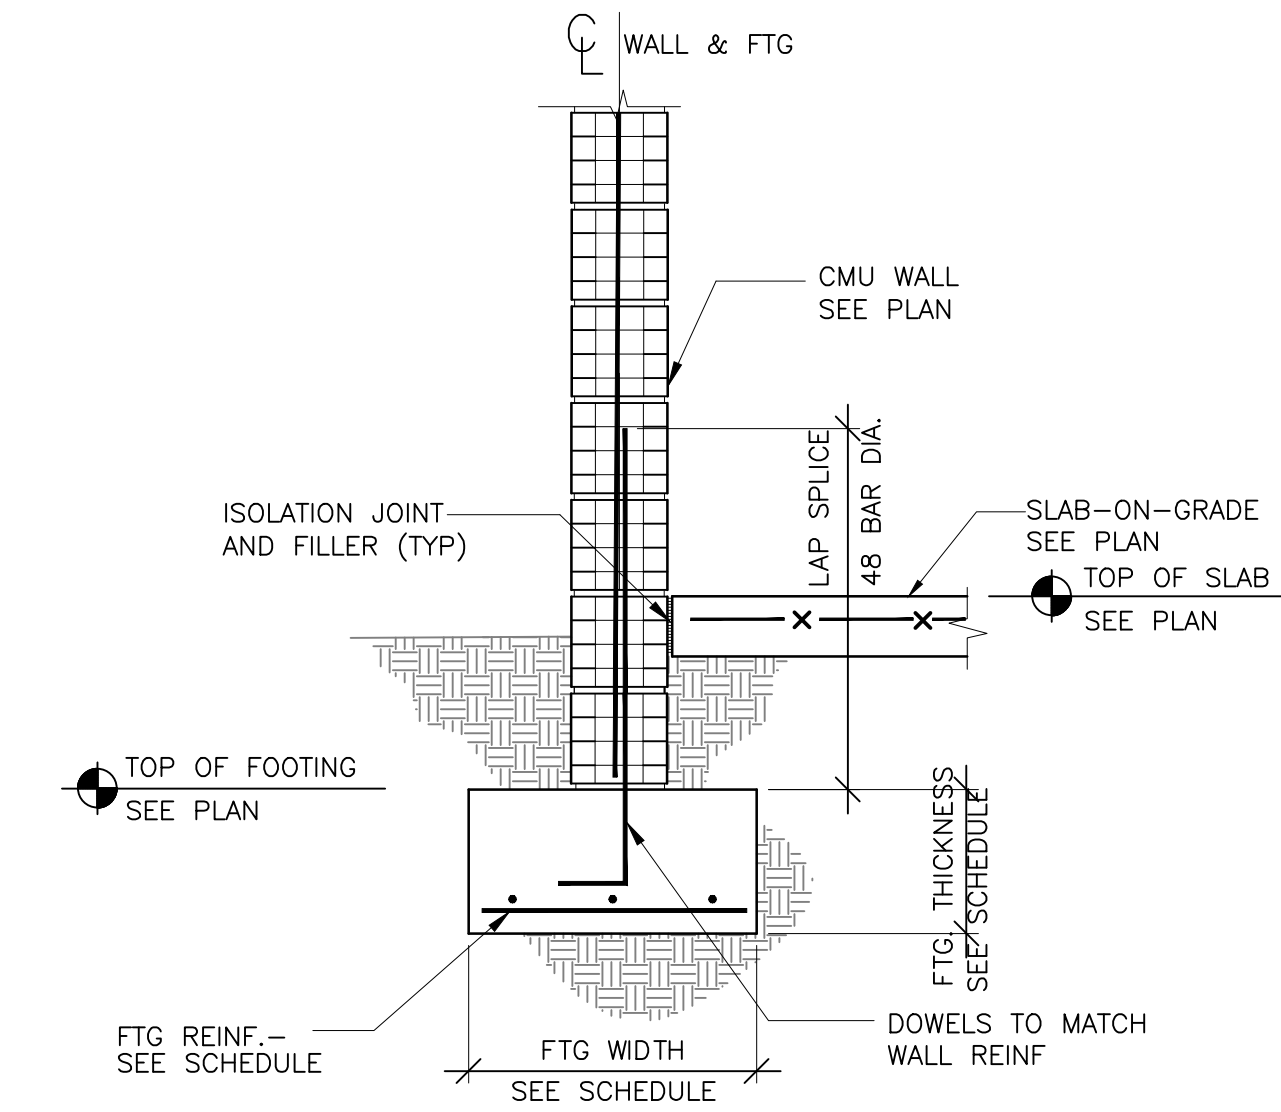
10

**TYPICAL DETAIL  
EXTERIOR LOAD-BEARING CMU WALL  
TO FOOTING CONNECTION**

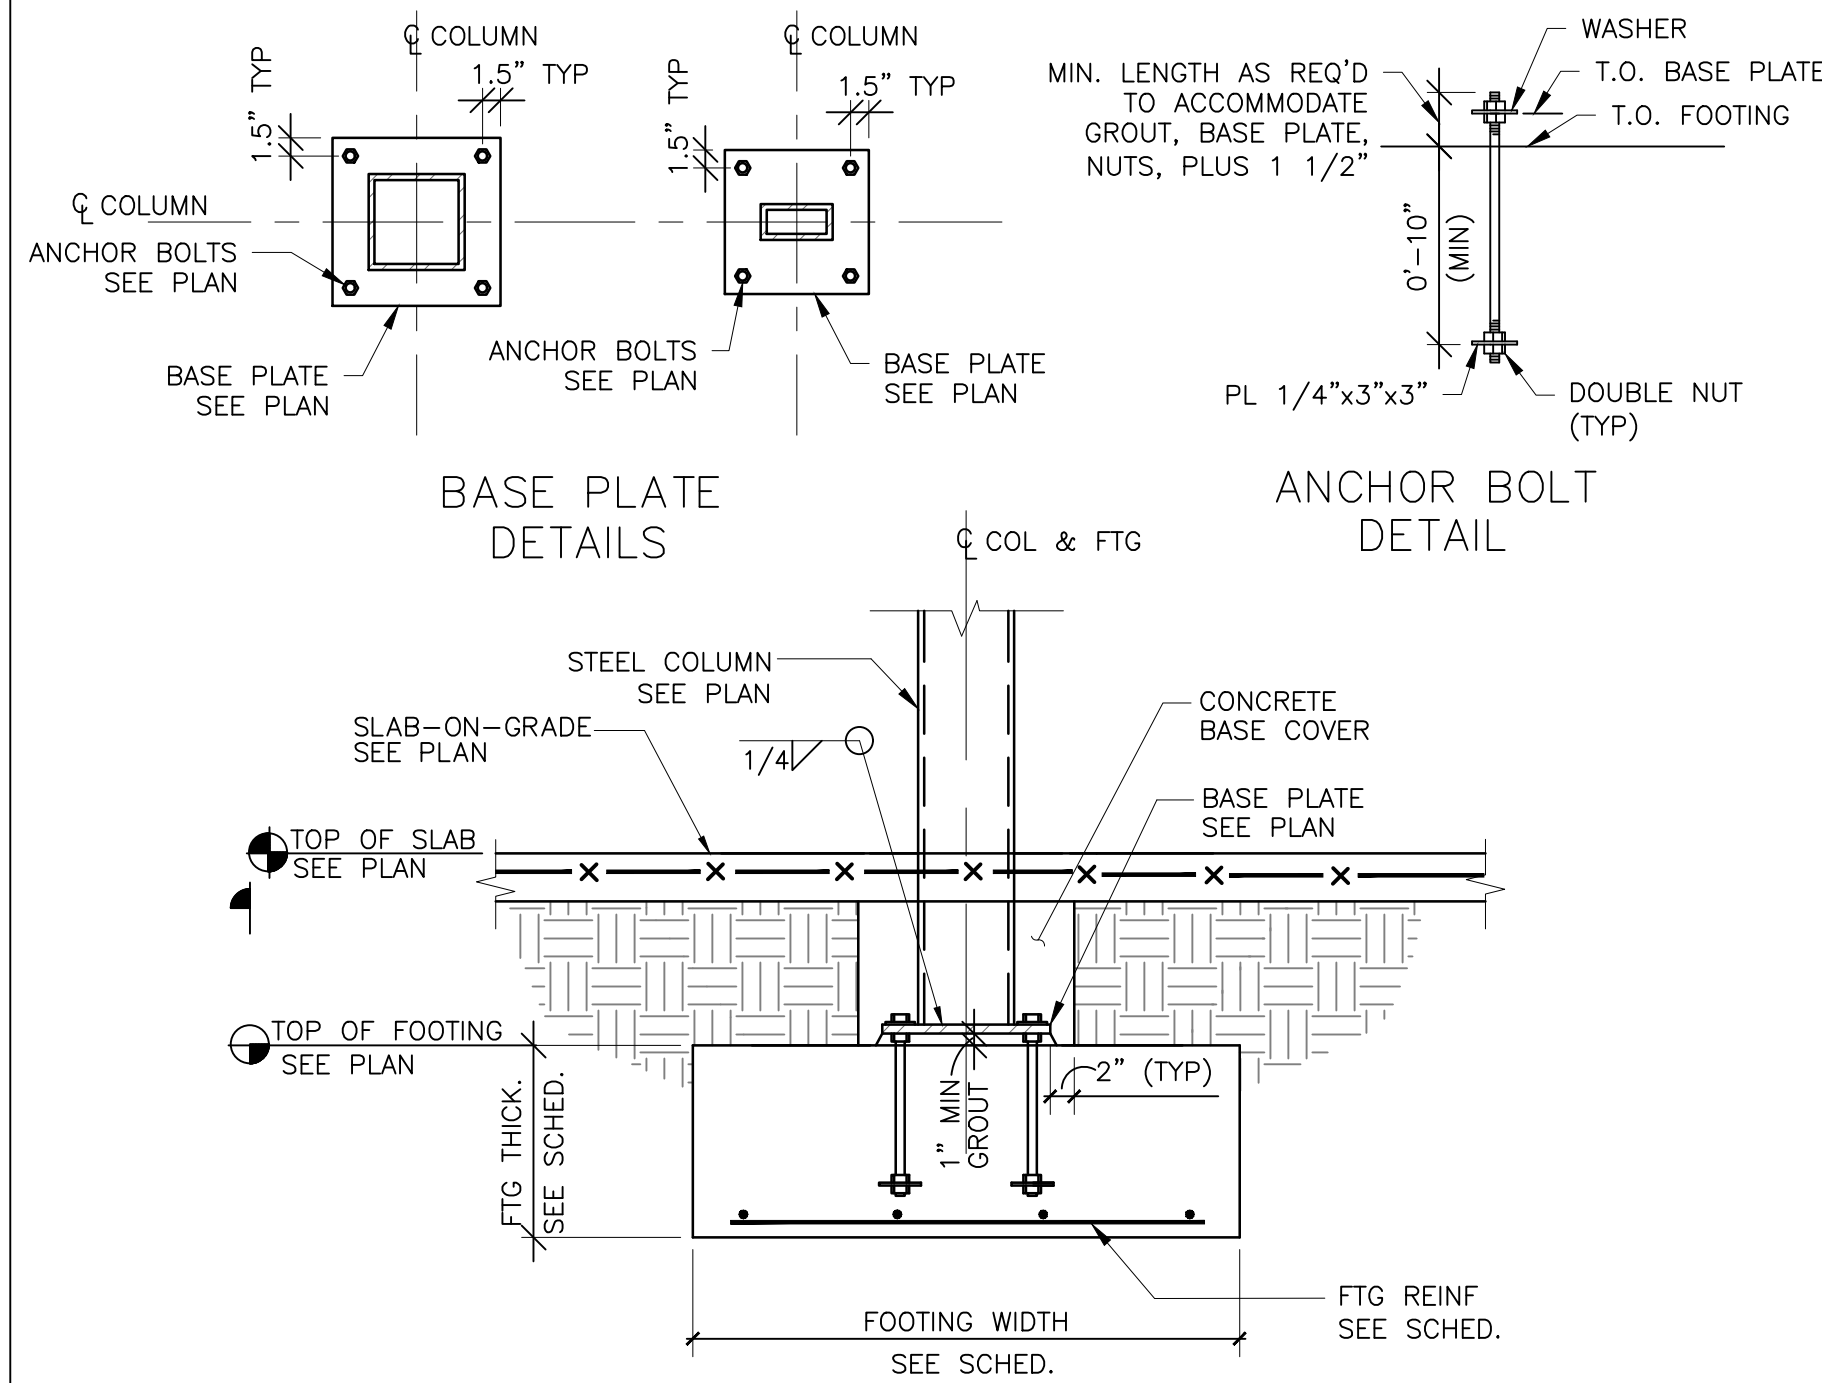
7

**TYPICAL DETAIL  
STEEL COLUMN TO FOOTING  
CONNECTION**

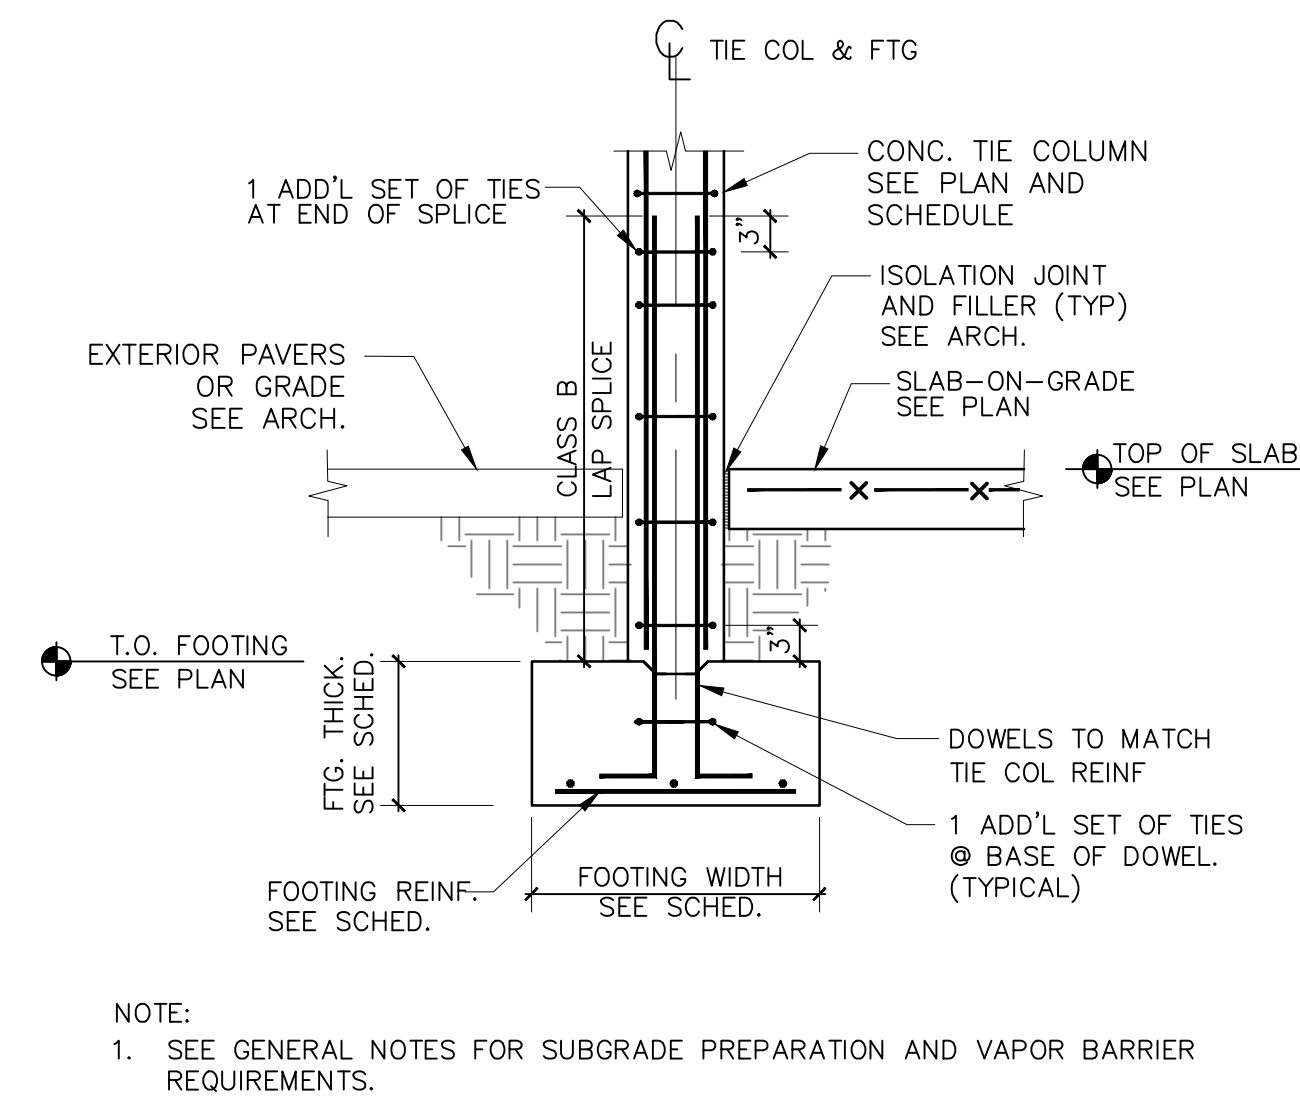
4

**TYPICAL DETAIL  
CONCRETE TIE COLUMN TO WALL FOOTING  
CONNECTION**

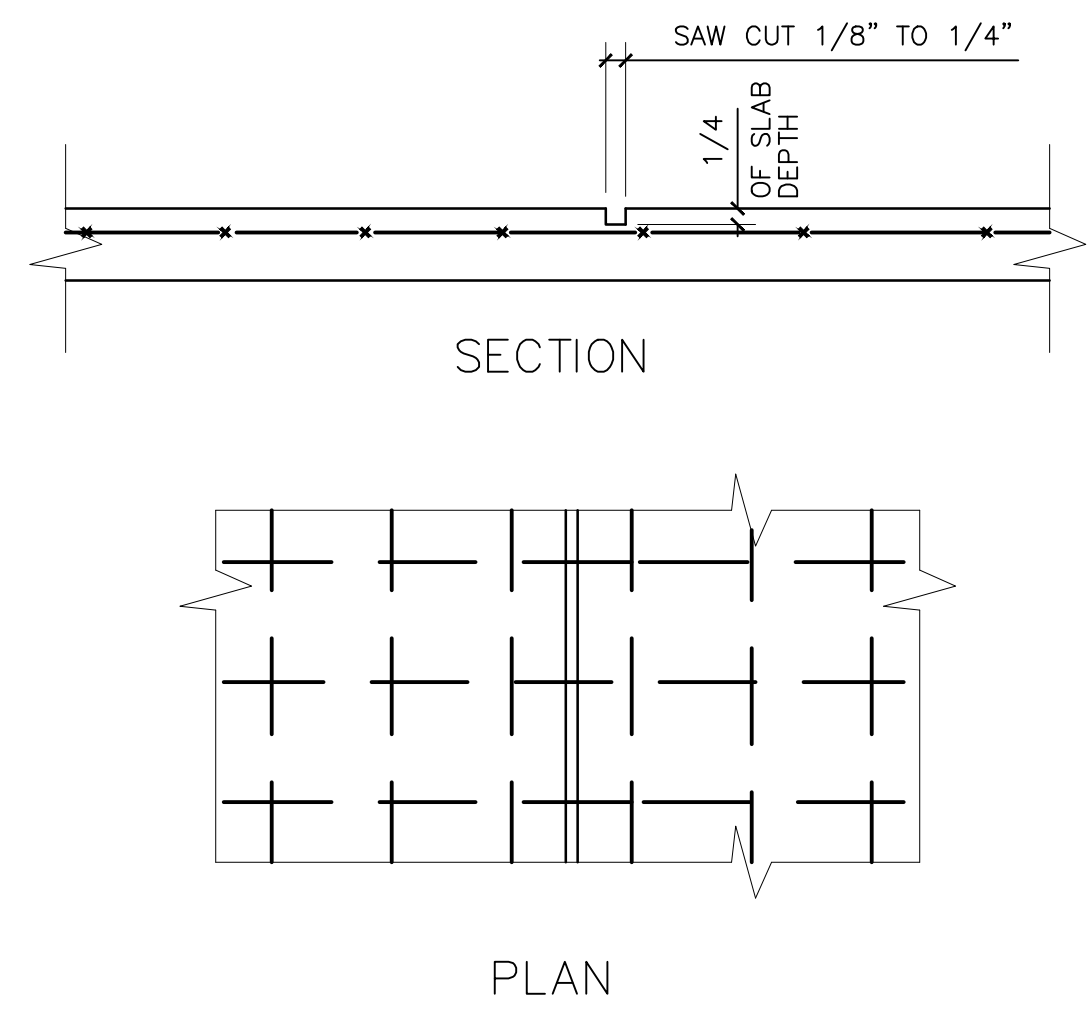
1

**TYPICAL DETAIL  
CONTROL JOINT  
SLAB-ON-GRADE**

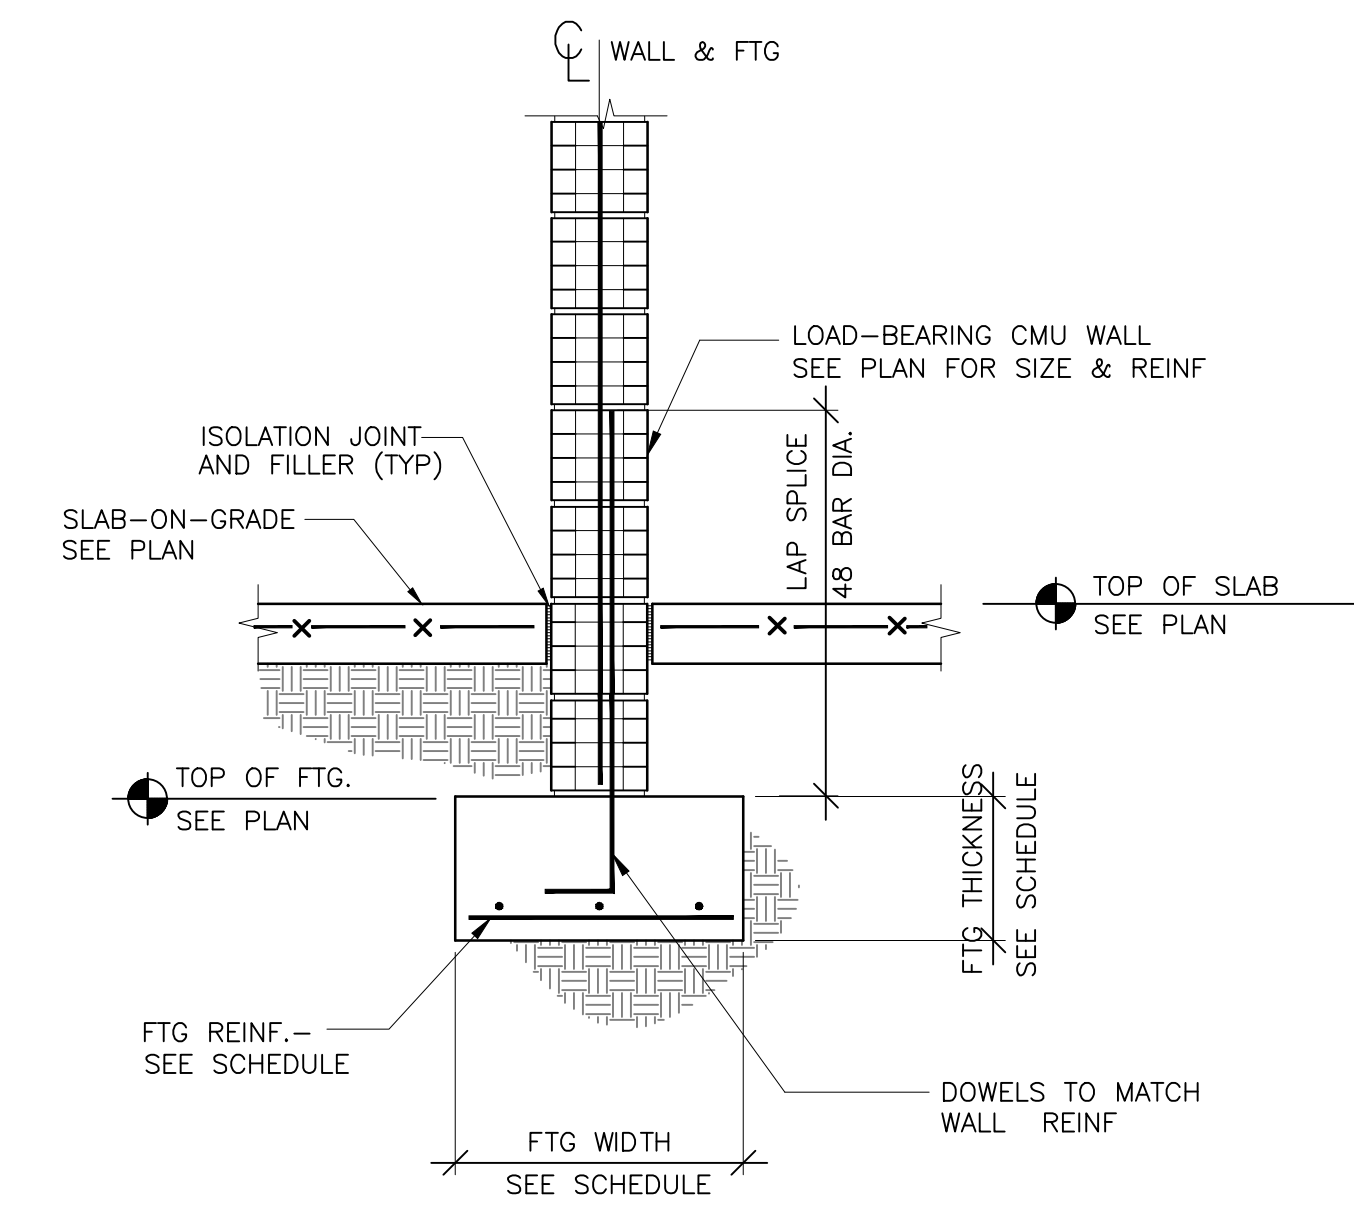
11

**TYPICAL DETAIL  
INTERIOR LOAD-BEARING CMU WALL  
TO FOOTING CONNECTION**

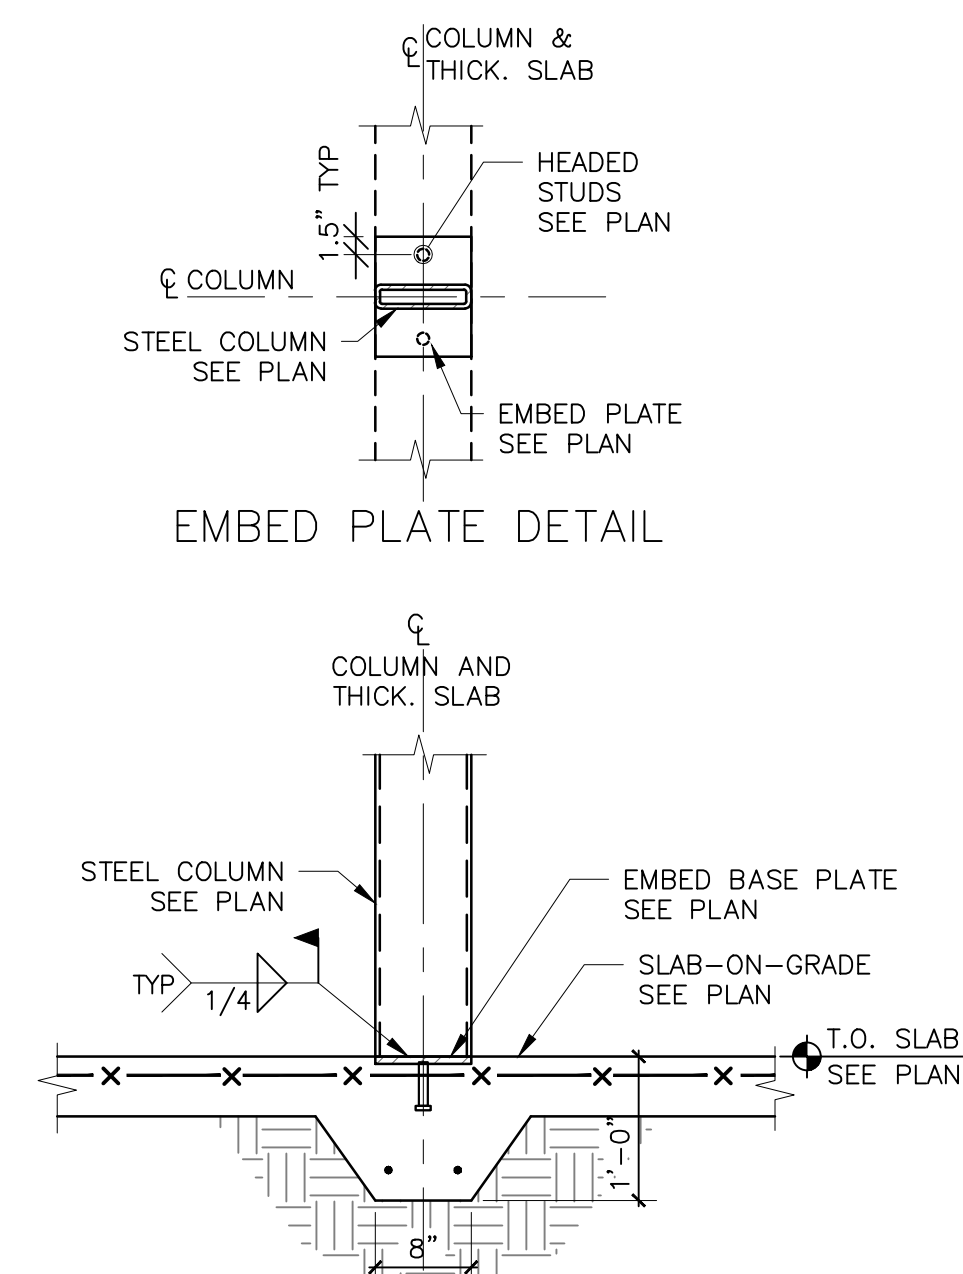
8

**TYPICAL DETAIL  
STEEL COLUMN TO THICKENED SLAB  
CONNECTION**

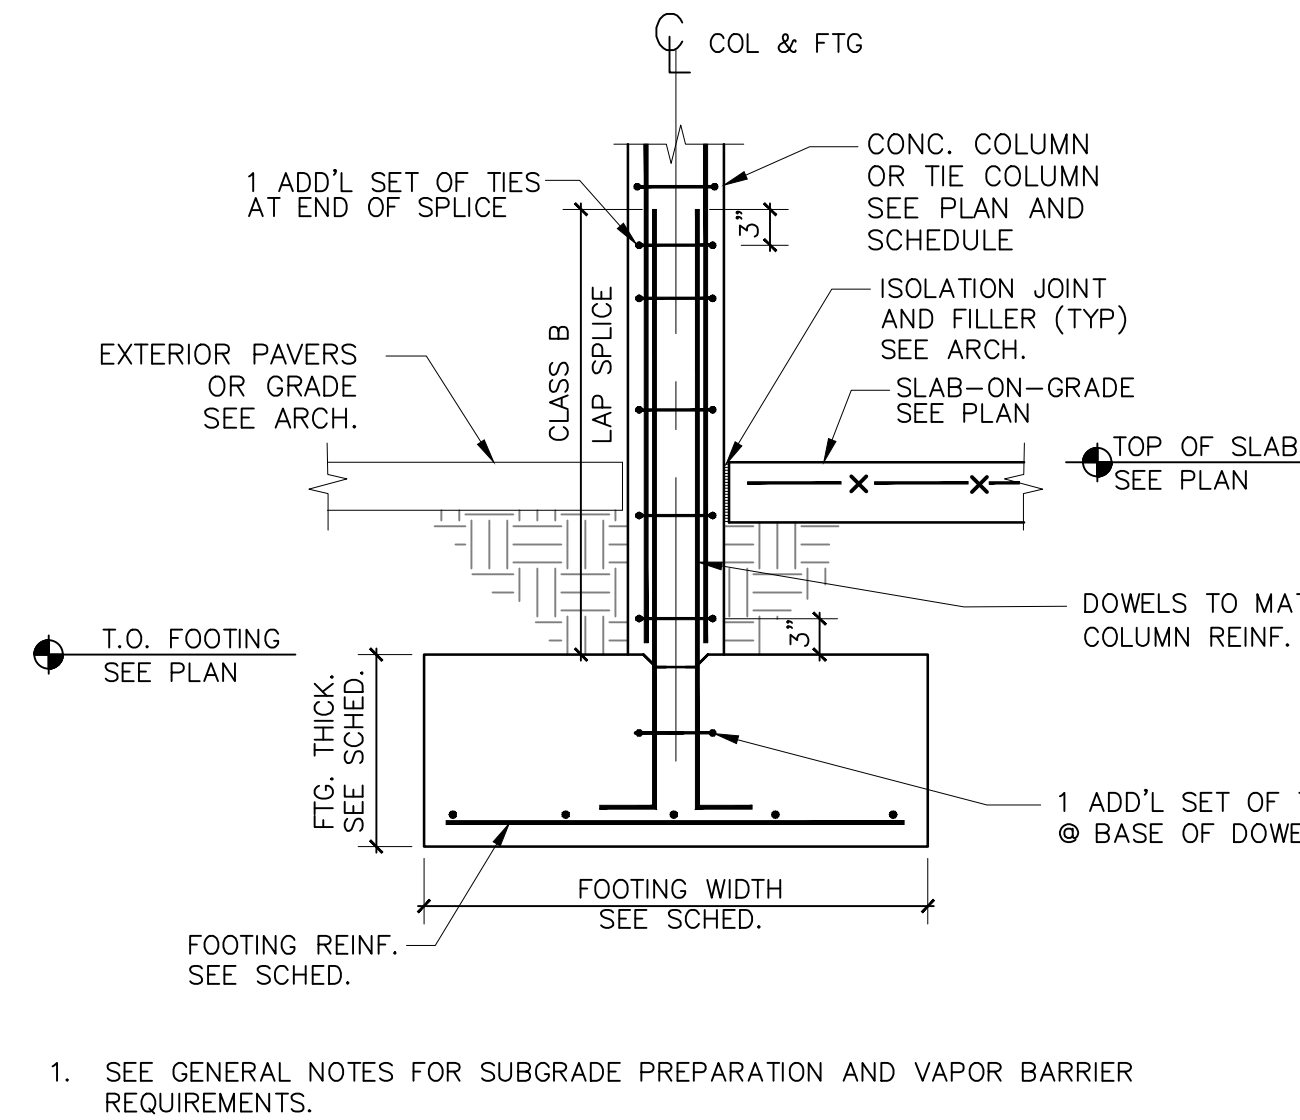
5

**TYPICAL DETAIL  
CONCRETE COLUMN OR TIE COLUMN  
TO FOOTING CONNECTION**

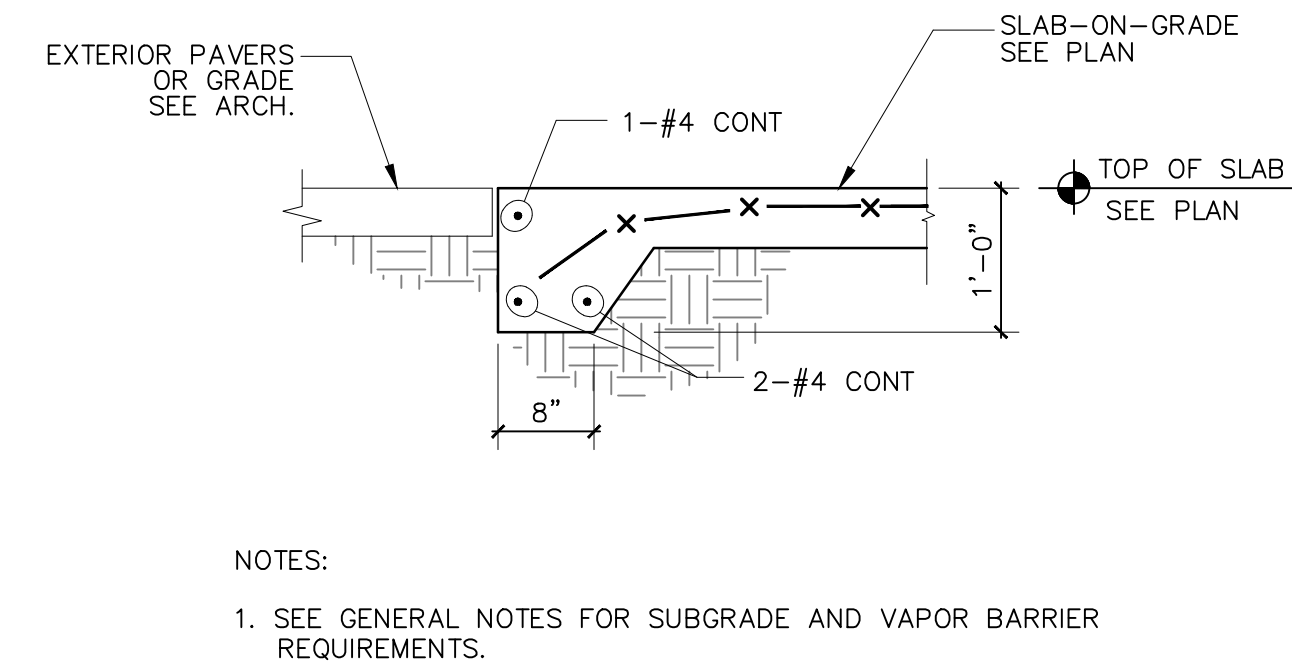
2

**TYPICAL DETAIL  
THICKENED SLAB EDGE  
SLAB-ON-GRADE**

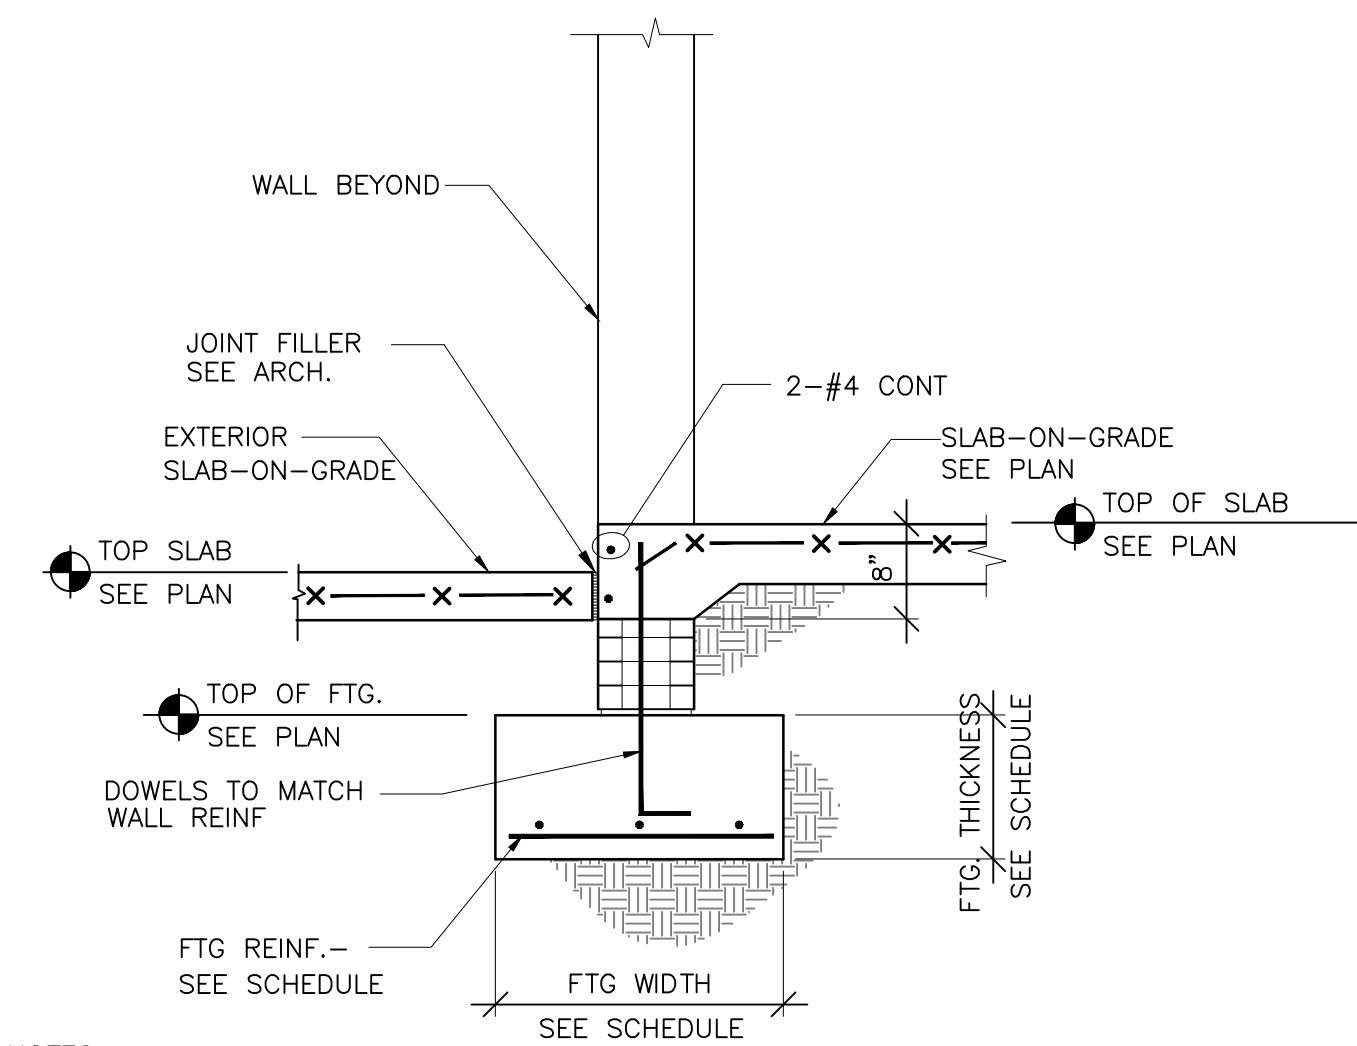
9

**TYPICAL DETAIL  
CMU WALL TO FOOTING CONNECTION  
AT EXTERIOR DOOR OPENING**

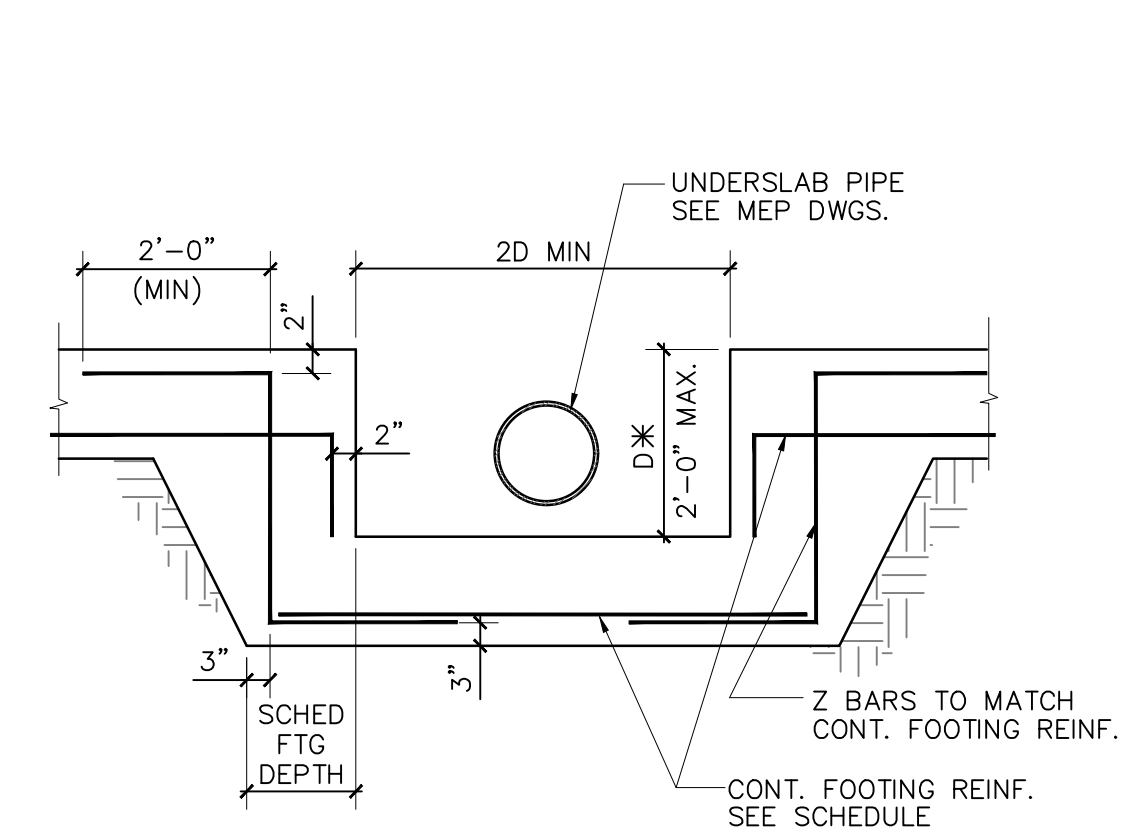
6

**TYPICAL DETAIL  
STEP FOOTING AT UNDERSLAB  
PIPE PENETRATIONS**

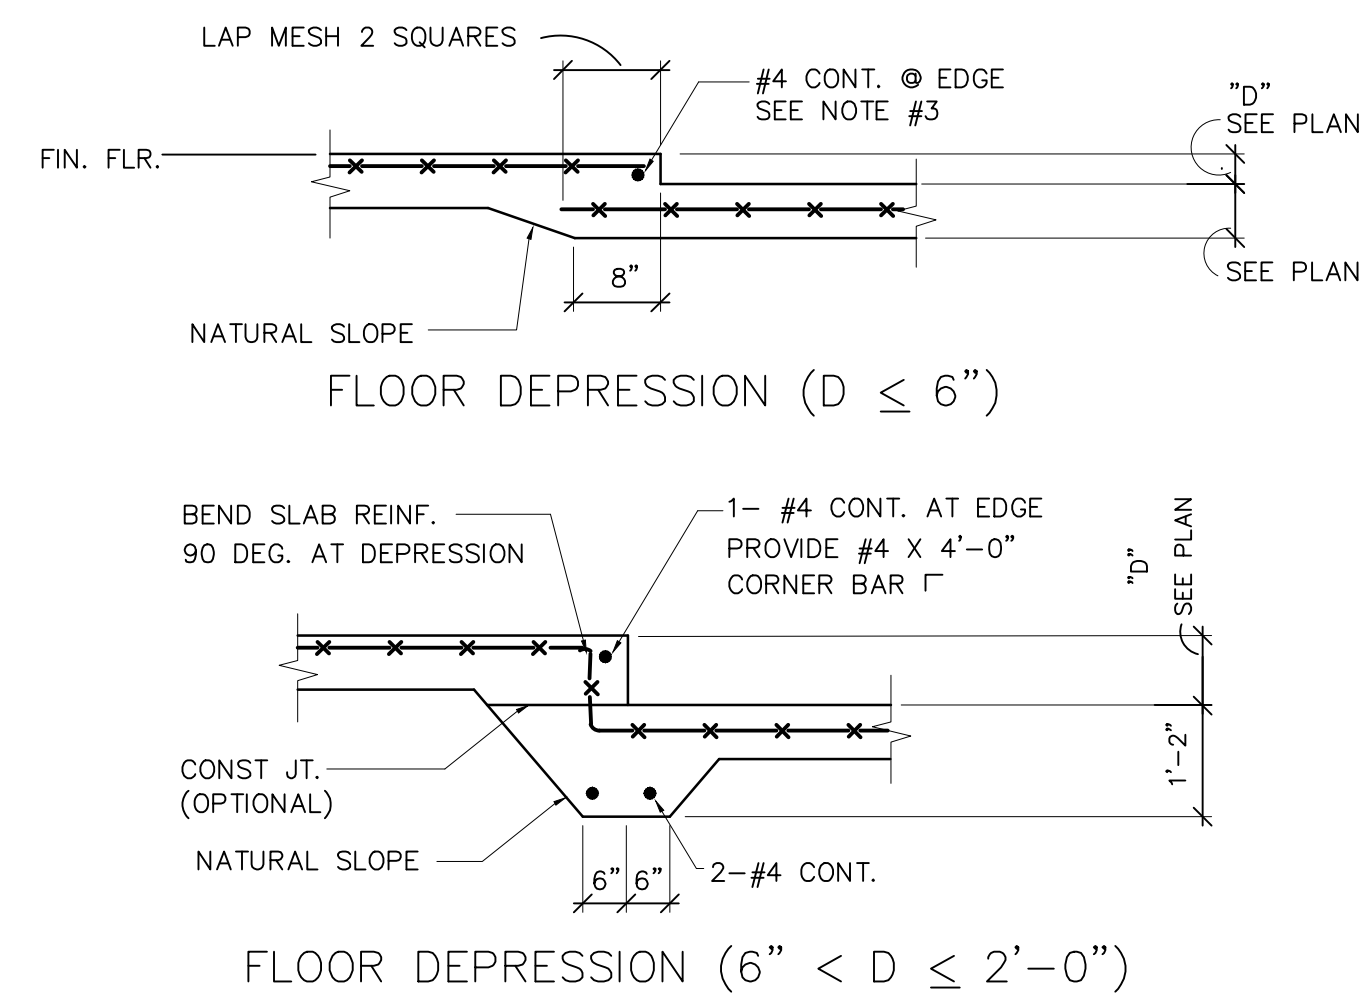
3

**TYPICAL DETAIL  
FLOOR DEPRESSIONS  
SLAB-ON-GRADE**
