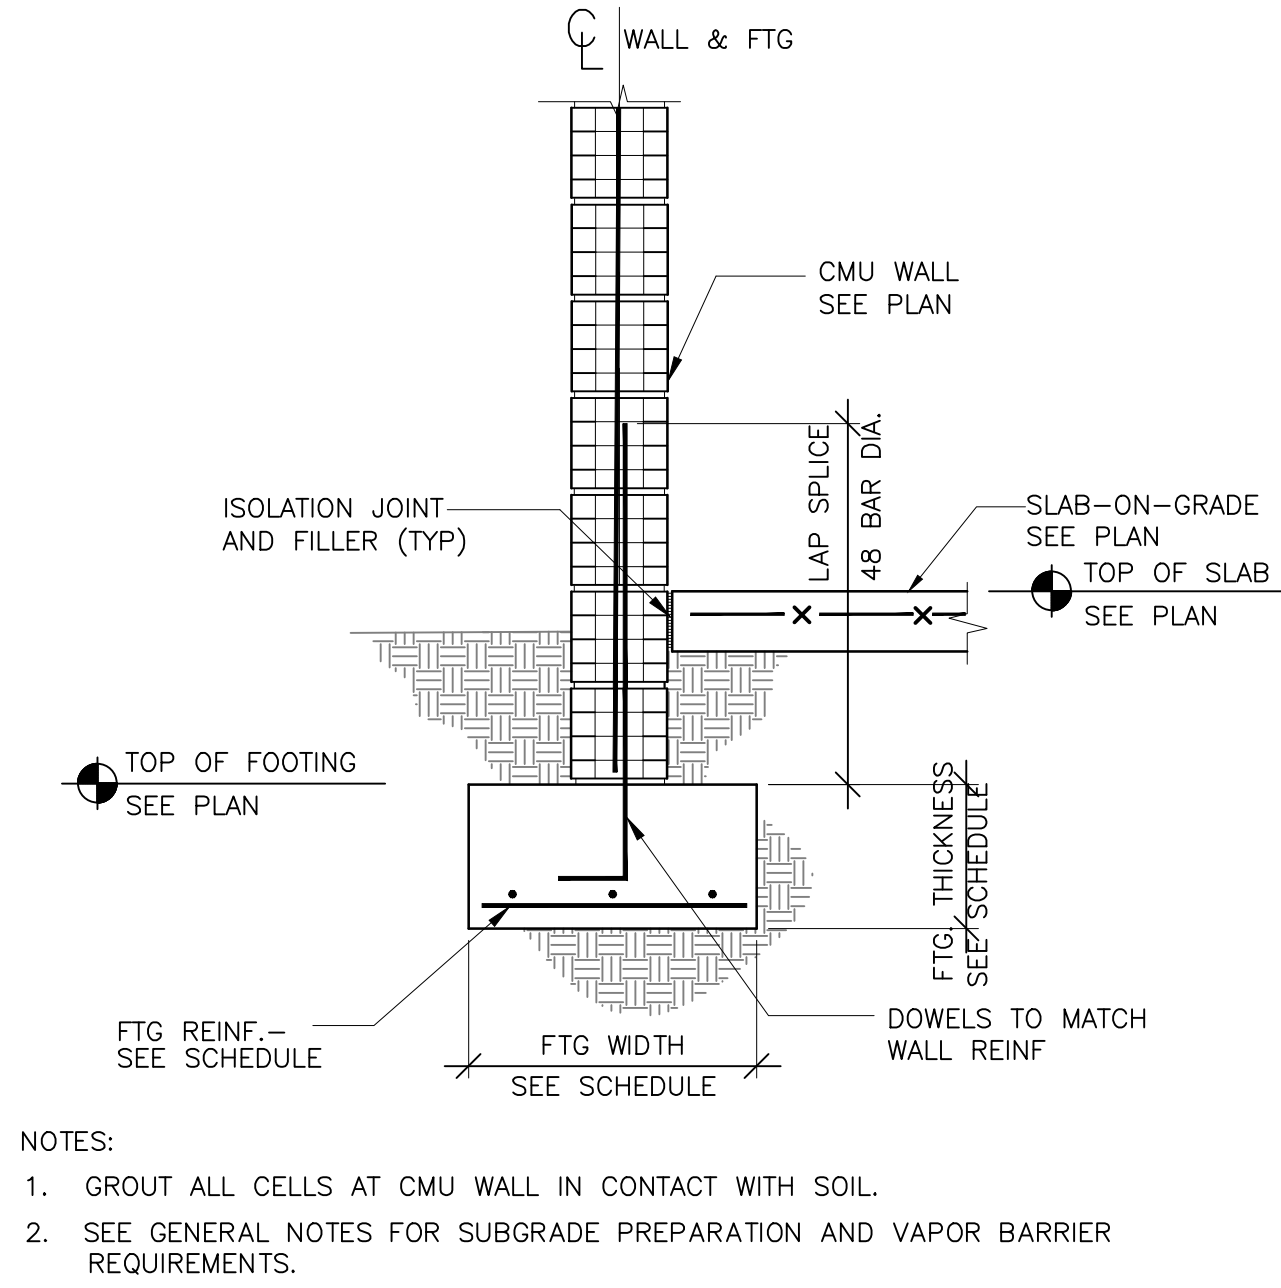
10

**TYPICAL DETAIL  
EXTERIOR LOAD-BEARING CMU WALL  
TO FOOTING CONNECTION**

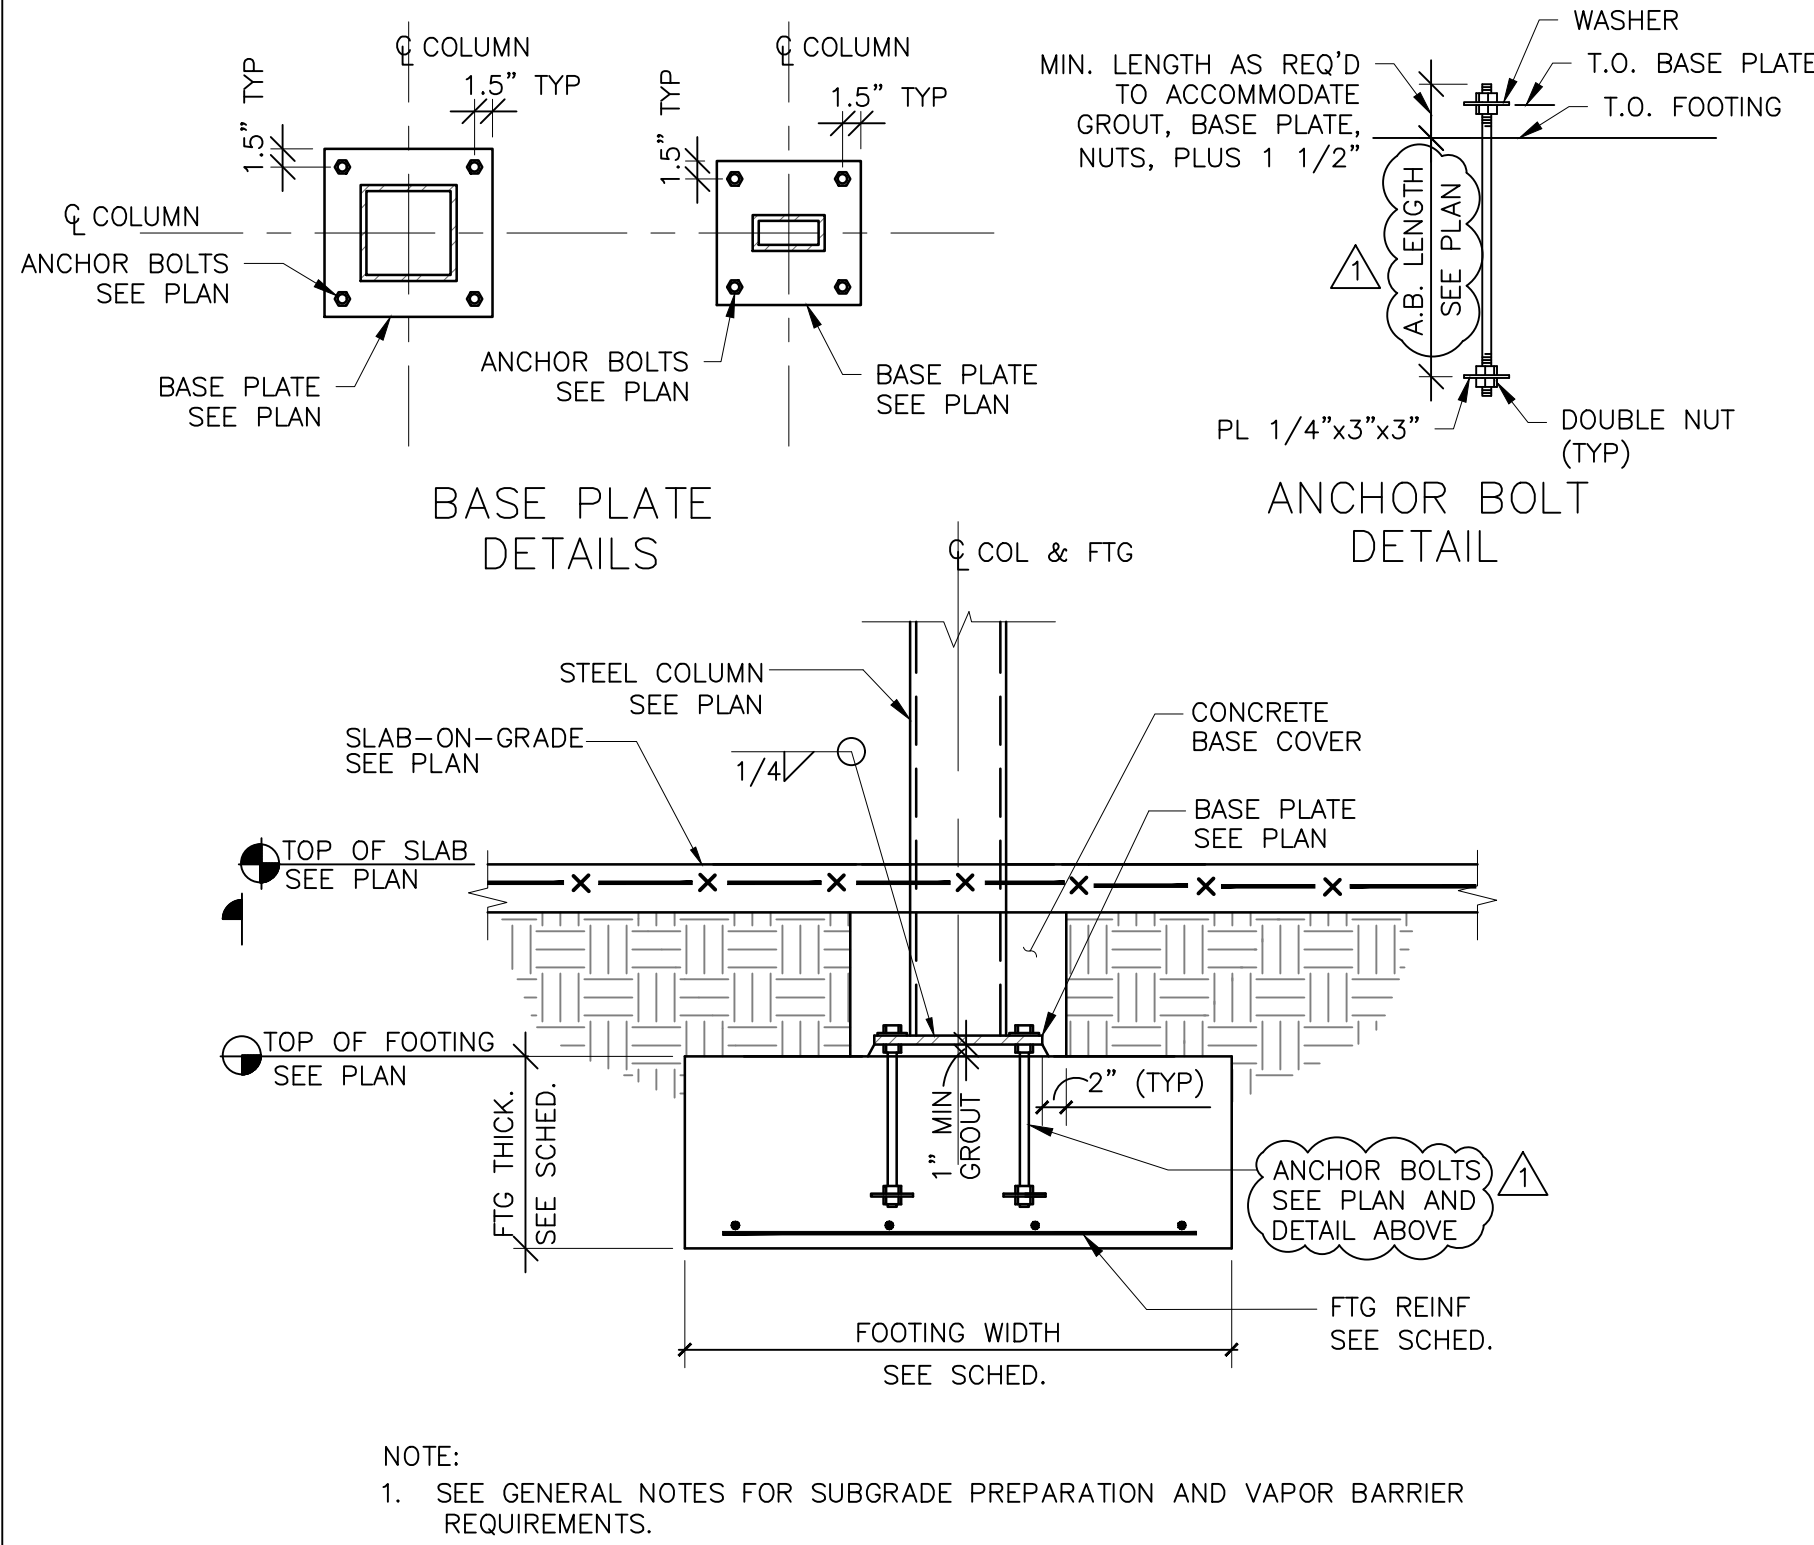
7

**TYPICAL DETAIL  
STEEL COLUMN TO FOOTING  
CONNECTION**

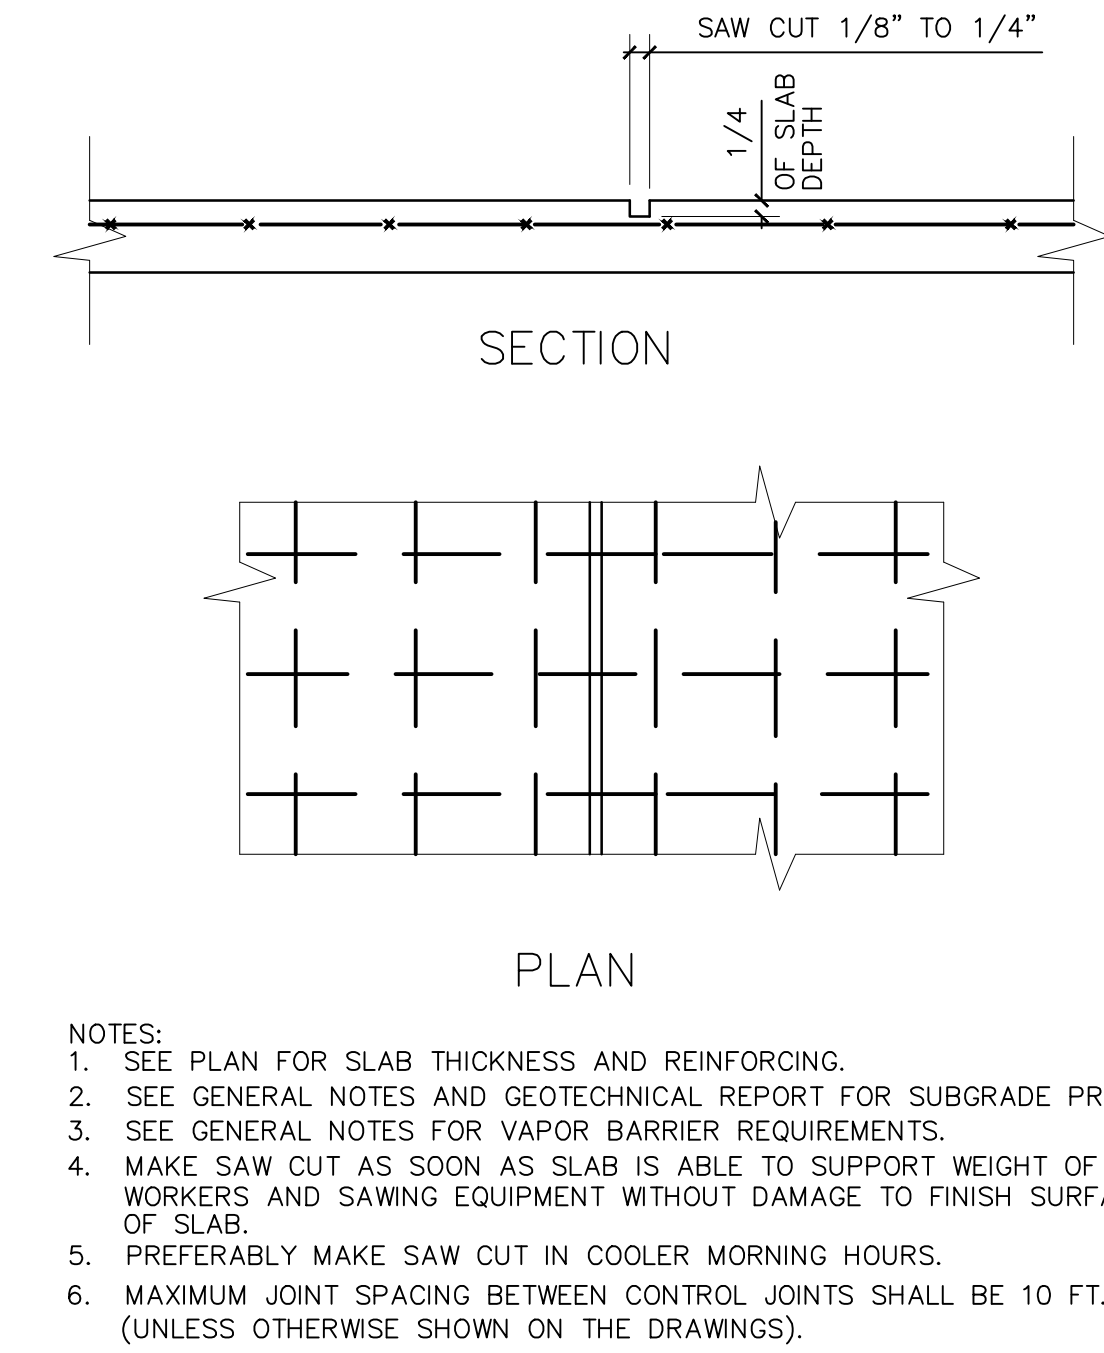
1

**TYPICAL DETAIL  
CONTROL JOINT  
SLAB-ON-GRADE**

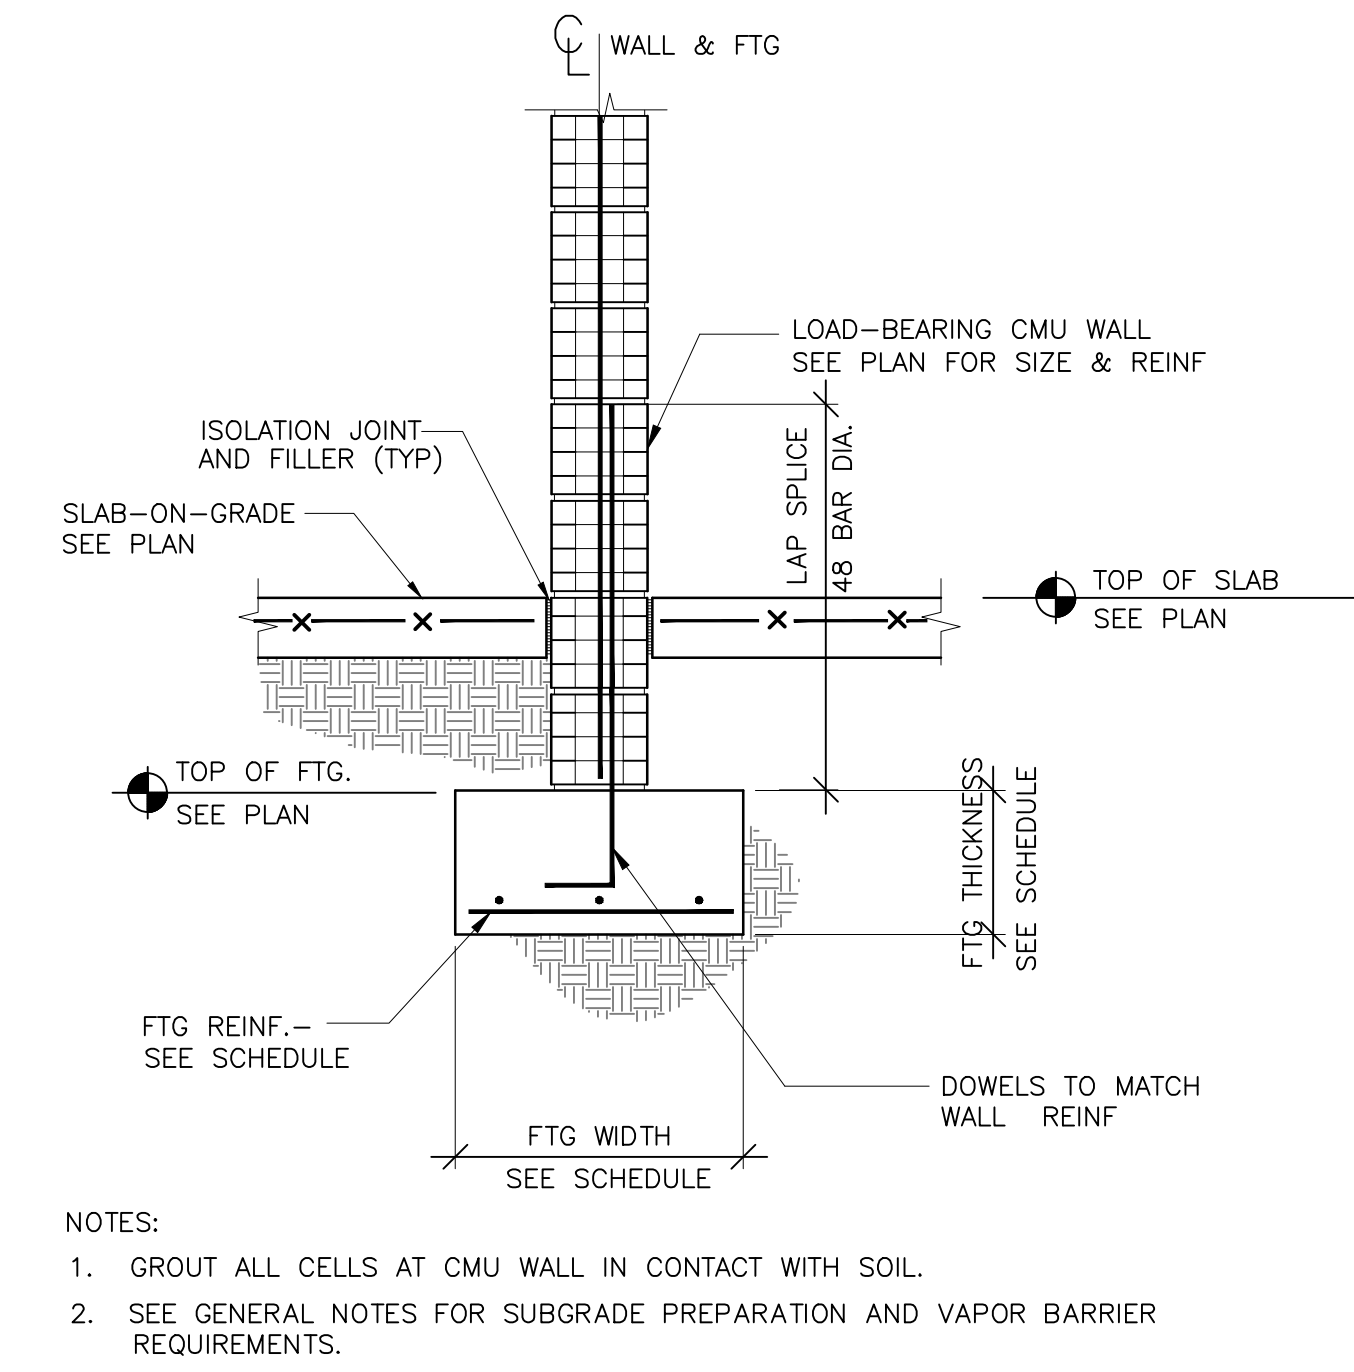
11

**TYPICAL DETAIL  
INTERIOR LOAD-BEARING CMU WALL  
TO FOOTING CONNECTION**

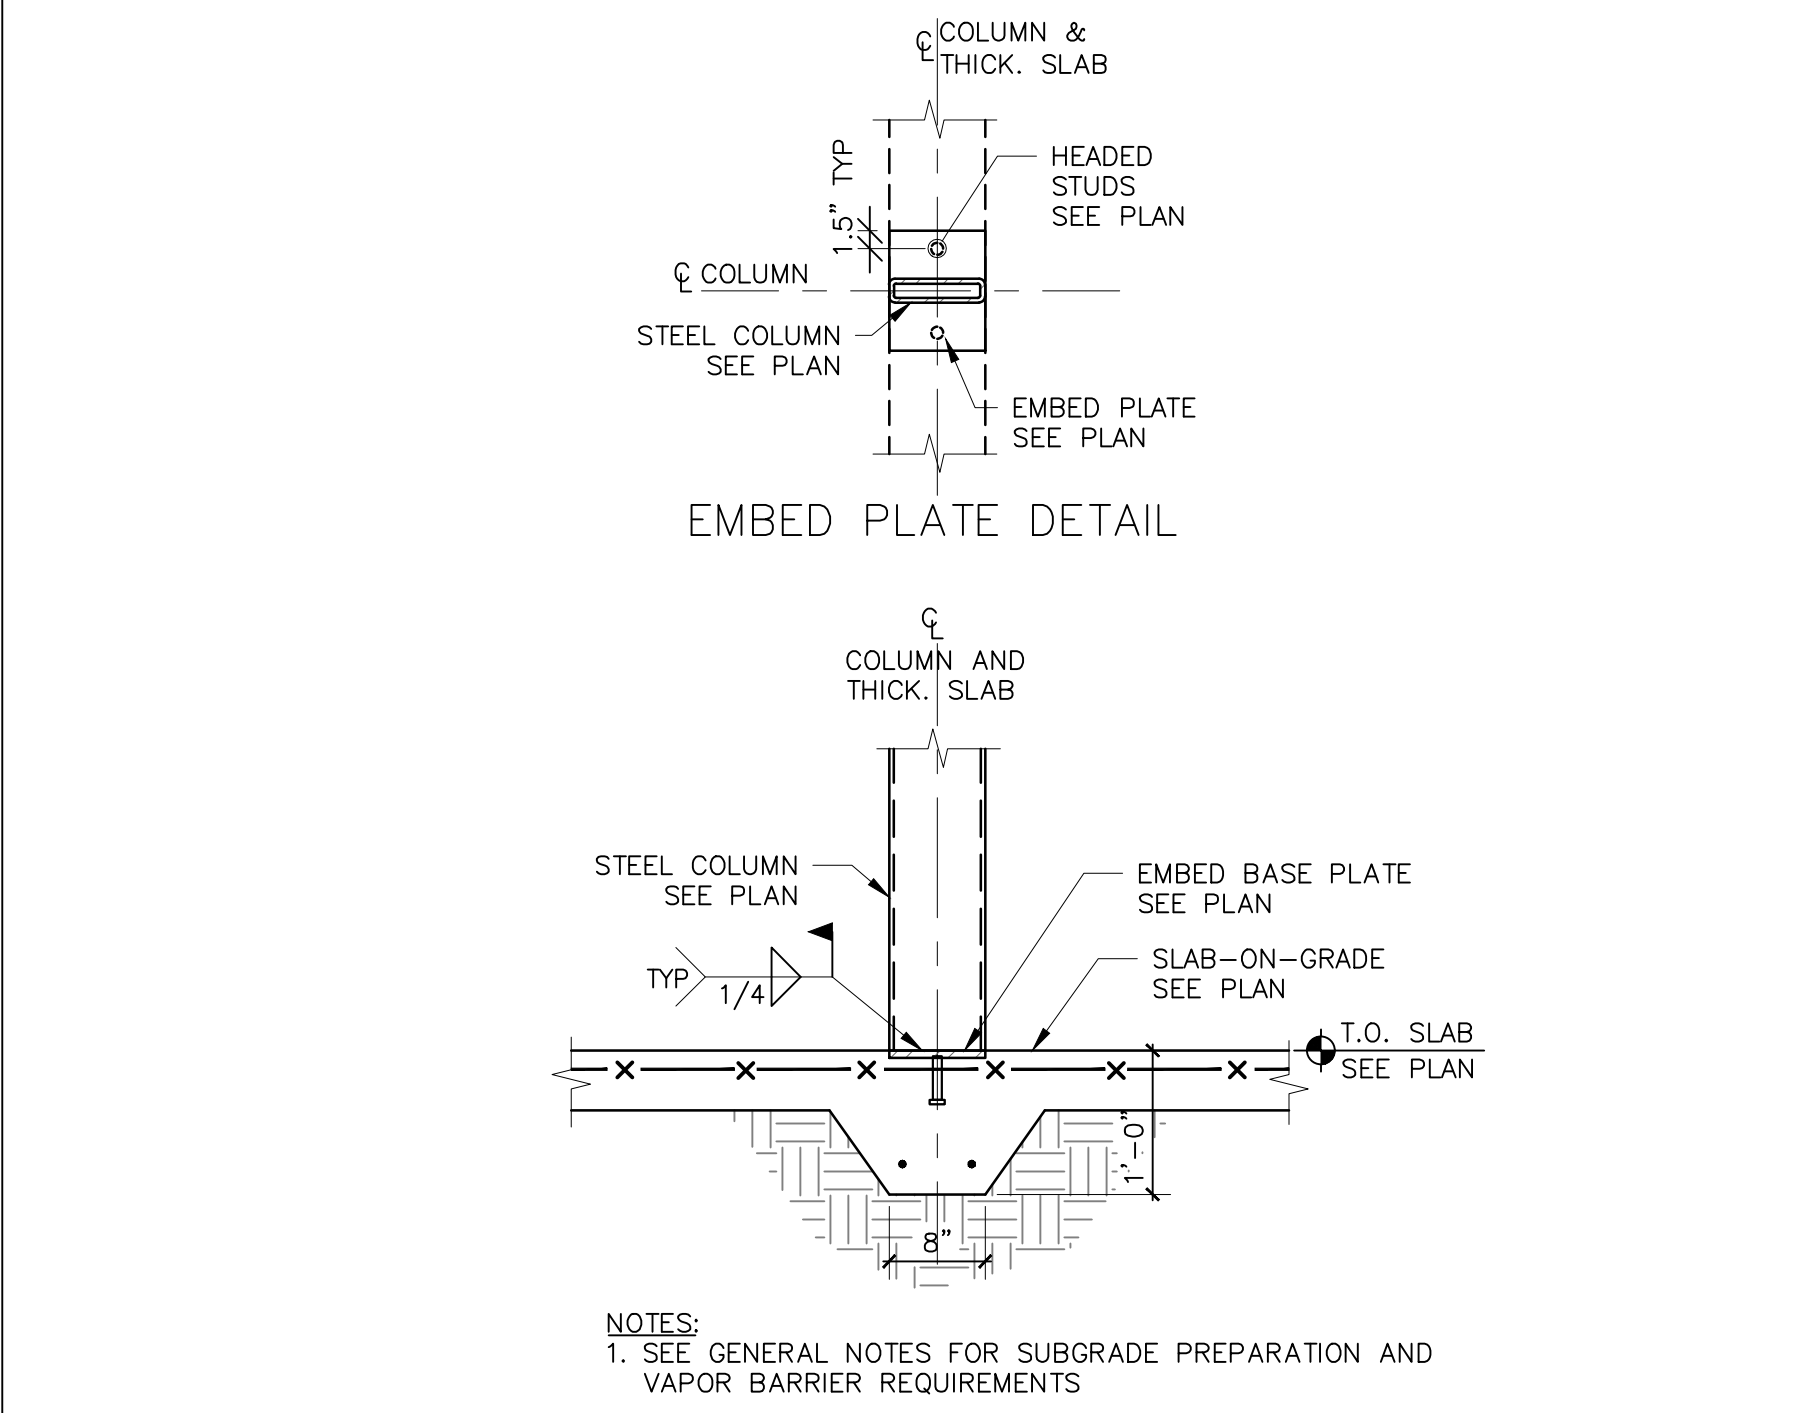
8

**TYPICAL DETAIL  
STEEL COLUMN TO THICKENED SLAB  
CONNECTION**

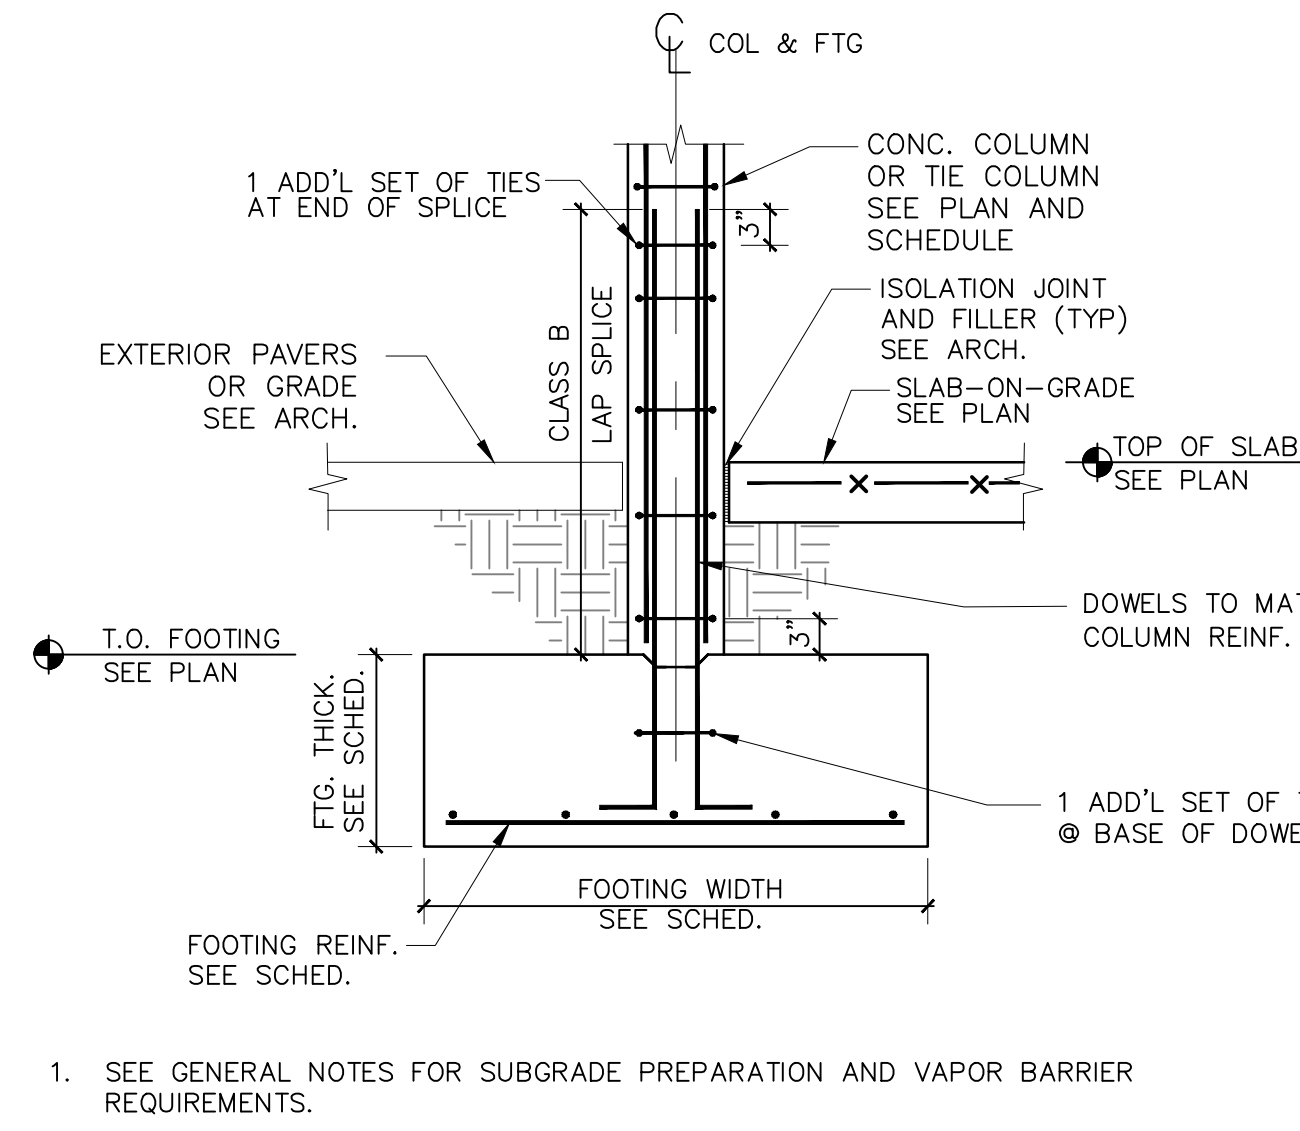
5

**TYPICAL DETAIL  
CONCRETE COLUMN OR TIE COLUMN  
TO FOOTING CONNECTION**

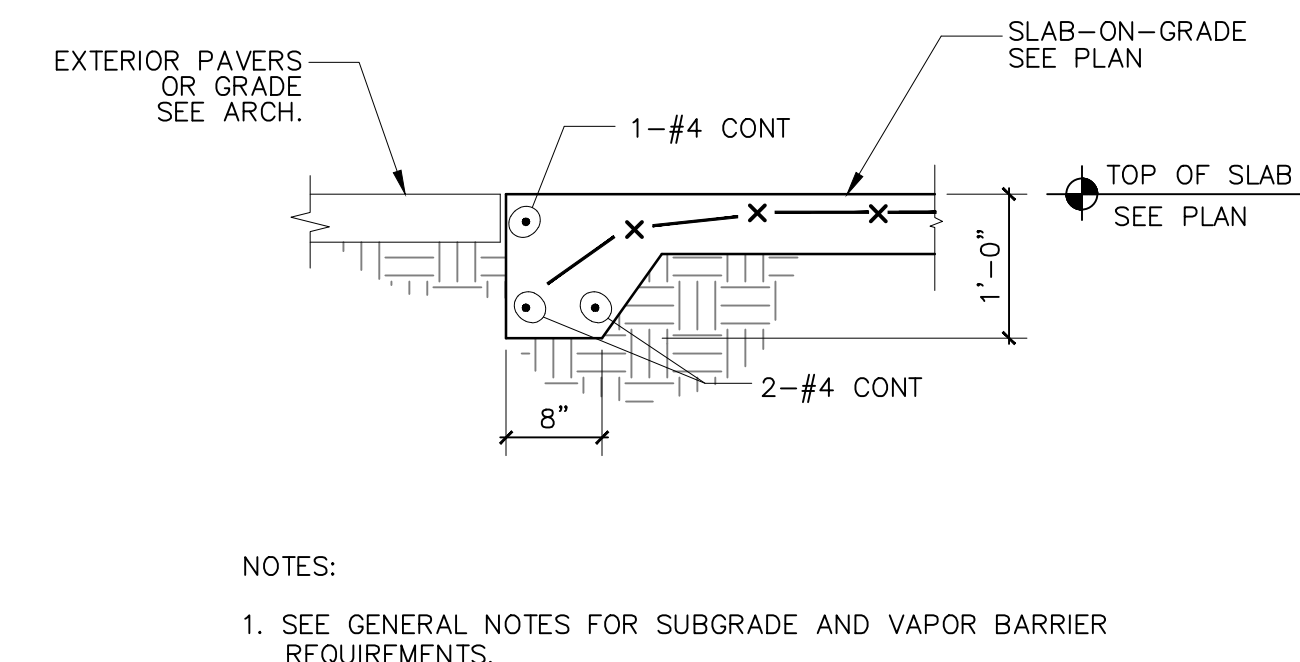
2

**TYPICAL DETAIL  
THICKENED SLAB EDGE  
SLAB-ON-GRADE**

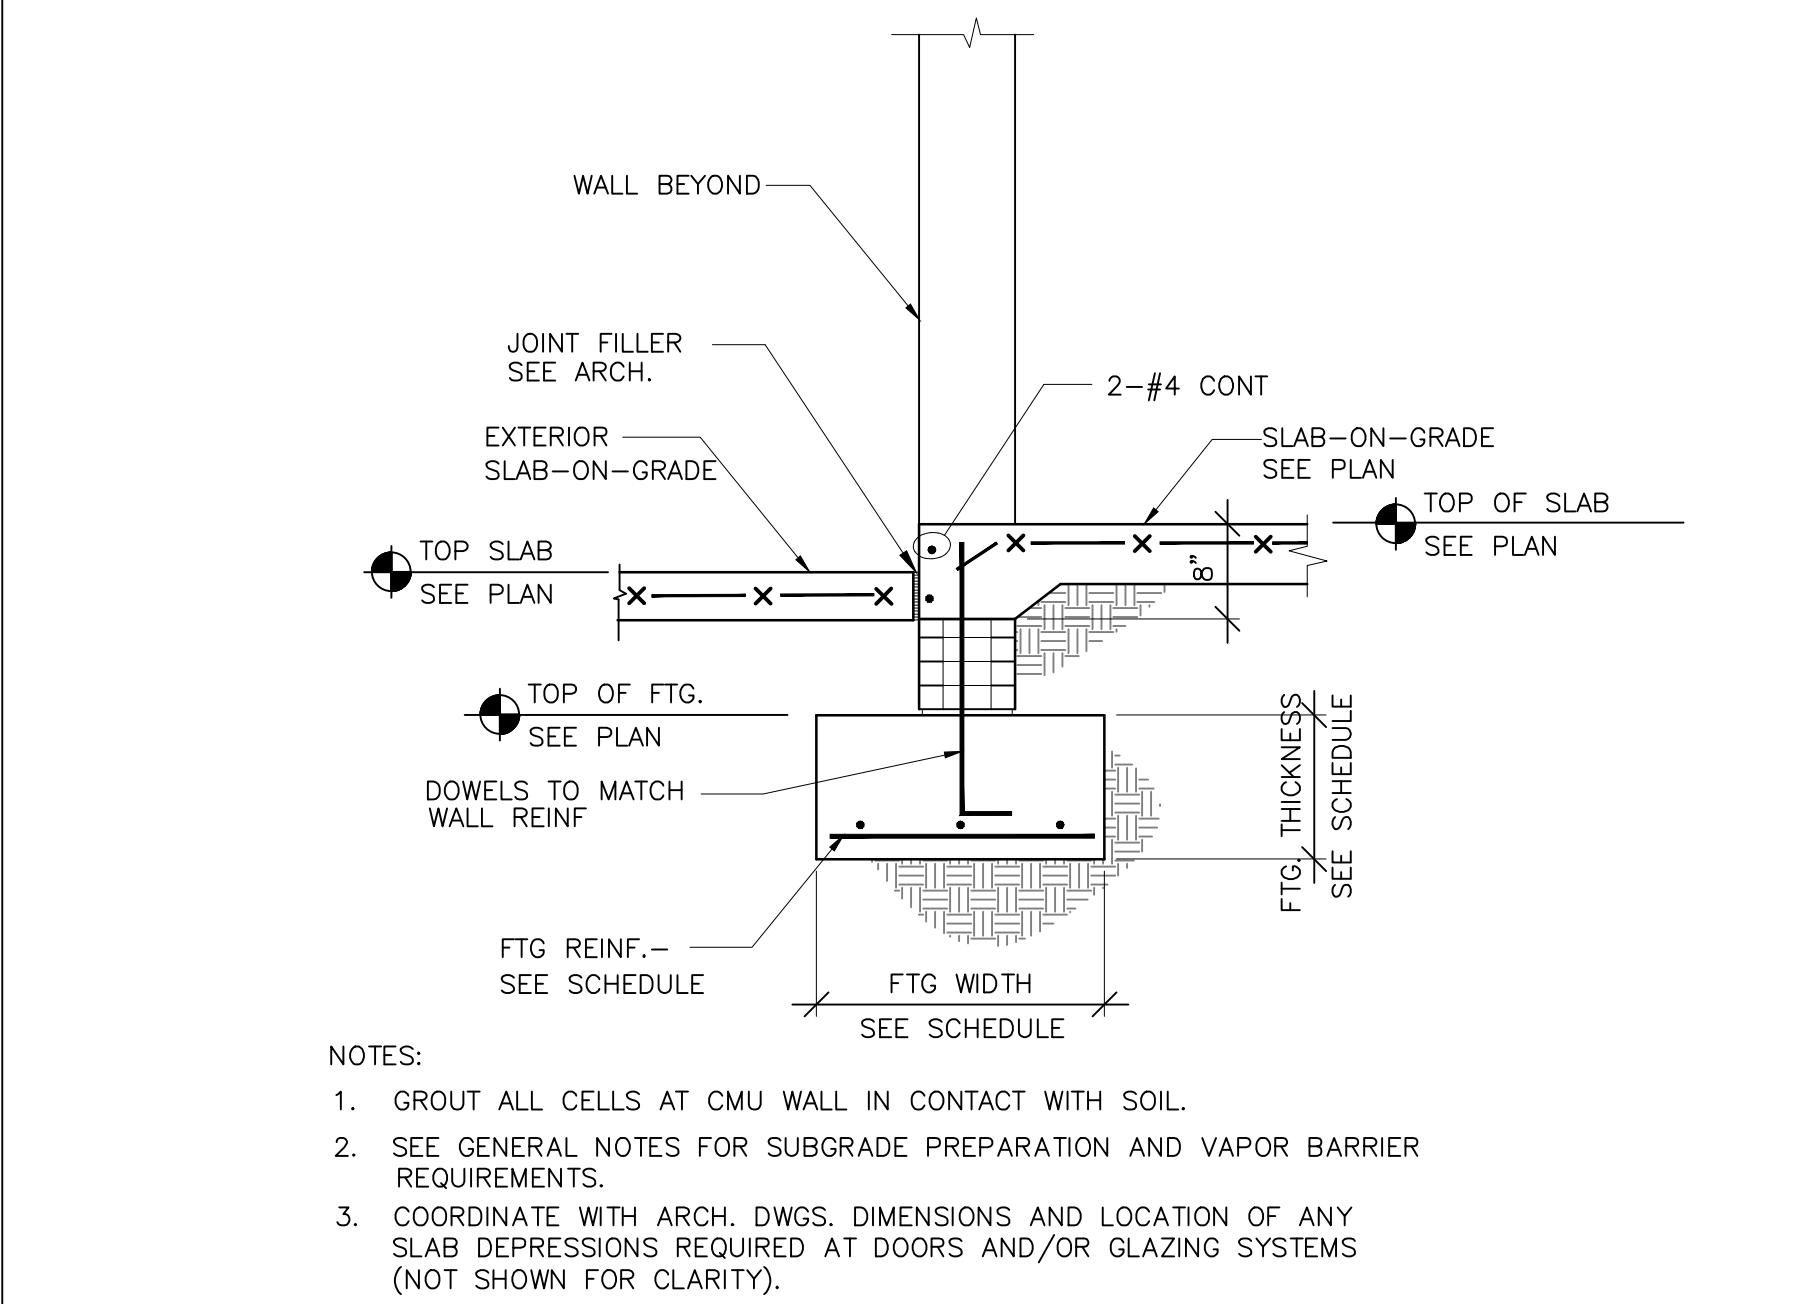
9

**TYPICAL DETAIL  
CMU WALL TO FOOTING CONNECTION  
AT EXTERIOR DOOR OPENING**

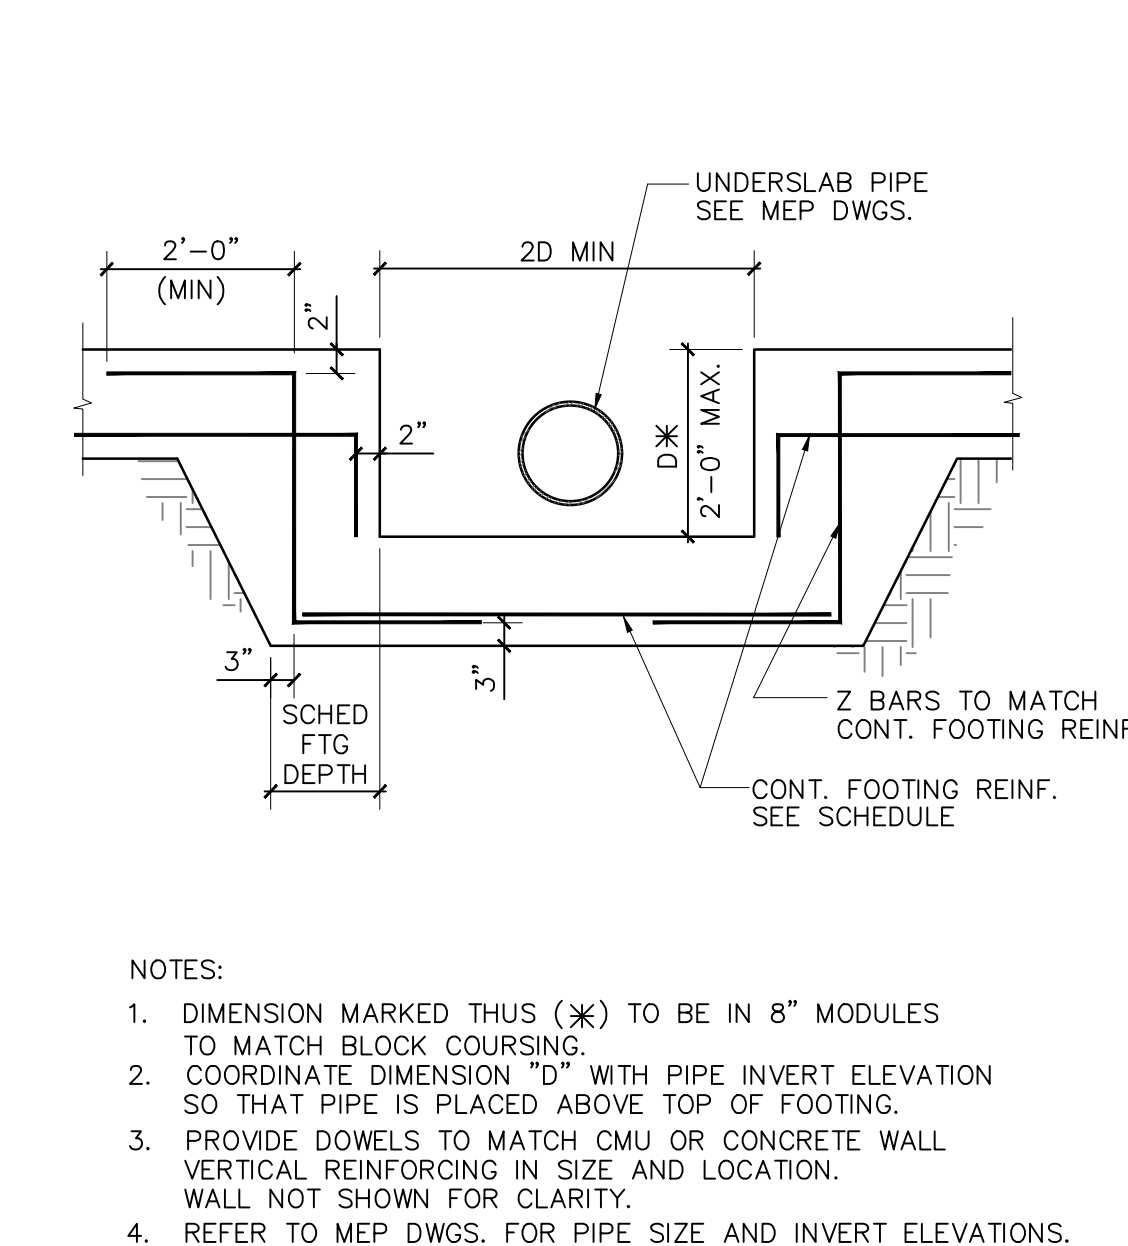
6

**TYPICAL DETAIL  
STEP FOOTING AT UNDERSLAB  
PIPE PENETRATIONS**

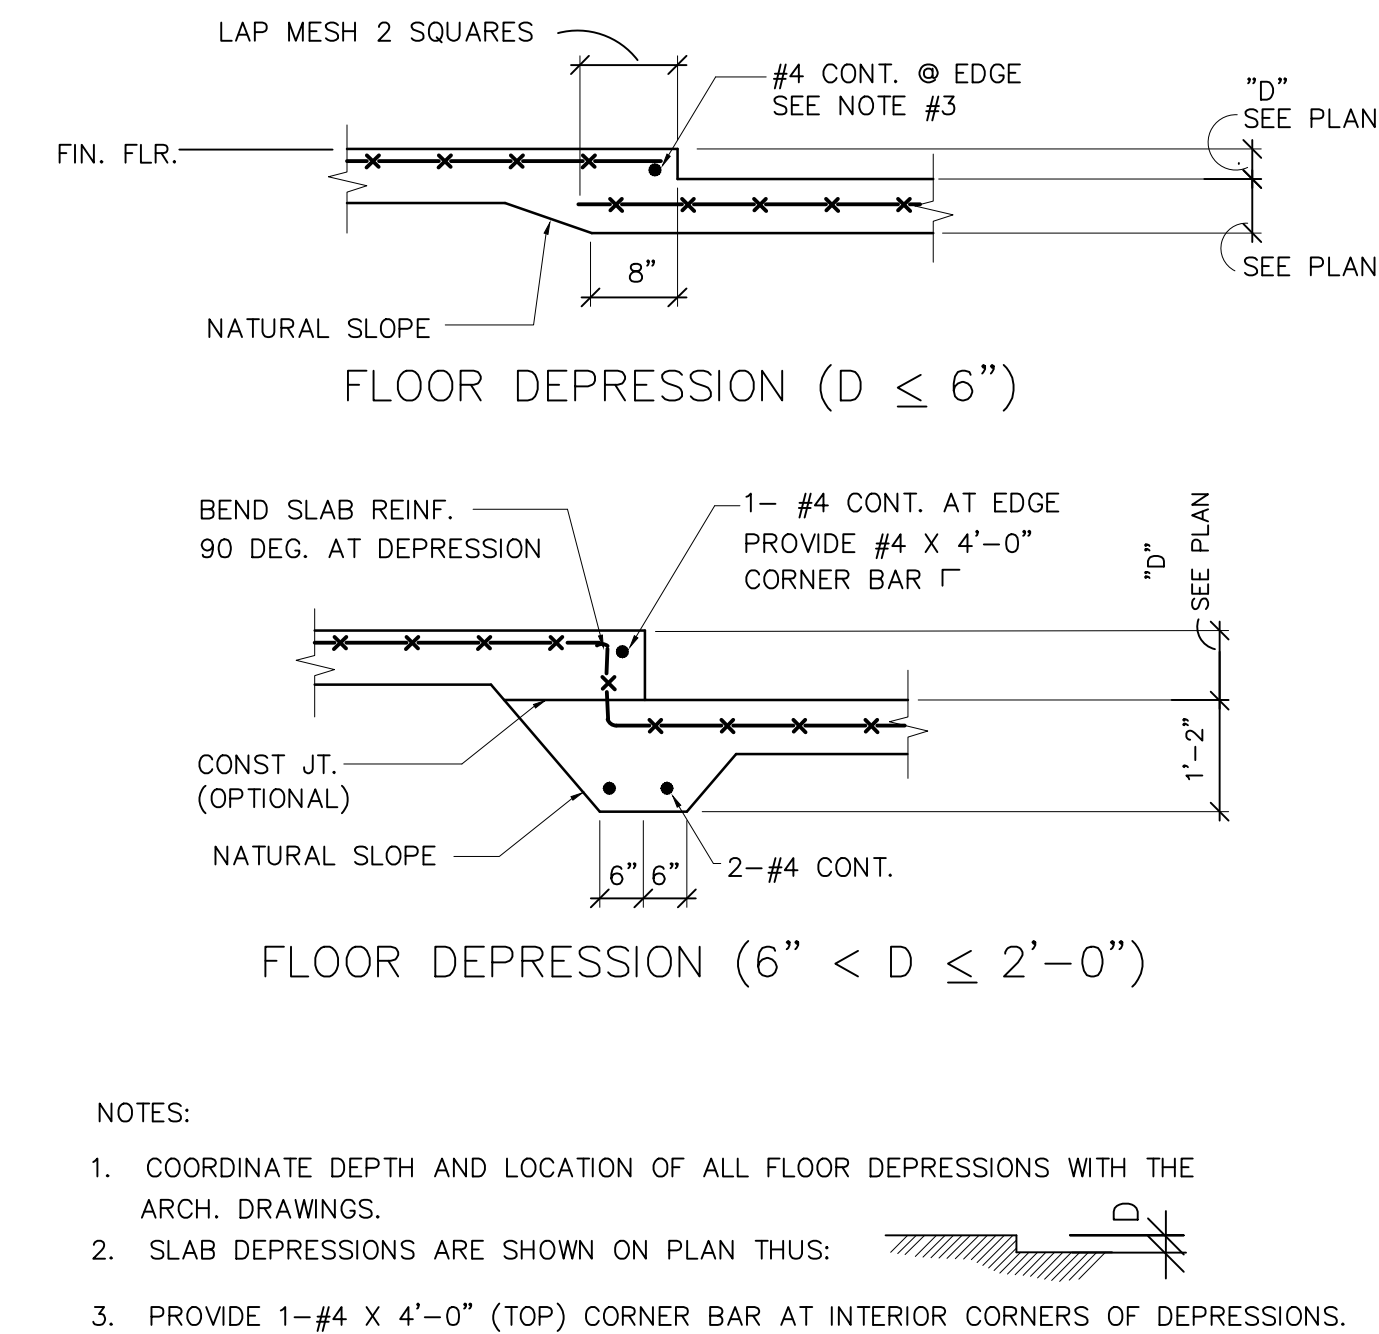
3

**TYPICAL DETAIL  
FLOOR DEPRESSIONS  
SLAB-ON-GRADE**
