New 2-Story Residence:  
6100 W Suburban Dr.  
Pinecrest, FL 33156

Tree Protection Plan  
Zoning Information

L-01.3

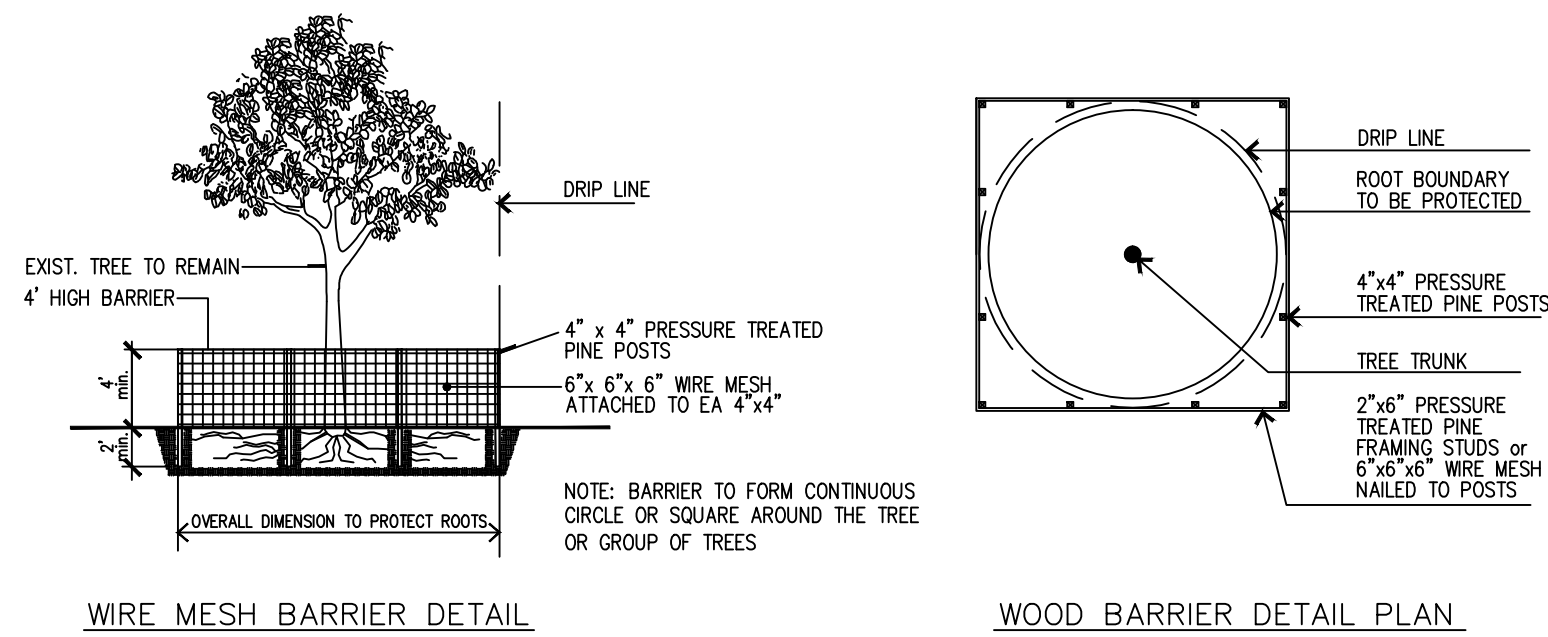
TREE PROTECTION BARRIER DETAIL  
N.T.S.

- 1) Tree Protection Barriers dimensions are measured from the center line of the trunk (as per Arborist's Report)
- 2) Tree Protection Barriers are adjusted where necessary to account for buildings, adjacent sidewalks, & street/curb.
- 3) No disturbance to soil or disposal of any building material/waste is permitted within the tree protection zone.
- 4) Barriers to remain in place throughout the duration of construction or demolition activities.
- 5) Barriers to be attached to existing CLF's, WD fences or concrete walls where applicable.

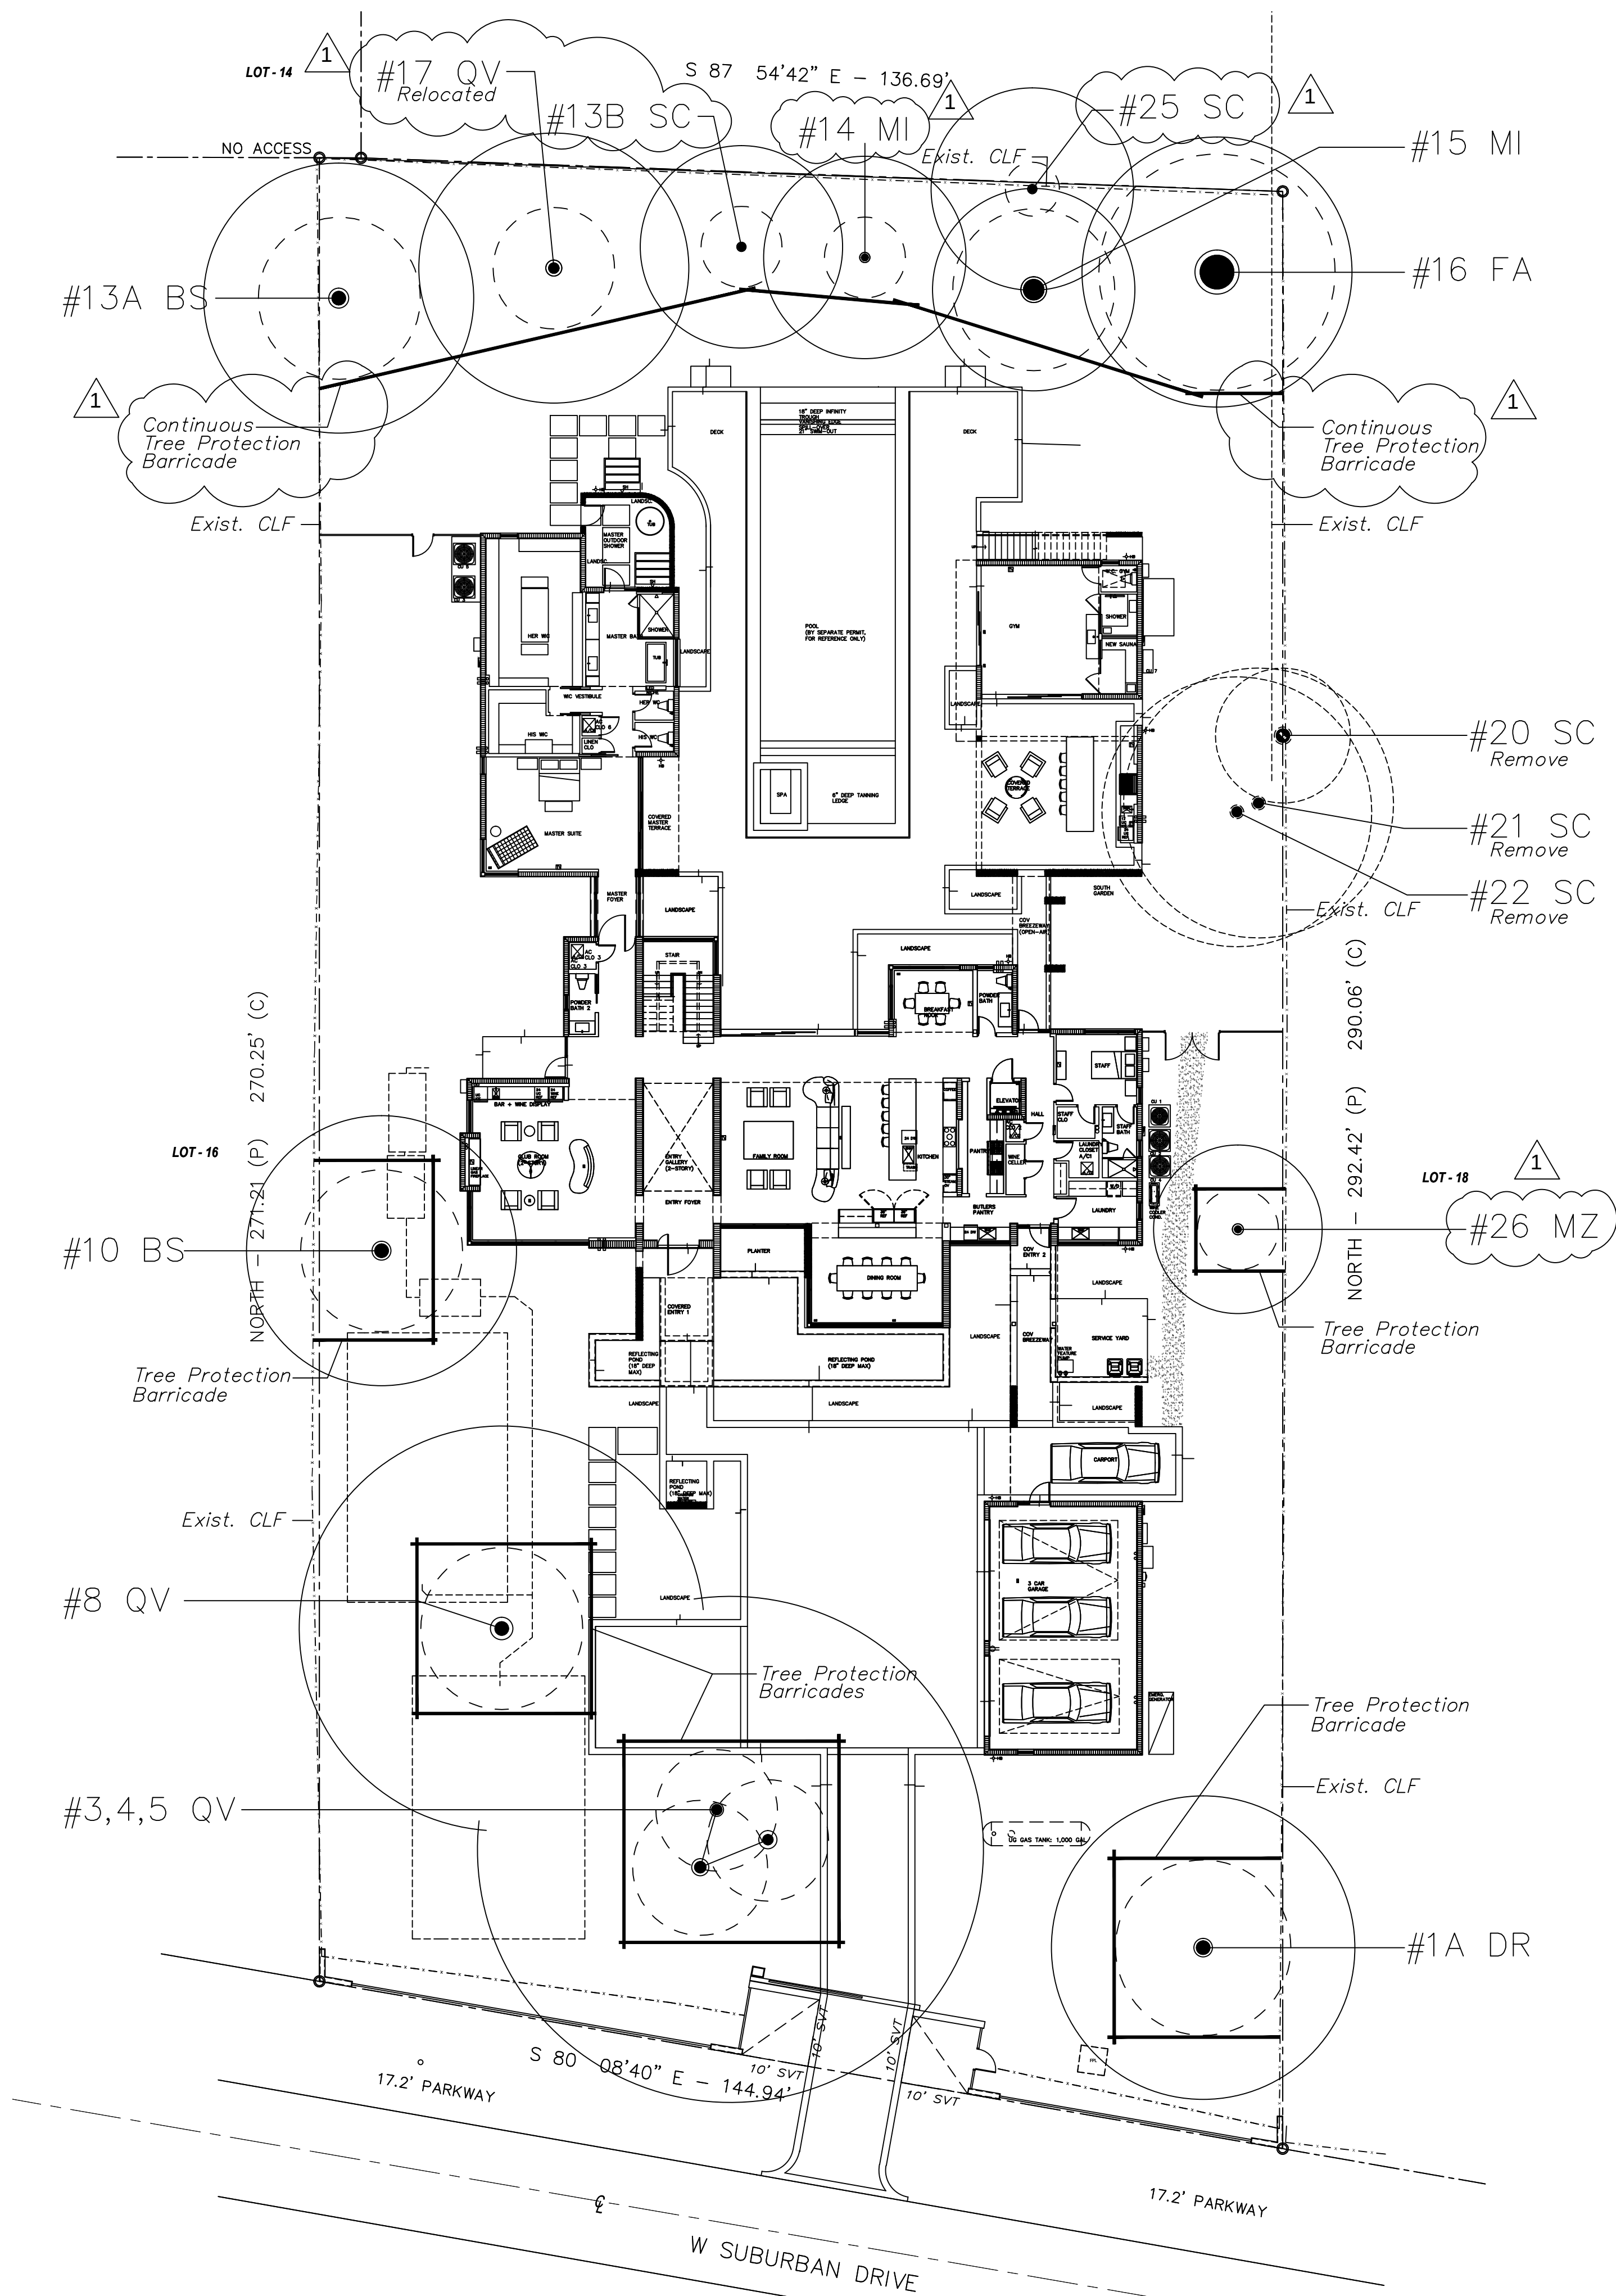
TREE SURVEY / DISPOSITION PLAN  
SCALE: 1/16" = 1'-0"

- 1) Tree Descriptions are as per Survey prov'd to LA, dated 09.17.2024, by Suarez Surveying & Mapping, Inc.
- 2) Tree species identification by, Landscape Architect, based on site visit in May 2024.
- 3) Trees #20,21,22 SC (African Tulip) to be removed as per PZ 2024-0264.

Indicates existing tree / palm to remain.  
CRZ, (Critical Root Zone)

Indicates existing tree / palm to be removed.
