**Model Designation: Standoff Glass Railing**

# **Test Report and Drawings**

### OFFICIAL TEST REPORT

**MANUFACTURER:** David Viera, LLC  
**ADDRESS:** 10435 NW 132<sup>nd</sup> Street  
Hialeah, Florida 33018  
**SPECIFICATIONS:** Florida Building Code  
Concentrated Load Test and ANSI Z97.1  
**PROJECT:** David Viera, LLC

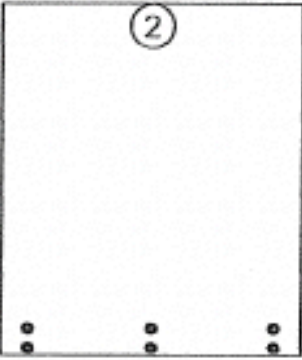
| Concentrated Load Test | | 200 lbf | | As per FBC section 1607.8.1/1607.8.1.1. The load was applied at the center of the glass. | |
| 2 | 3.187" | None | Passed | | |

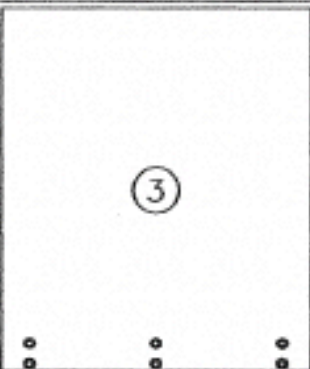
| Drop Test | | As per FBC section 1618.4.6.3 |
| 3 | Passed | Impacted center of lite. After impact the glass did break but remained in the place and there wasn't any apparent tear in the inter layer film. |
