The Mirror of Paradise  
Gabriela Fojt  
LA 6667277  
LC 26000628  
2700 E Oakland Park Blvd  
Suite C  
Fort Lauderdale  
FL 33306  
c (954) 478 3064  
www.florida-landscape.com  
gabriela@themirrorofparadise.com

8100 S.W. 120th STREET  
PINECREST  
FL 33156

REMOVAL PLAN, EXISTING TREES LIST, TREE PROT. DETAIL

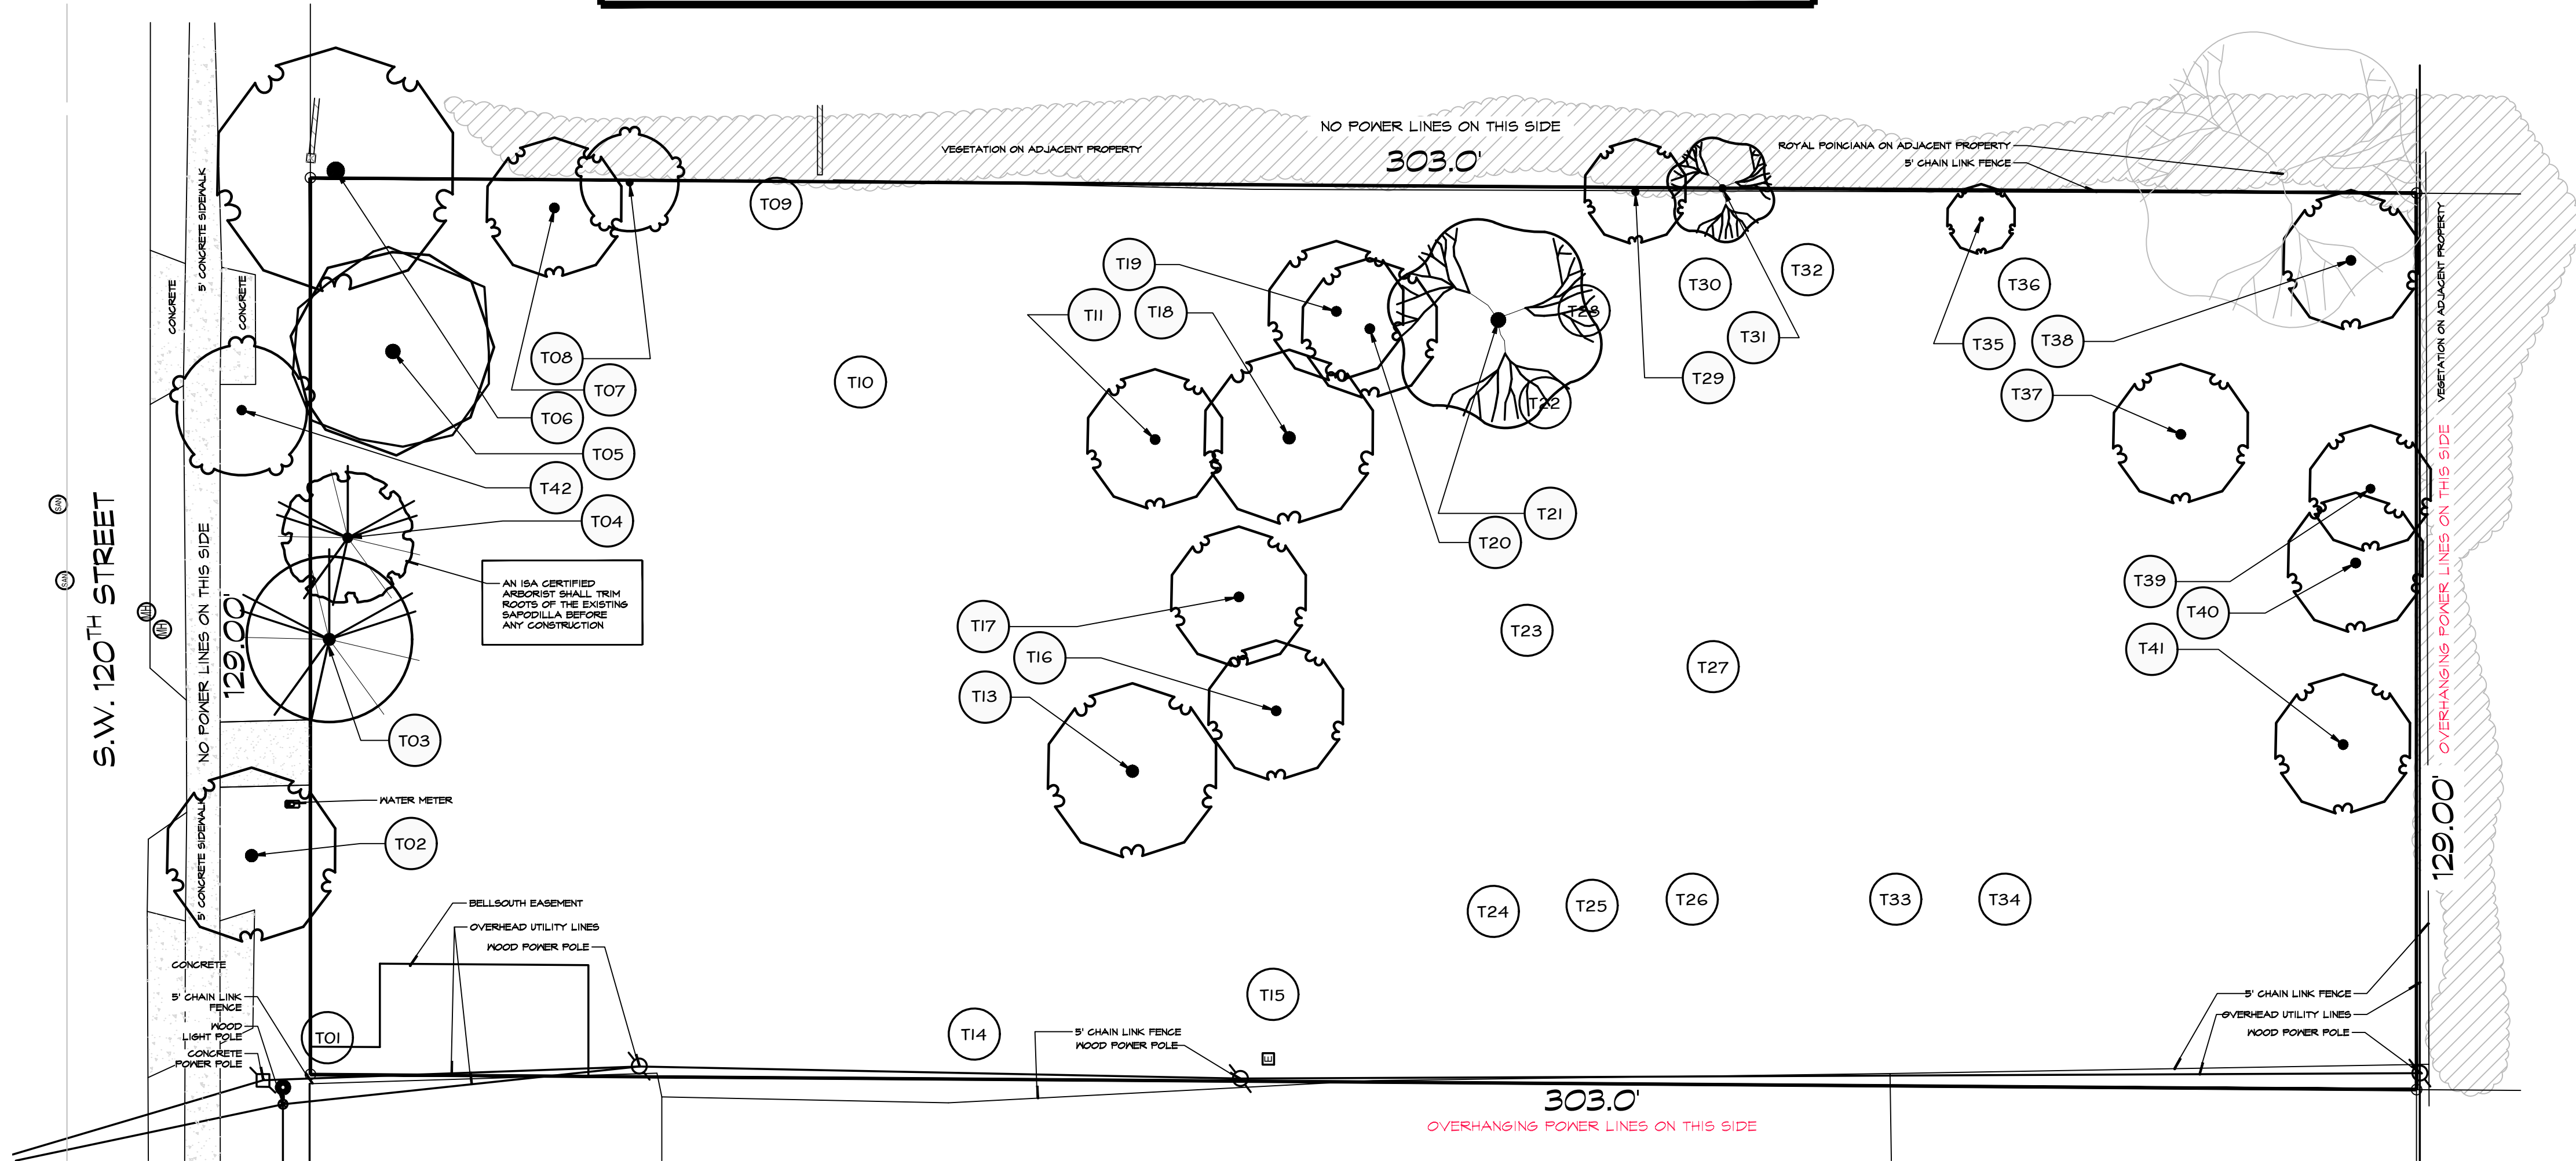
A GENERAL LAYOUT  
scale 1/16"=1'-0"

NUMBERS IN CIRCLES SHOW TREES NOTED ON TREE SURVEY BUT REMOVED BEFORE THE LA'S SITE VISIT.  
THE SPECIES & DIMENSIONS OF REMOVED TREES COULD NOT BE DETERMINED
