8100 S.W. 120th STREET  
PINECREST  
FL 33156

REMOVAL PLAN, EXISTING TREES LIST, TREE PROT. DETAIL

### Arborist Report

LANDSCAPE PLAN, PLANT SCHEDULE, CODE CHART

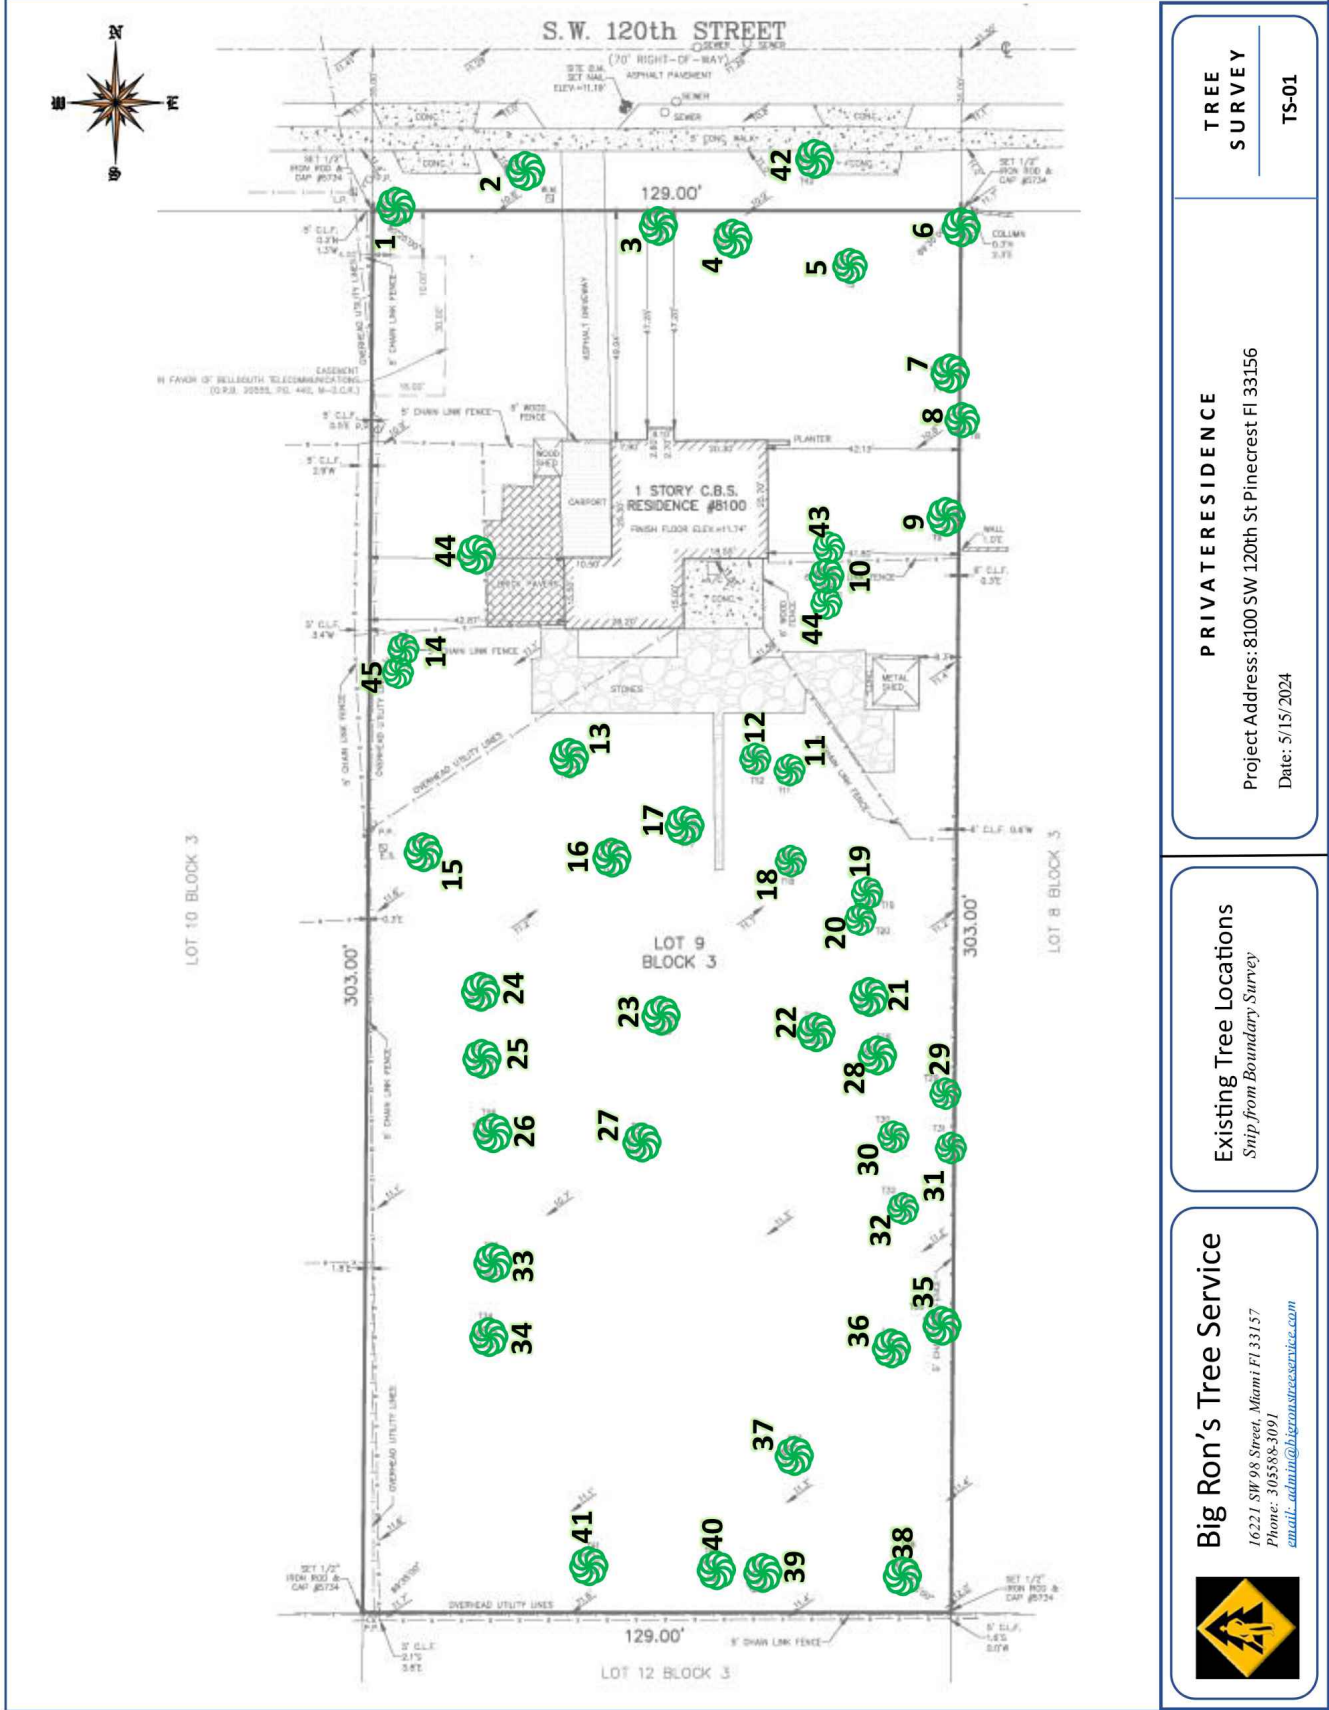
#### Tree Locations

Tree No. 2 and 42 are located on the right of way, 6, 8 and 31 are located on the eastern property line and all other trees are located within this property. See location diagram below.
