September 9, 2023

**Certified Arborist Assessment  
6200 SW 123 Terrace, Pinecrest, Florida  
NLE Project No. 34623002**

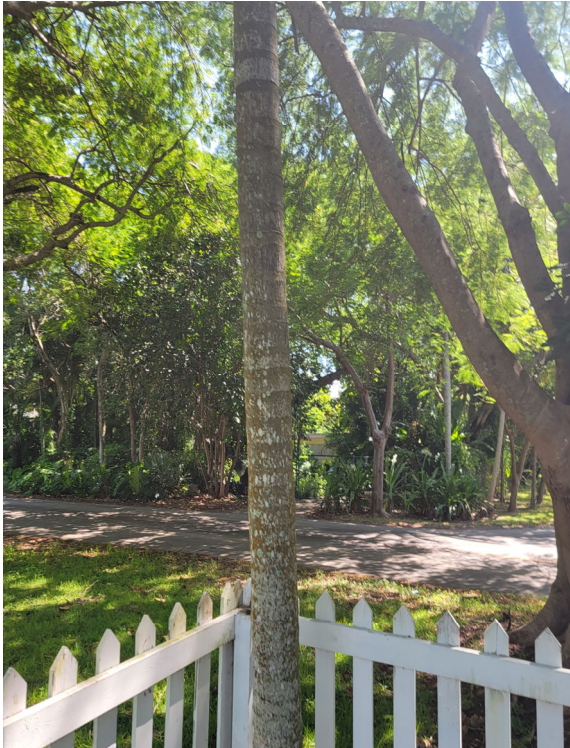
Tree 21A Christmas palm  
(*Adonidia merrellii*)  
7 inch DBH, GOOD condition  
35 foot height, 12 foot spread

25'c.t.

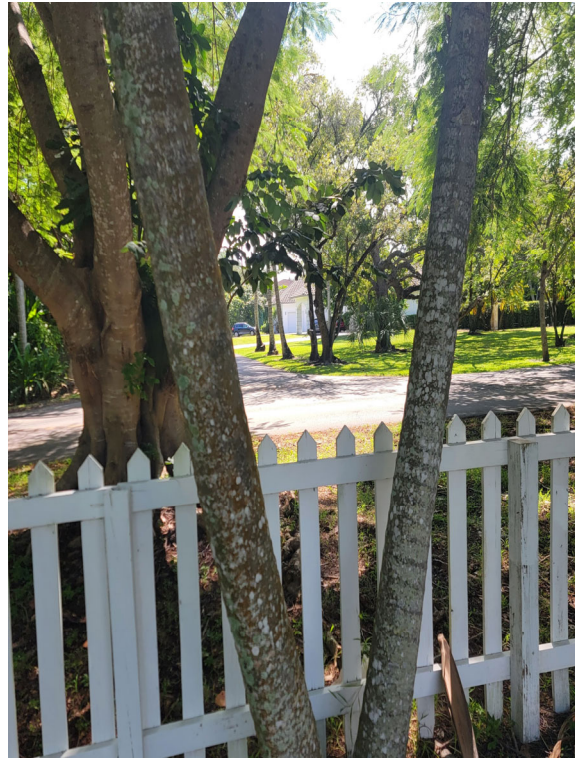
Tree 21B Christmas palm  
(*Adonidia merrellii*)  
cluster inch DBH GOOD condition  
32 foot height, 12 foot spread

24'c.t.

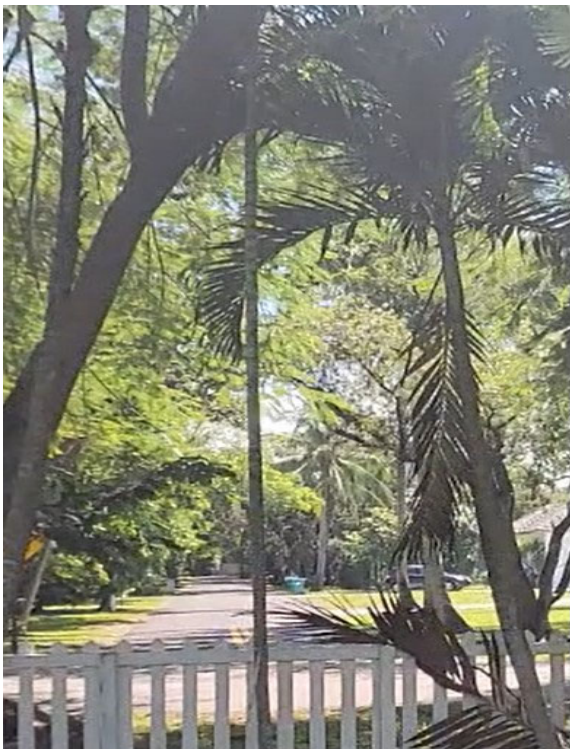
Tree 21C solitaire palm  
(*Ptychosperma elegans*)  
3 inch DBH, GOOD condition  
26 foot height, 10 foot spread

18'c.t.

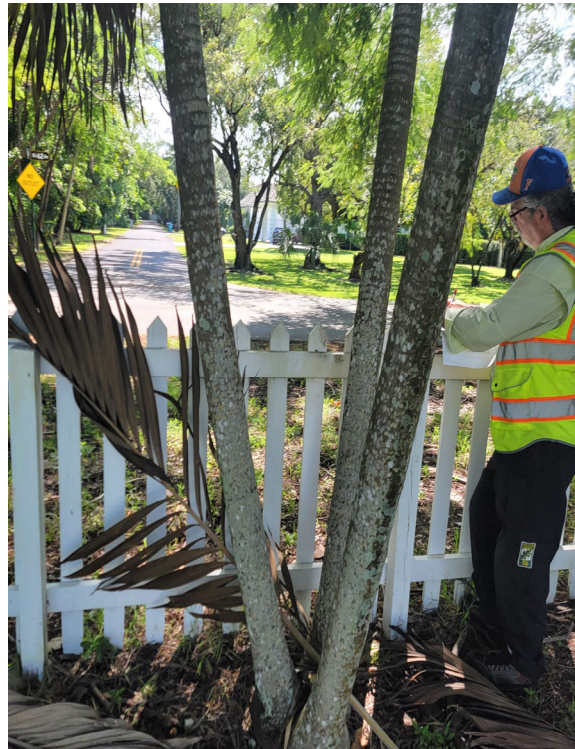
Tree 21D Macarthur palm  
(*Ptychosperma macarthurii*)  
cluster inch DBH GOOD condition  
19 foot height, 10 foot spread

10'c.t.

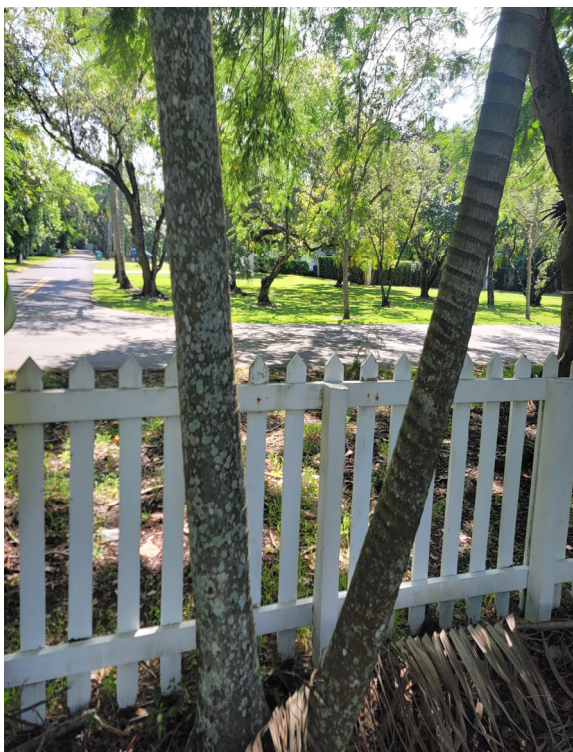
Tree 21E Macarthur palm  
(*Ptychosperma macarthurii*)  
cluster inch DBH, GOOD condition  
44 foot height, 10 foot spread

36'c.t.

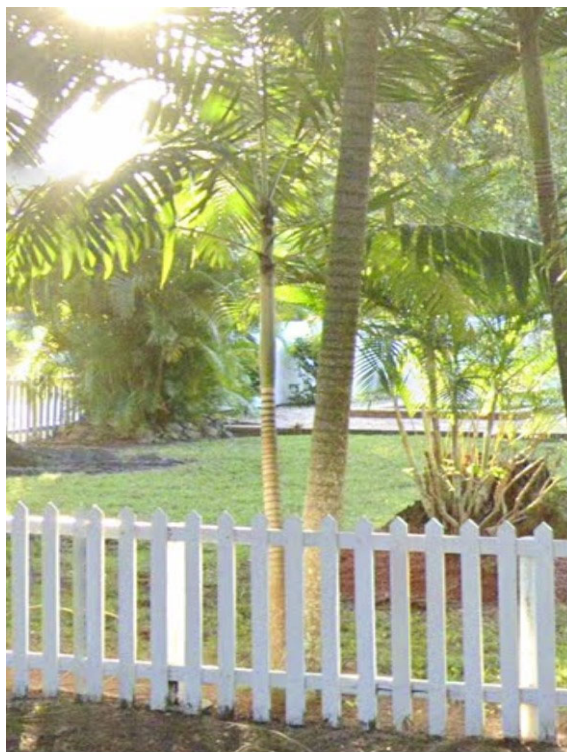
Tree 21F Macarthur palm  
(*Ptychosperma macarthurii*)  
6 inch DBH GOOD condition  
32 foot height, 10 foot spread

24'c.t.

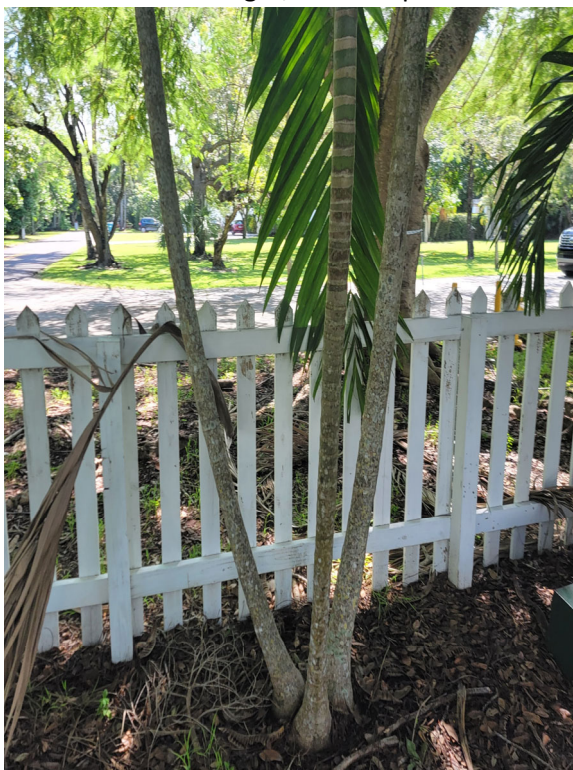
Tree 21G Macarthur palm  
(*Ptychosperma macarthurii*)  
cluster inch DBH, GOOD condition  
20 foot height, 10 foot spread

10'c.t.

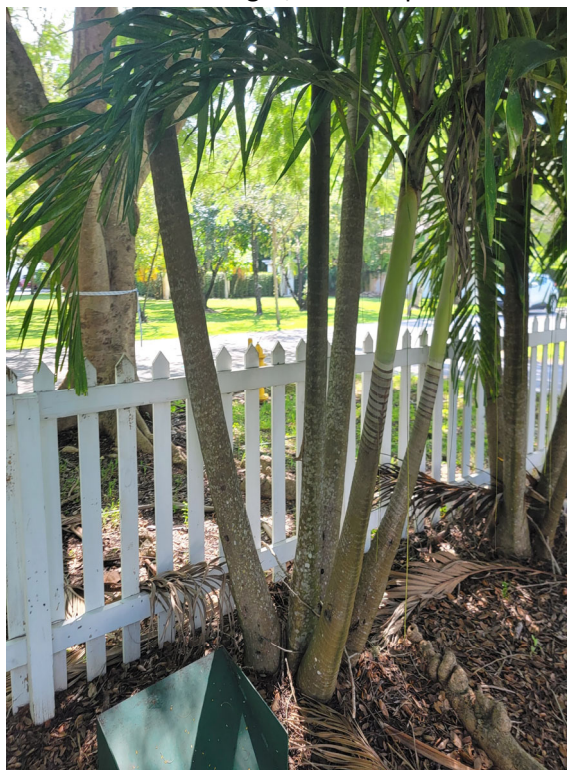
Tree 21H Macarthur palm  
(*Ptychosperma macarthurii*)  
cluster inch DBH GOOD condition  
20 foot height, 10 foot spread

8'c.t.

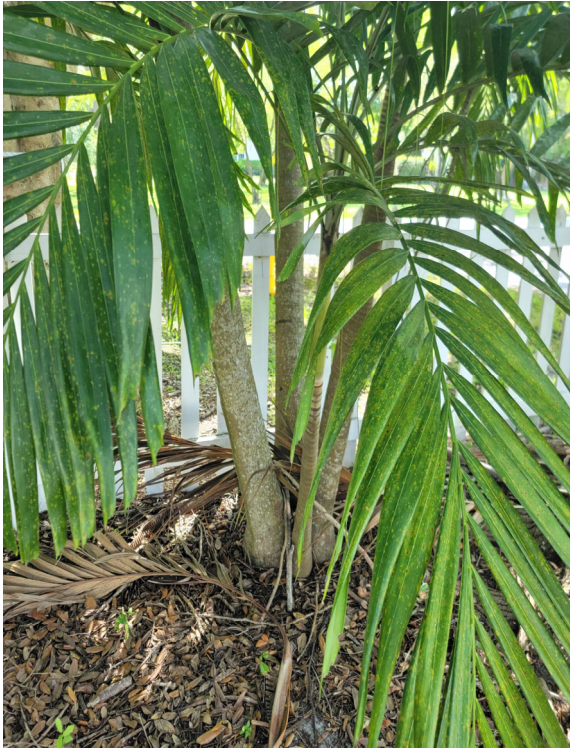
Tree 21i Macarthur palm  
(*Ptychosperma macarthurii*)  
cluster inch DBH, GOOD condition  
18 foot height, 10 foot spread

10'c.t.

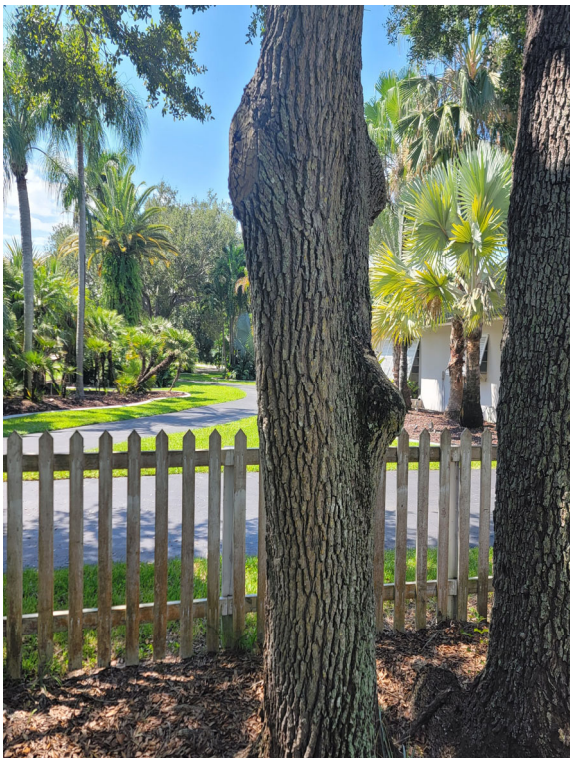
Tree 23A live oak  
(*Quercus virginiana*)  
22 inch DBH, GOOD condition  
35 foot height, 30 foot spread

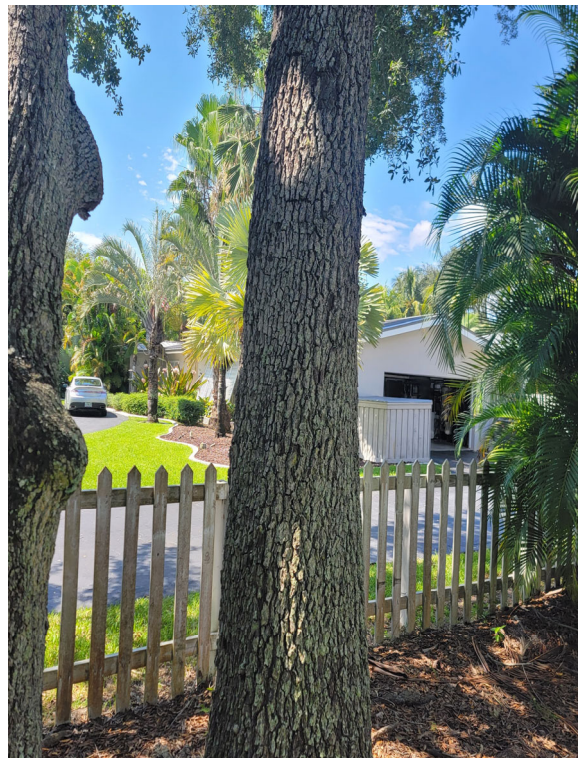
Tree 23B live oak  
(*Quercus virginiana*)  
23 inch DBH GOOD condition  
35 foot height, 30 foot spread

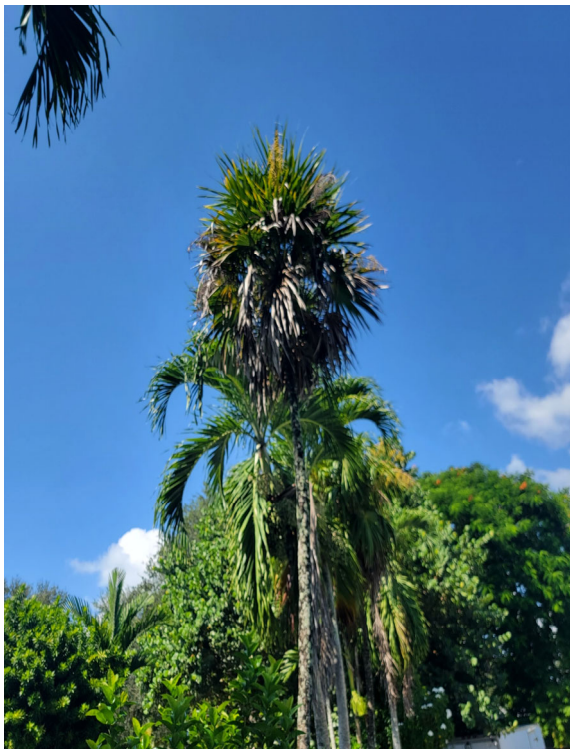
Tree 26 Florida thatch palm  
(*Thrinax radiata*)  
4 inch DBH, GOOD condition  
24 foot height, 10 foot spread

12'c.t.

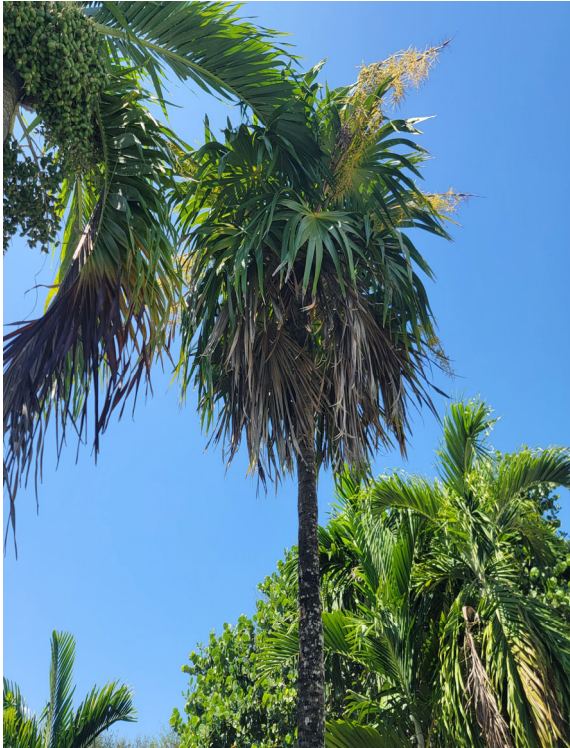
Tree 28 Florida thatch palm  
(*Thrinax radiata*)  
5 inch DBH, GOOD condition  
19 foot height, 10 foot spread

15'c.t.

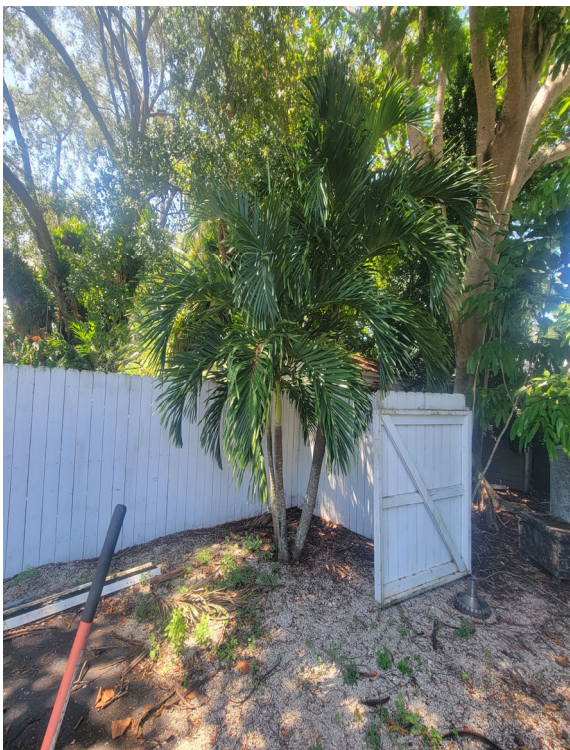
Tree 29 Christmas palm  
(*Adonidia merrellii*)  
cluster inch DBH, GOOD condition  
16 foot height, 12 foot spread

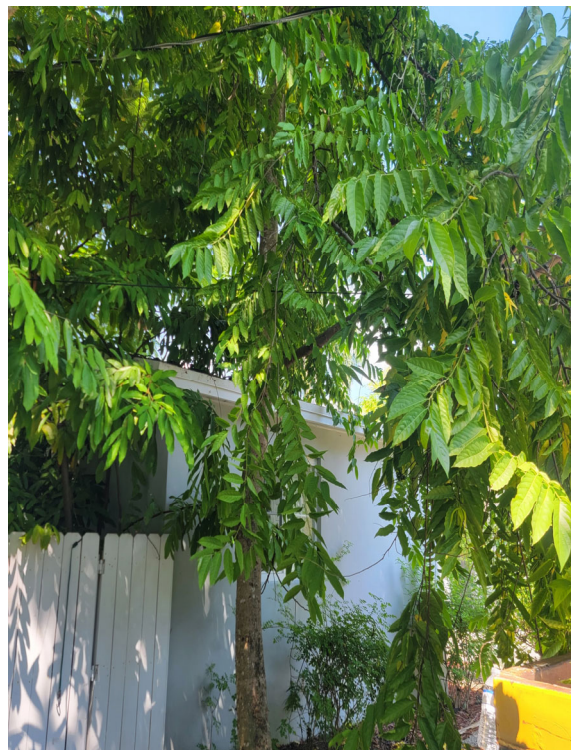
Tree 30 ylang ylang  
(*Cananga odorata*)  
10 inch DBH GOOD condition  
30 foot height, 30 foot spread

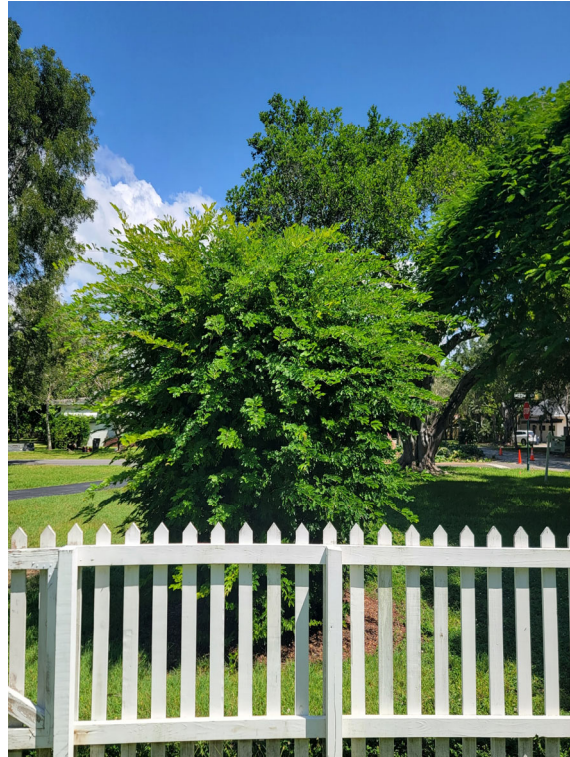
Tree 32 powder puff  
(Calliandra surinamensis)  
bush inch DBH GOOD condition  
12 foot height, 12 foot spread
