New 2-Story Residence:  
6100 W Suburban Dr.  
Pinecrest, FL 33156

DRAWING  
Tree Survey /  
Disposition Plan

L-01.2

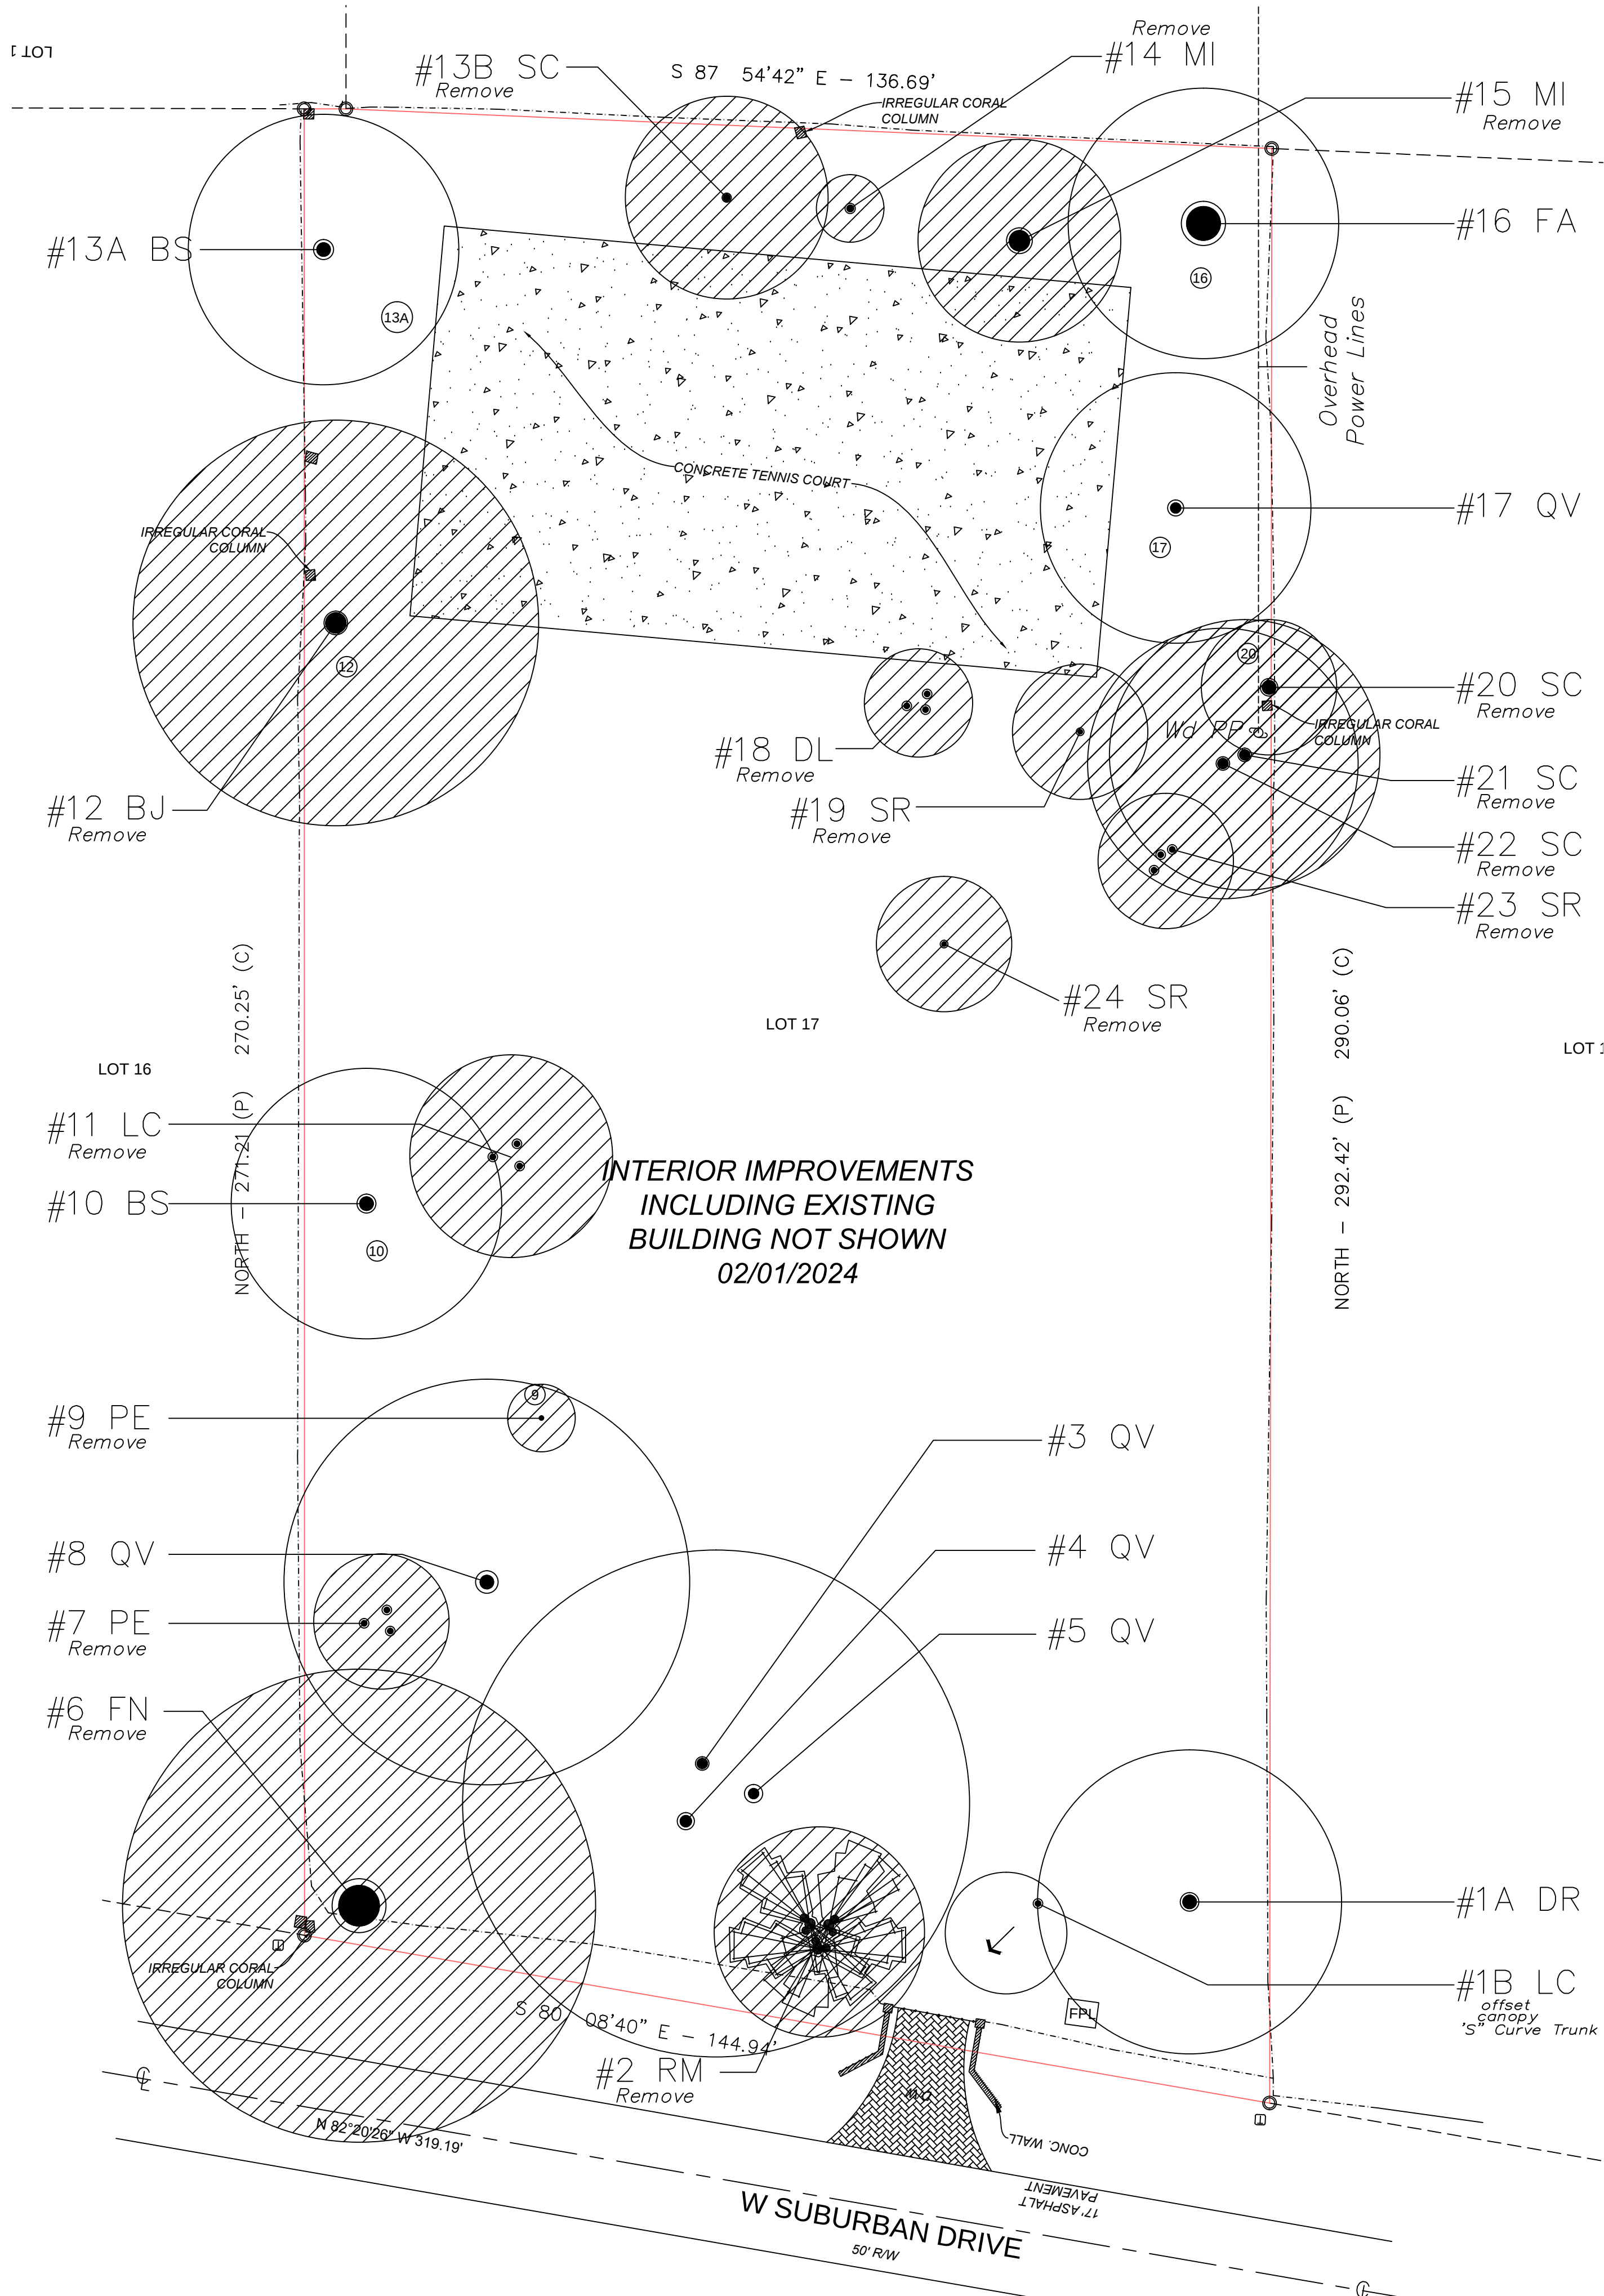
TREE SURVEY / DISPOSITION PLAN

- Tree Descriptions are as per Survey prov'd to LA.
- Tree species identification by, Landscape Architect, based on site visit in May 2024.
- Trees #13b,20,21,22 SC (African Tulip) to be removed as per PZ 2024-0264.

Indicates existing tree / palm to be removed.

Indicates existing tree/palm to remain.  
CRZ, (Critical Root Zone)

Mitigation Req'd: 6 Palms  
2 Trees
