10635 SW 63 AV  
MIAMI, FL

BALLI-TRAUTMAN ARCHITECTS LLC -AA2600

L 104

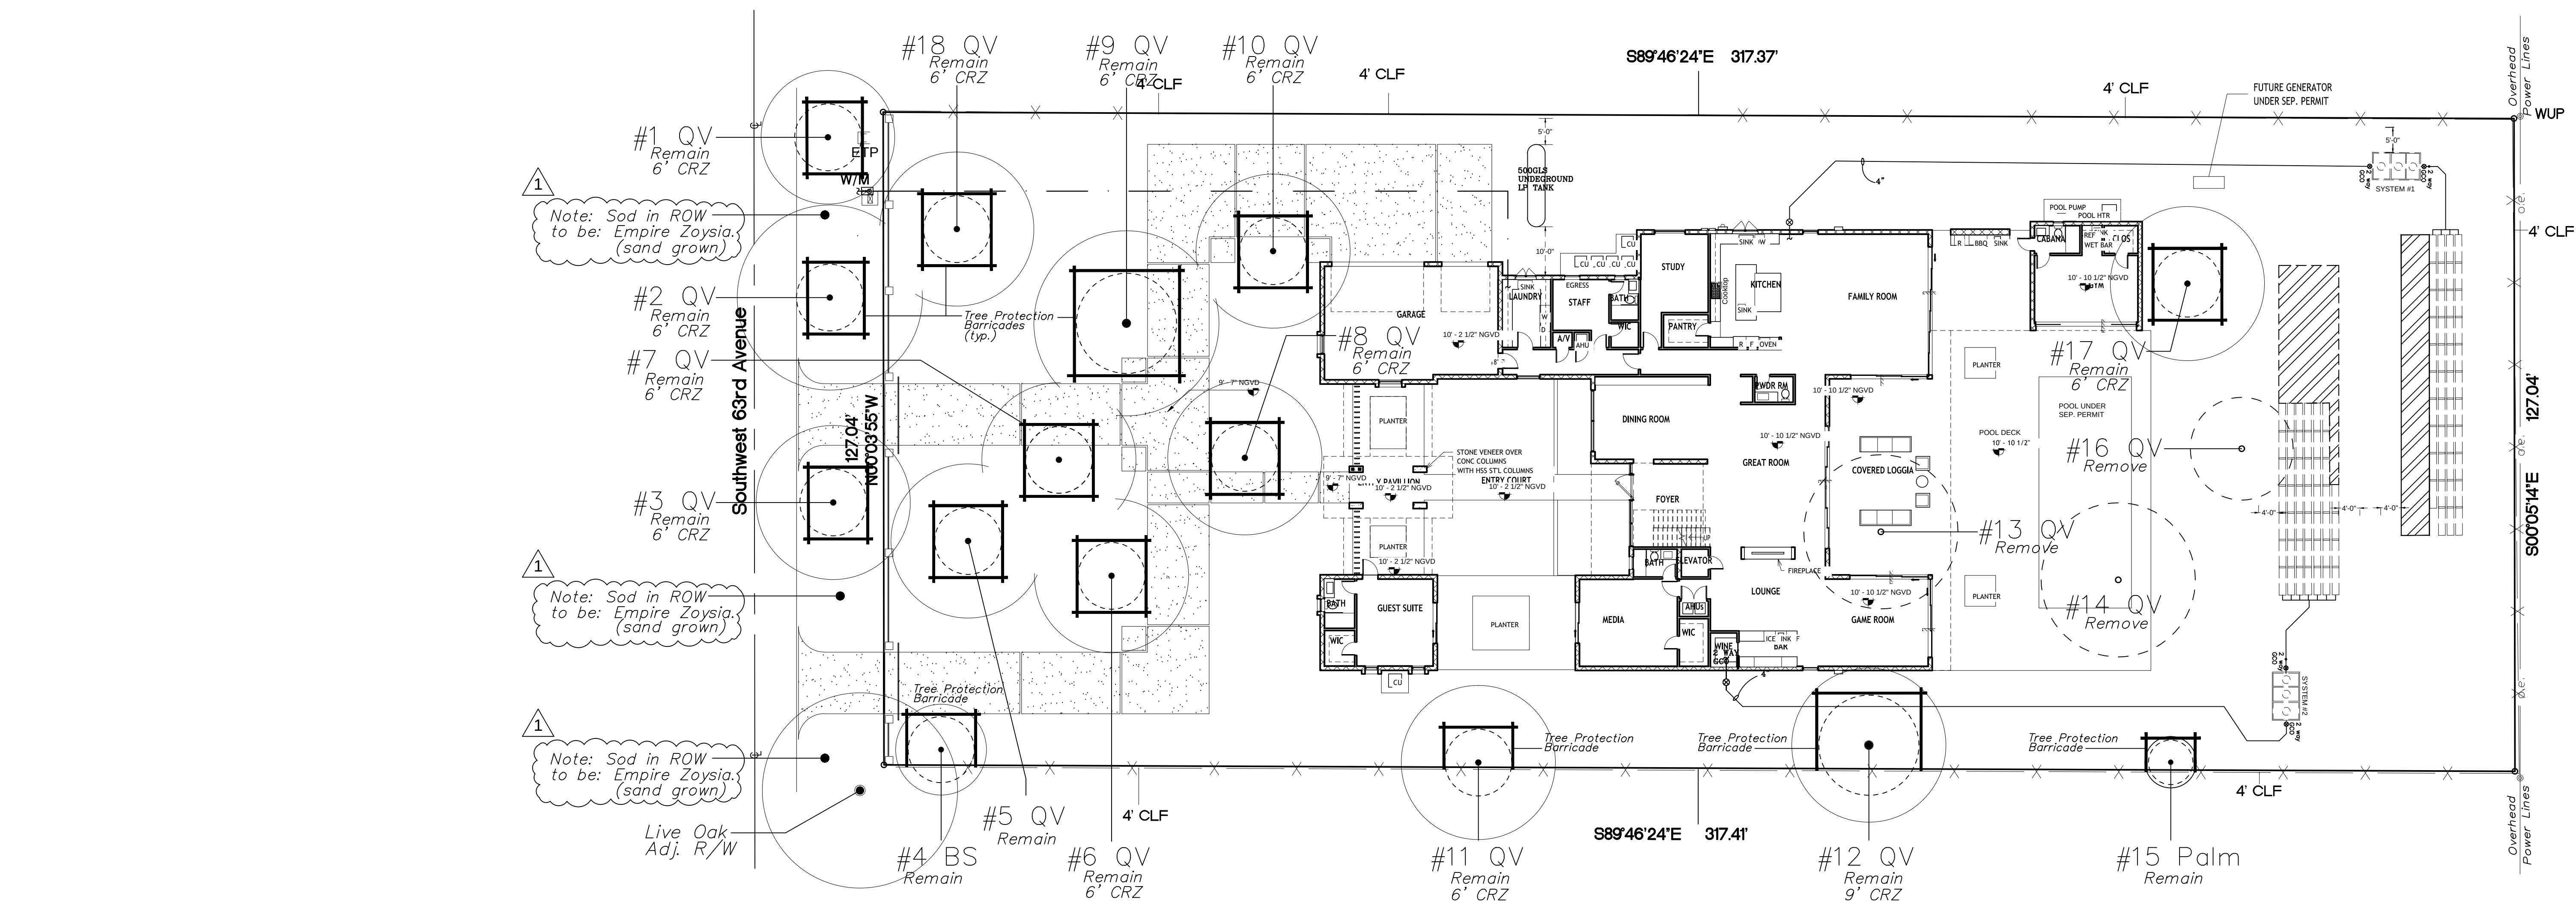
1

SCALE: 1" = 16'-0"

—Existing Tree / Palm to remain.  
CRZ, (Critical Root Zone)  
(dim. from face of trunk)

—Existing Tree / Palm to be removed.

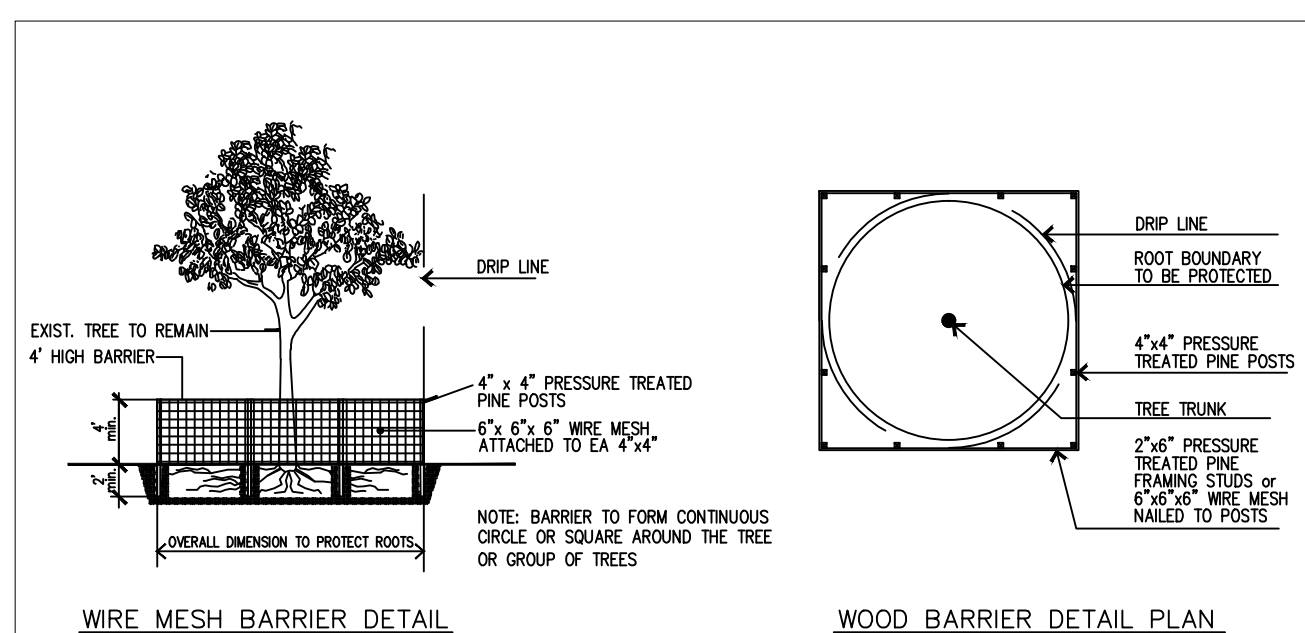
TREE PROTECTION BARRIER DETAIL

N.T.S.

Notes:

- 1) Tree Protection Barriers dimensions are measured from the center line of the trunk. (as per Arborist's Report)
- 2) Tree Protection Barriers are placed where necessary to enclose buildings, adjacent sidewalks, & street/curb.
- 3) No disturbance to soil or disposal of any building material/waste is permitted within the tree protection zone.
- 4) Barriers to remain in place throughout the duration of construction or demolition activities.
- 5) Barriers to be attached to existing GLF's, WD fences or concrete walls where applicable.
