| EXISTING TREE DISPOSITION CHART | | | | | | | | | |

### GENERAL TREE WORK REQUIREMENTS, NOTES & SPECIFICATIONS

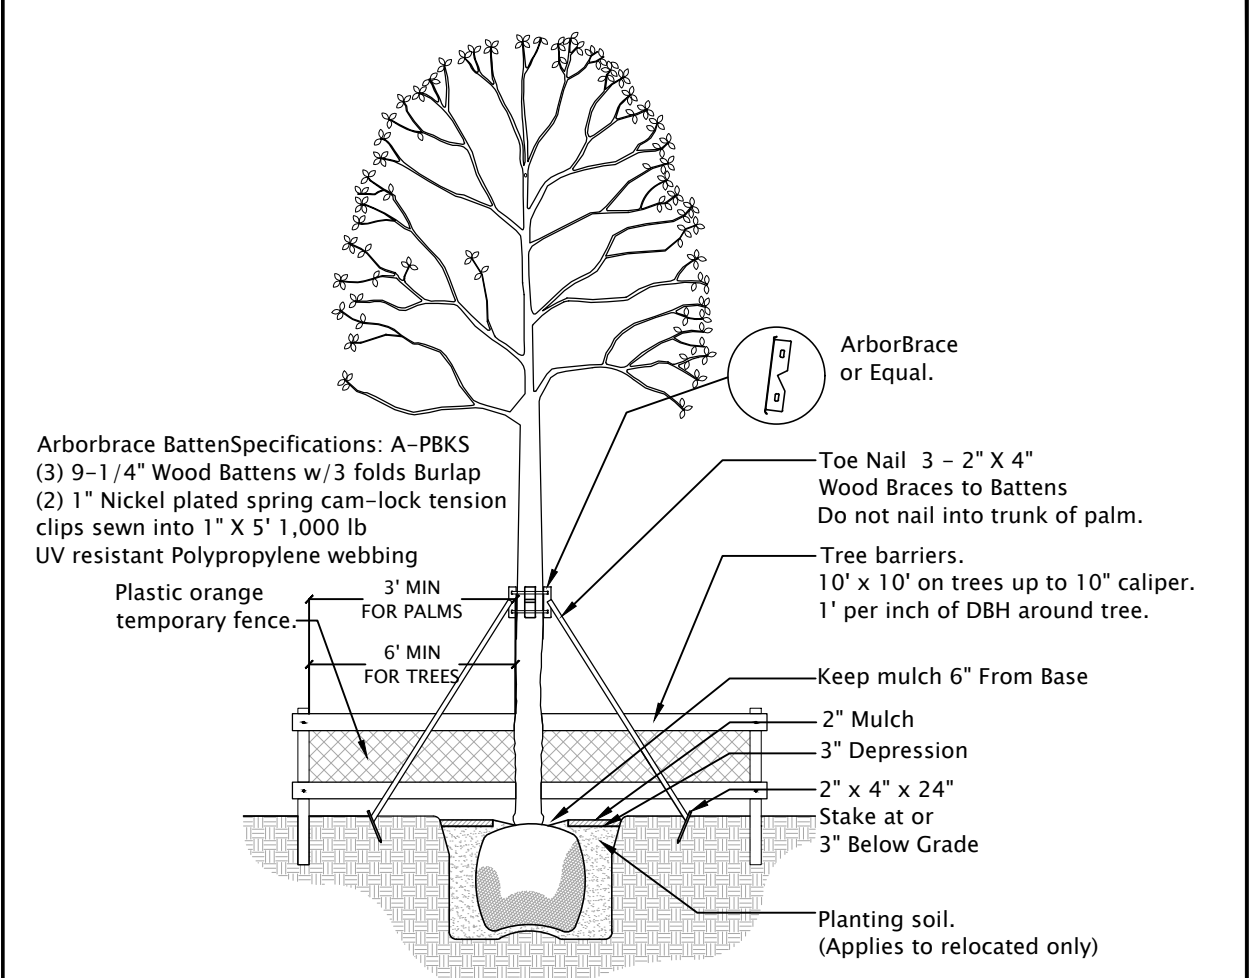
Existing & Relocated Trees and Palms  
Protective Barrier & Bracing Section Detail

N.T.S.  
Place three wood braces on trees & palms up to 8" caliper  
Place four wood braces on trees & palms over 8" caliper  
Place protective barrier on trees & palms to remain and trees & palms to be relocated.  
Existing barriers on trees to remain or planted may be made constructed of wood and plastic orange temp. fence.

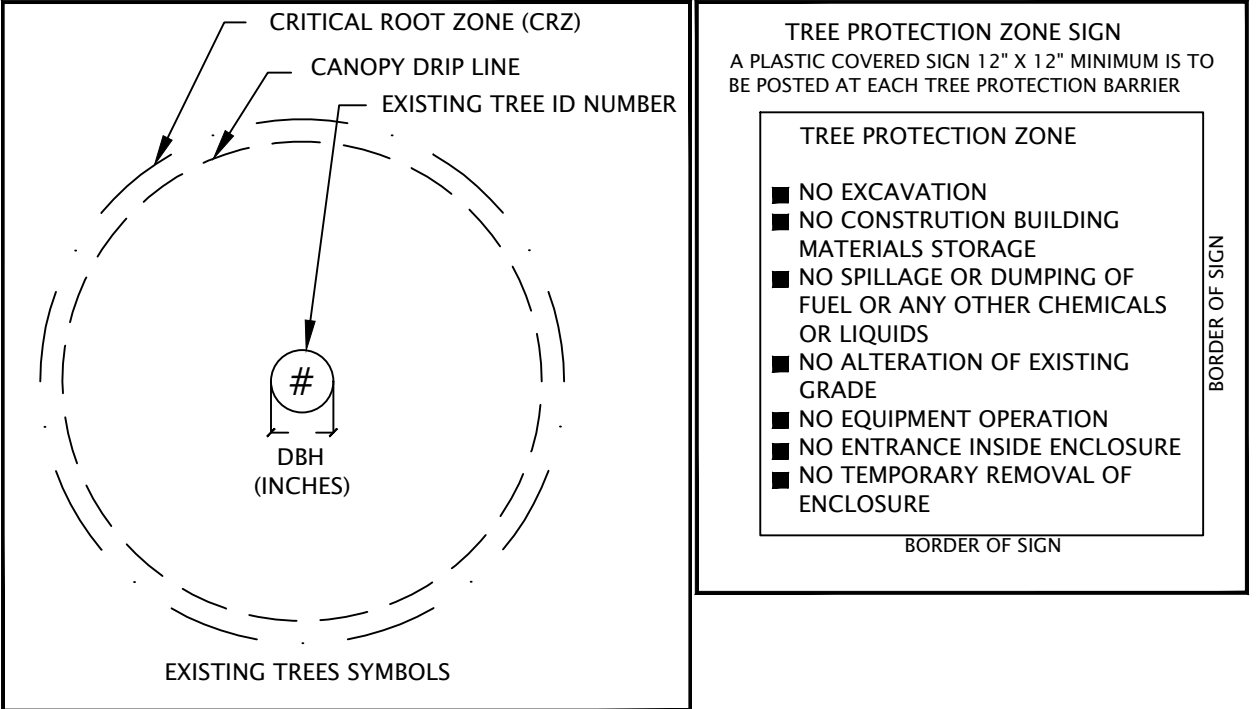
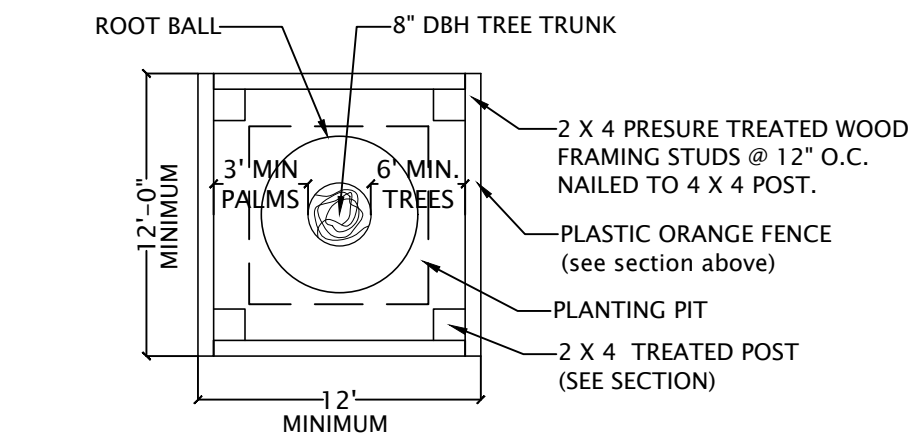
TREE PROTECTIVE BARRIER DETAIL-PLAN VIEW DETAIL  
Tree protection during construction. N.T.S.

PROTECTIVE BARRIERS TO BE MINIMUM 6' FROM TRUNK OF TREES AND 3' FROM TRUNK OF PALMS. BARRIERS MUST BE MINIMUM 2' FROM EDGE OF PAVEMENT.

- ALL EXISTING TO REMAIN, ROOT PRUNED TREES FOR RELOCATION OR RELOCATED TREES WITHIN THE SITE SHALL HAVE A PROTECTIVE BARRIER AS SPECIFIED IN THE TREE PROTECTION BARRIER DETAIL IN THE TREE DISPOSITION PLAN.
